## **AFFIDAVIT OF BETTY B. WERNER**

3. I am the co-owner of a farm consisting of approximately 58.6 acres known as Four Corners Farm in Franklin County.
4. I have been monitoring the construction activity for the Mountain Valley Pipeline, and documenting violations of the terms of the 401 Certification and impacts to Teels Creek and Little Creek and the unnamed tributaries to these streams.

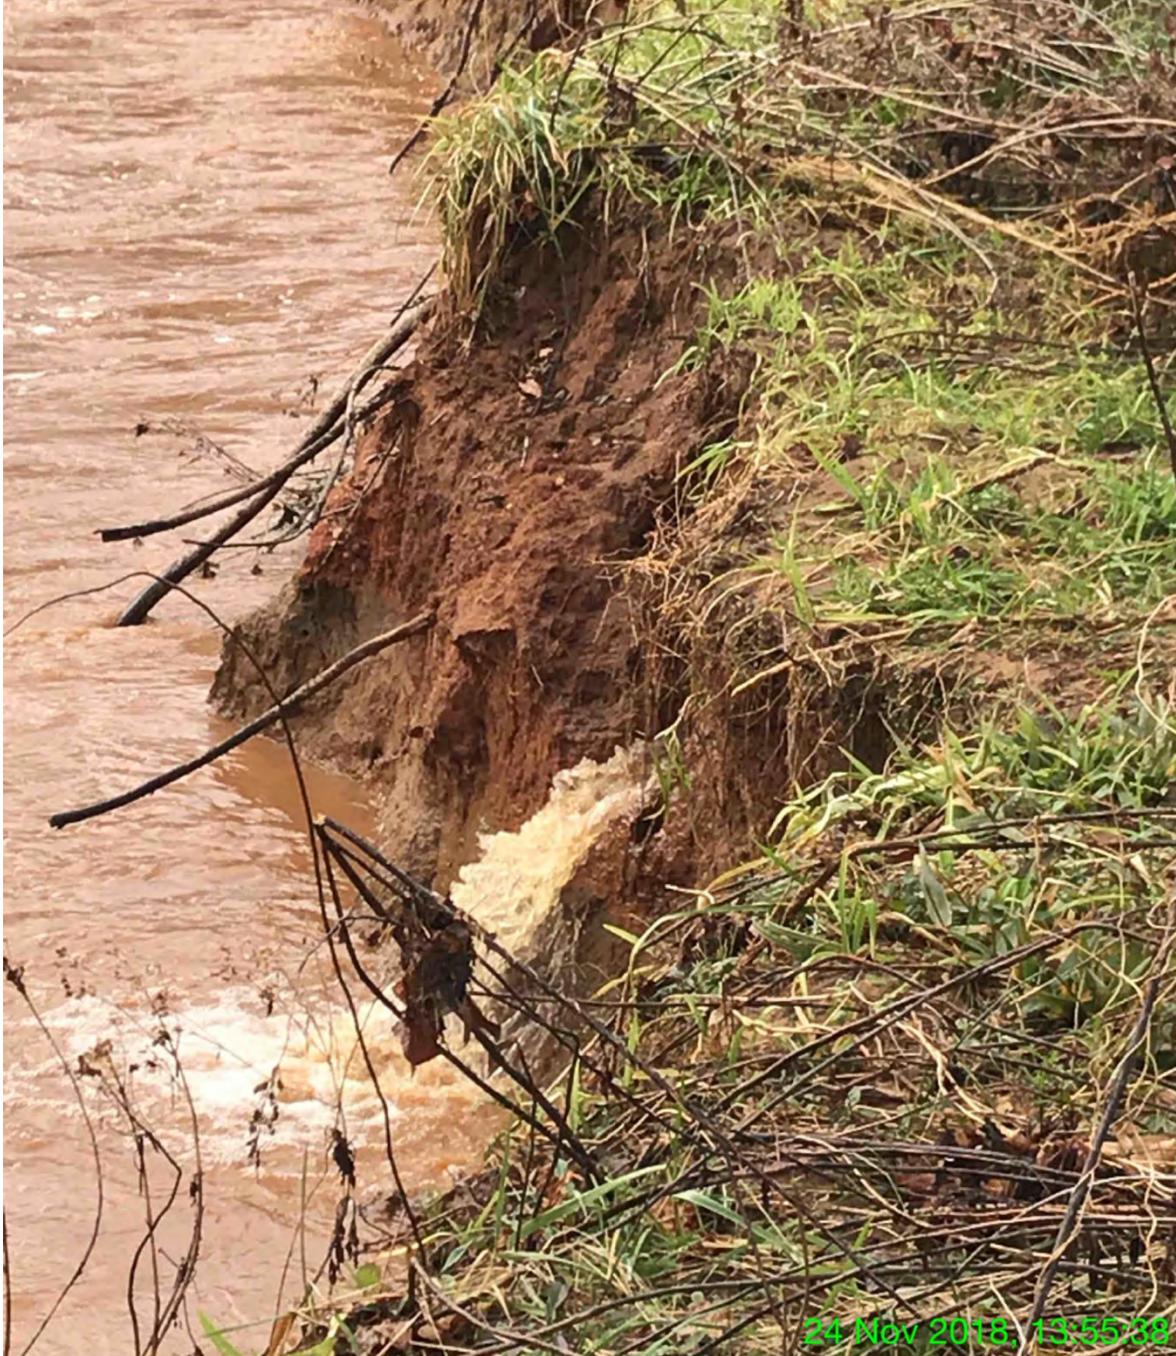
12. On November 15, 2018, I discovered that water was gushing out of the bank of Little Creek. See Exhibits A, B, and C. It was the sound of the water that got my attention.

EXHIBIT A – Water gushing out of bank of Little Creek on Four Corners Farm, November 24, 2018. The gusher was discovered on November 15, 2018.

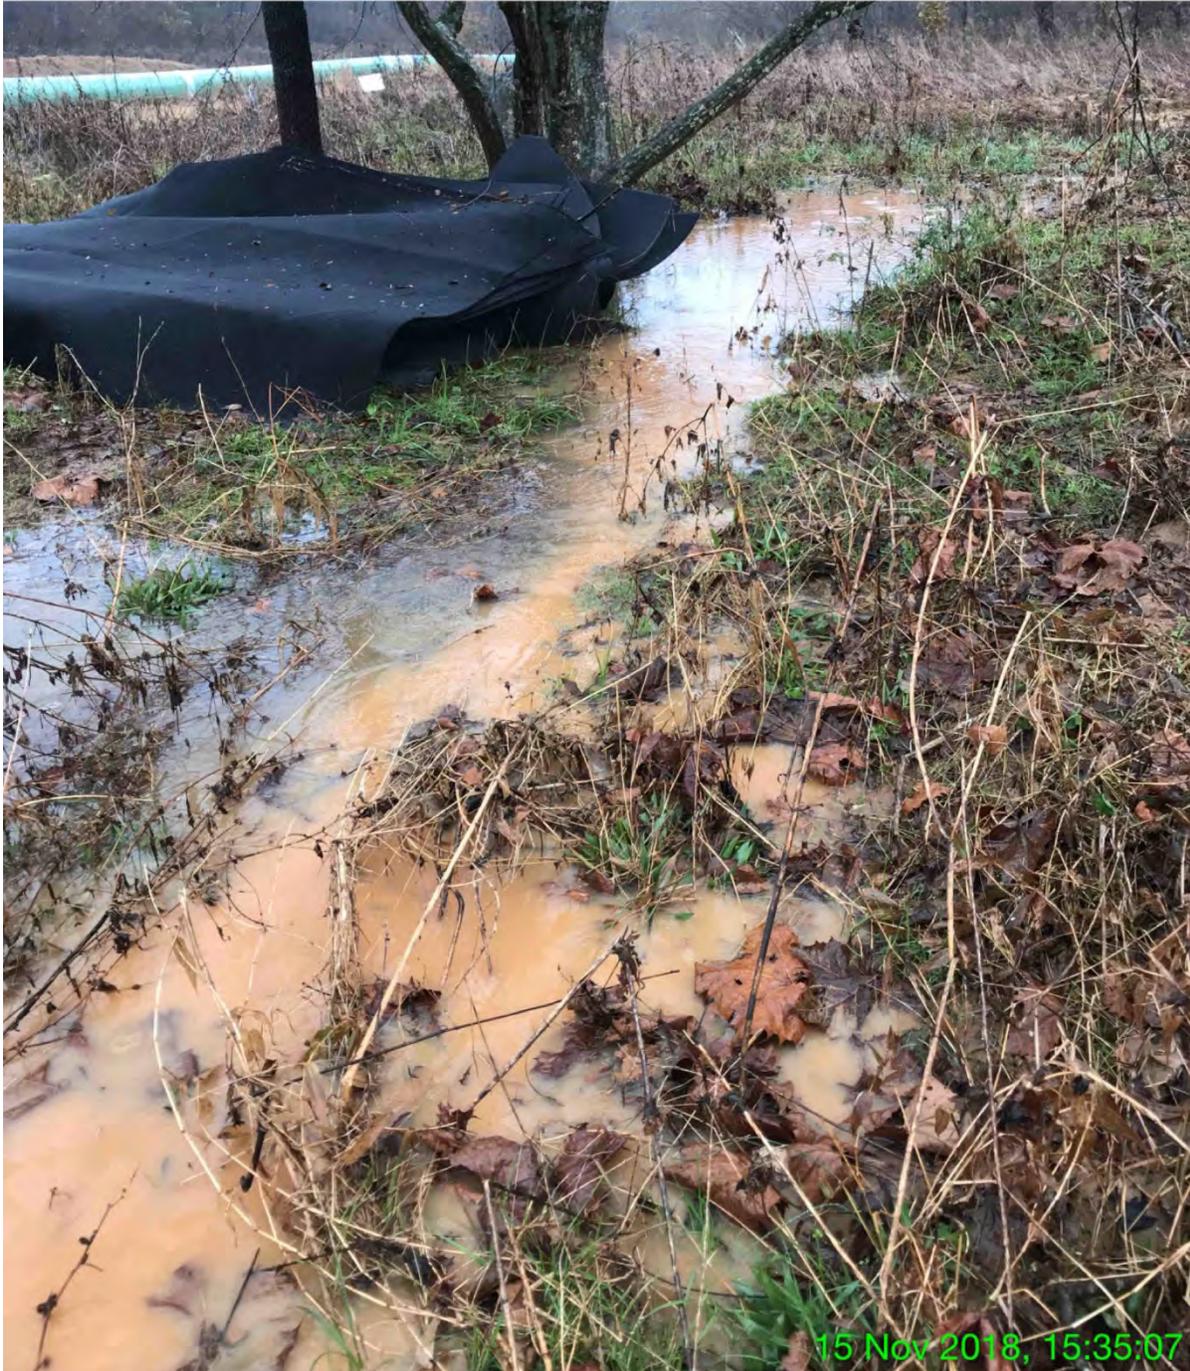
EXHIBIT B – Sediment-laden stormwater that was flowing out the gusher on the creek bank when the gusher was discovered on November 15, 2018. The black matting against the tree washed off the corridor and is a point of reference in these photos.

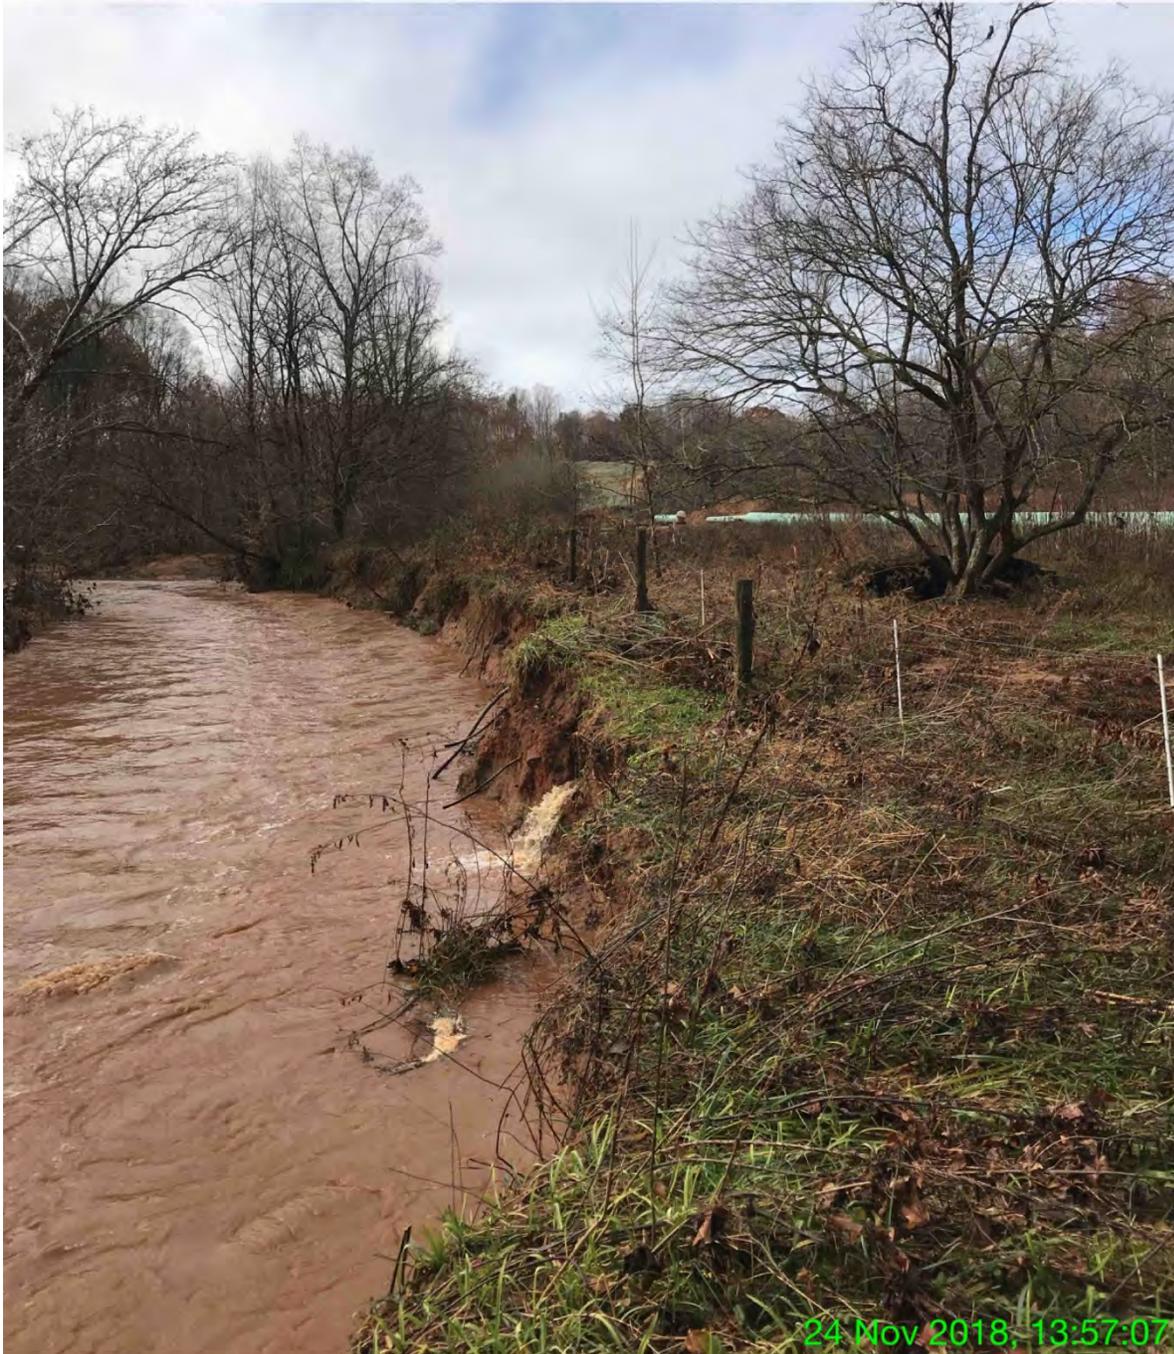
16. Before construction started, the fencing in Exhibit C was at least six feet from the bank of Little Creek. The creek is scouring our land away like no other time in our ownership of the property.

18. Comparing Exhibit C to Exhibit H, the fence will soon collapse into the creek. It would be only a matter of time before the pipeline itself would be at risk.

EXHIBIT C – Water gushing out of bank of Little Creek. Note the location of the cattle fence on the creek bank. Black matting against the tree and pipe on ground in background.

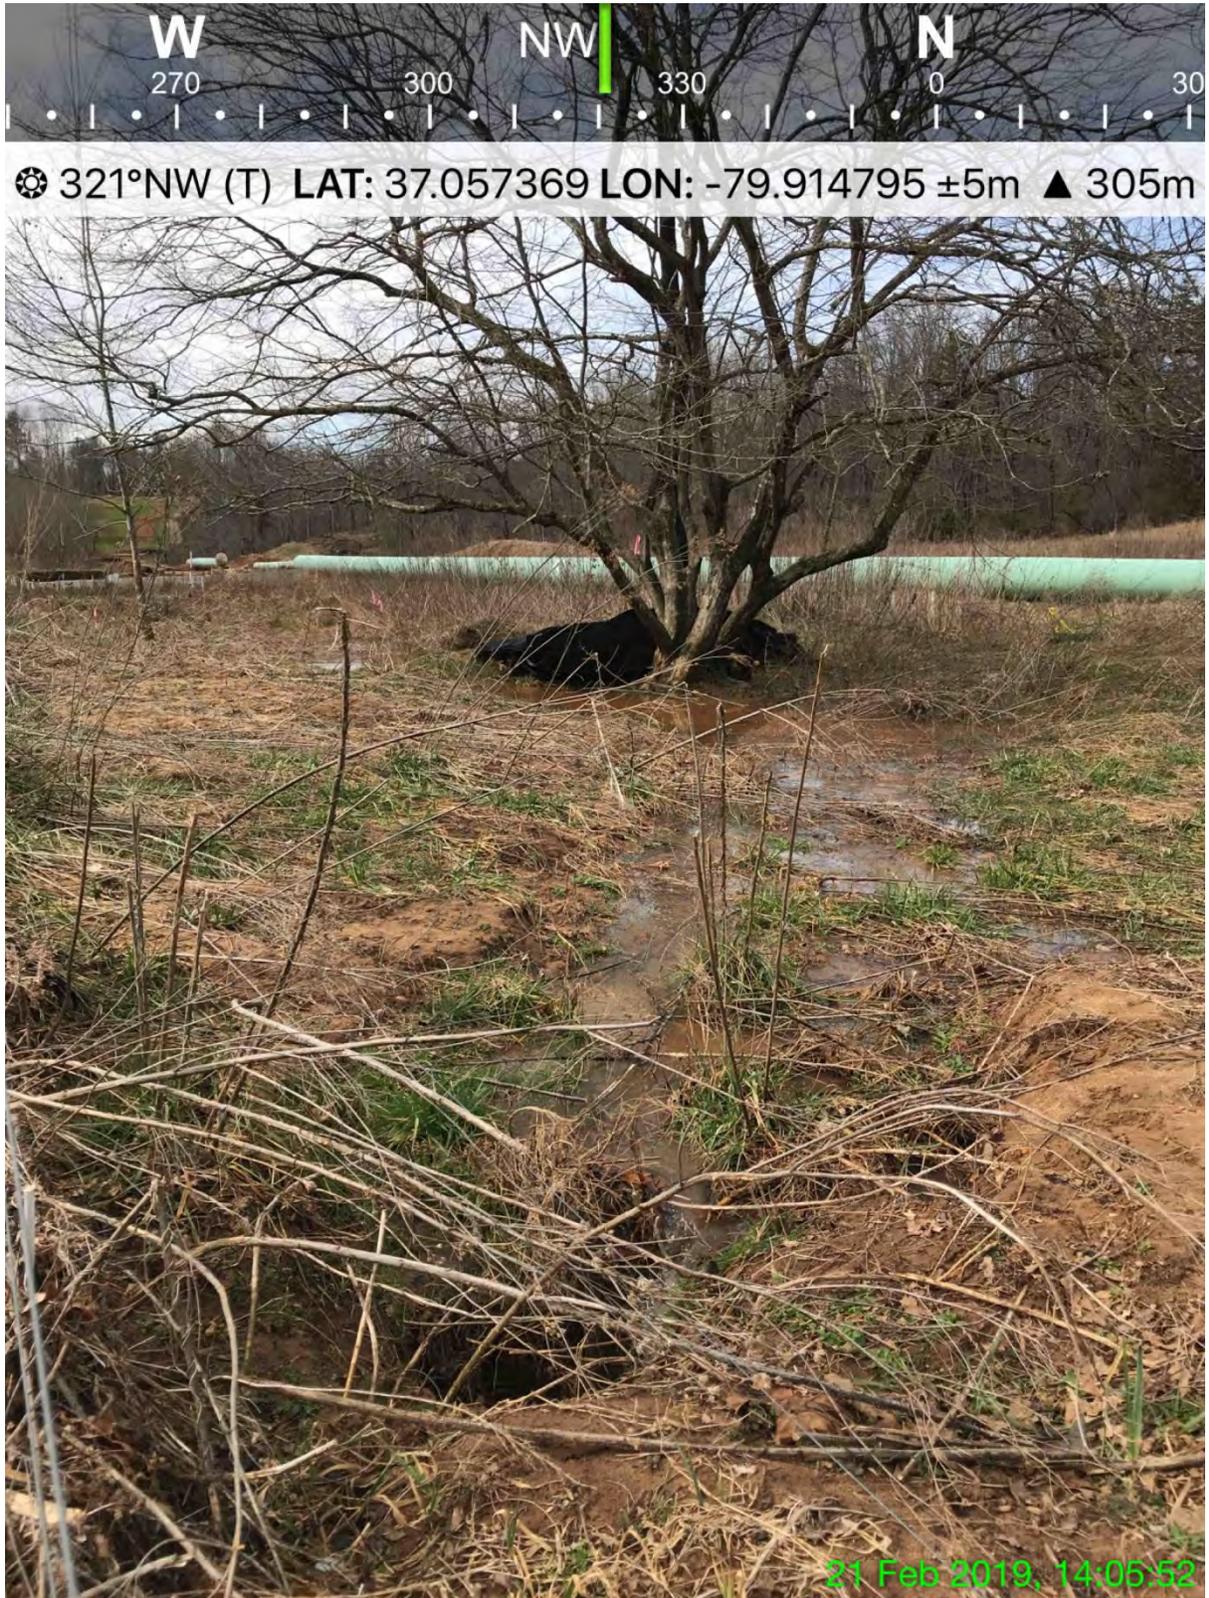
EXHIBIT D – Water flow from corridor toward Little Creek. The water that had been gushing from a hole is now eroding the creek bank.

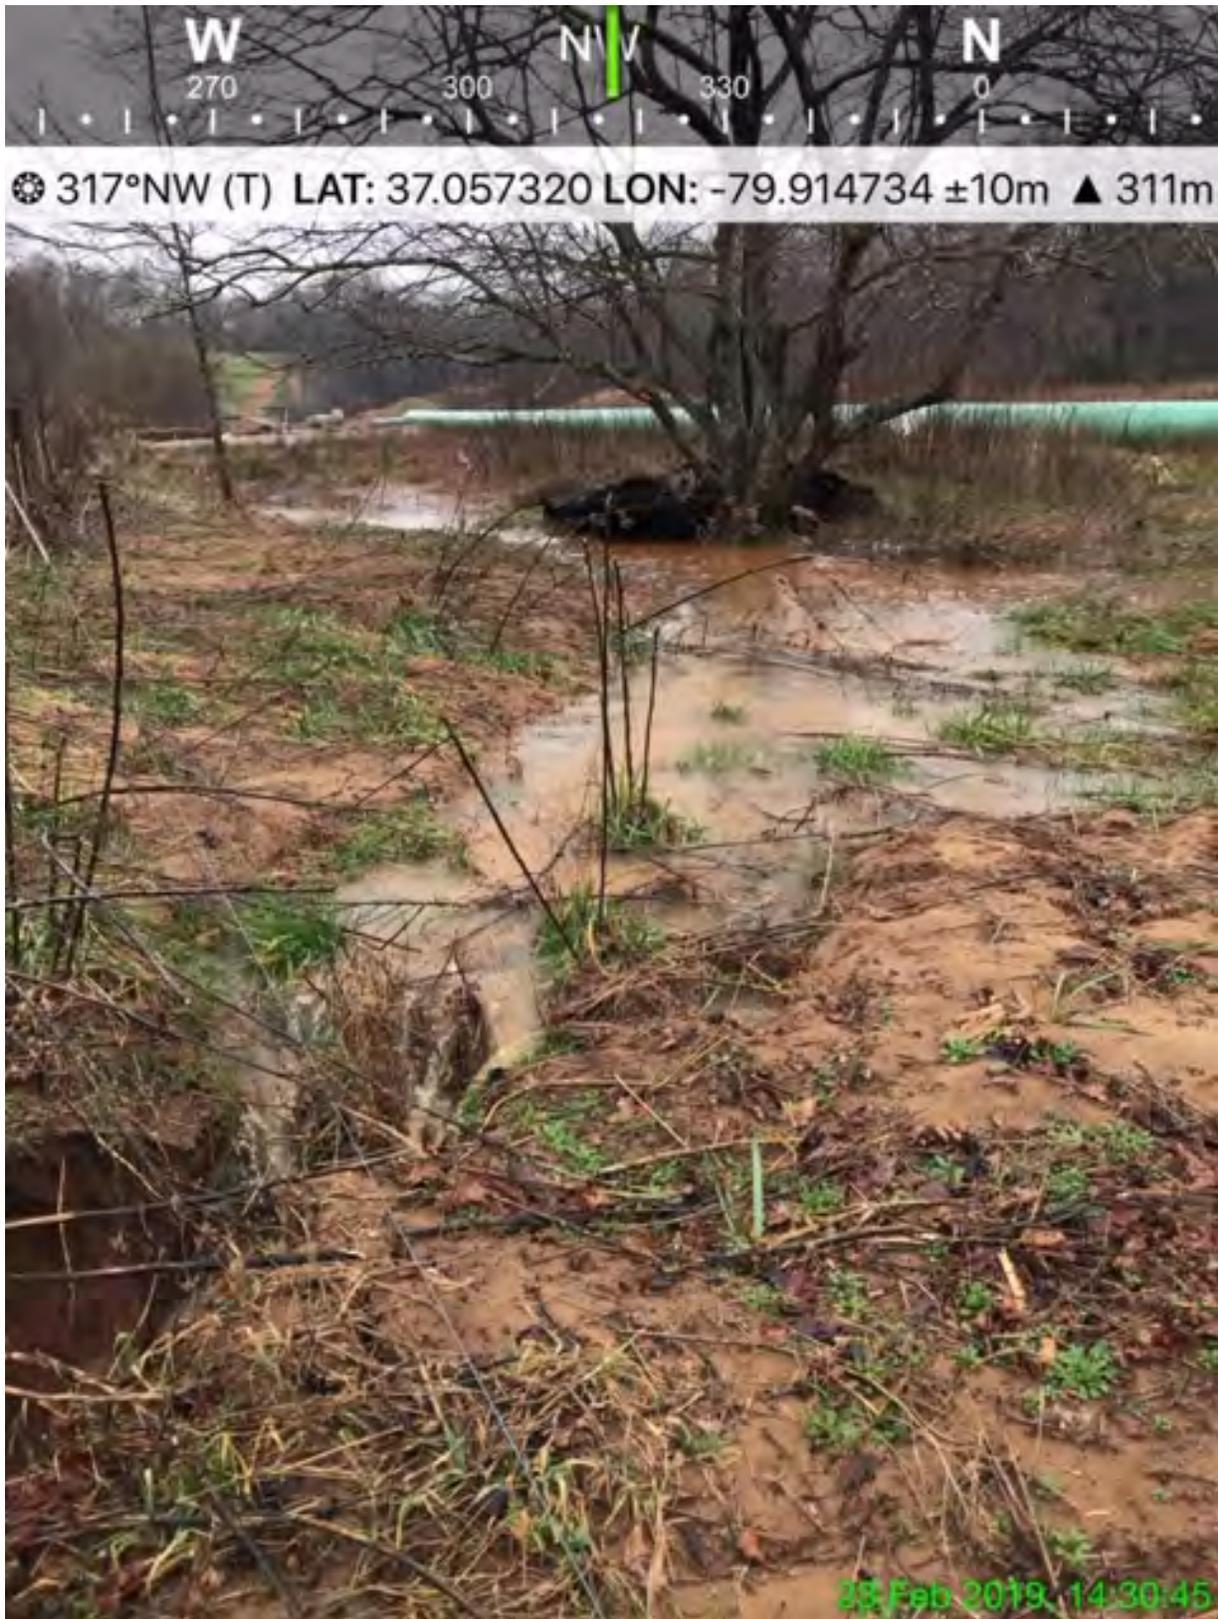
Exhibit E – Same location as in Exhibit D, two days later, after 2.5 inches of rain. The drainage into the creek is collapsing. The fence wire is visible on the left.

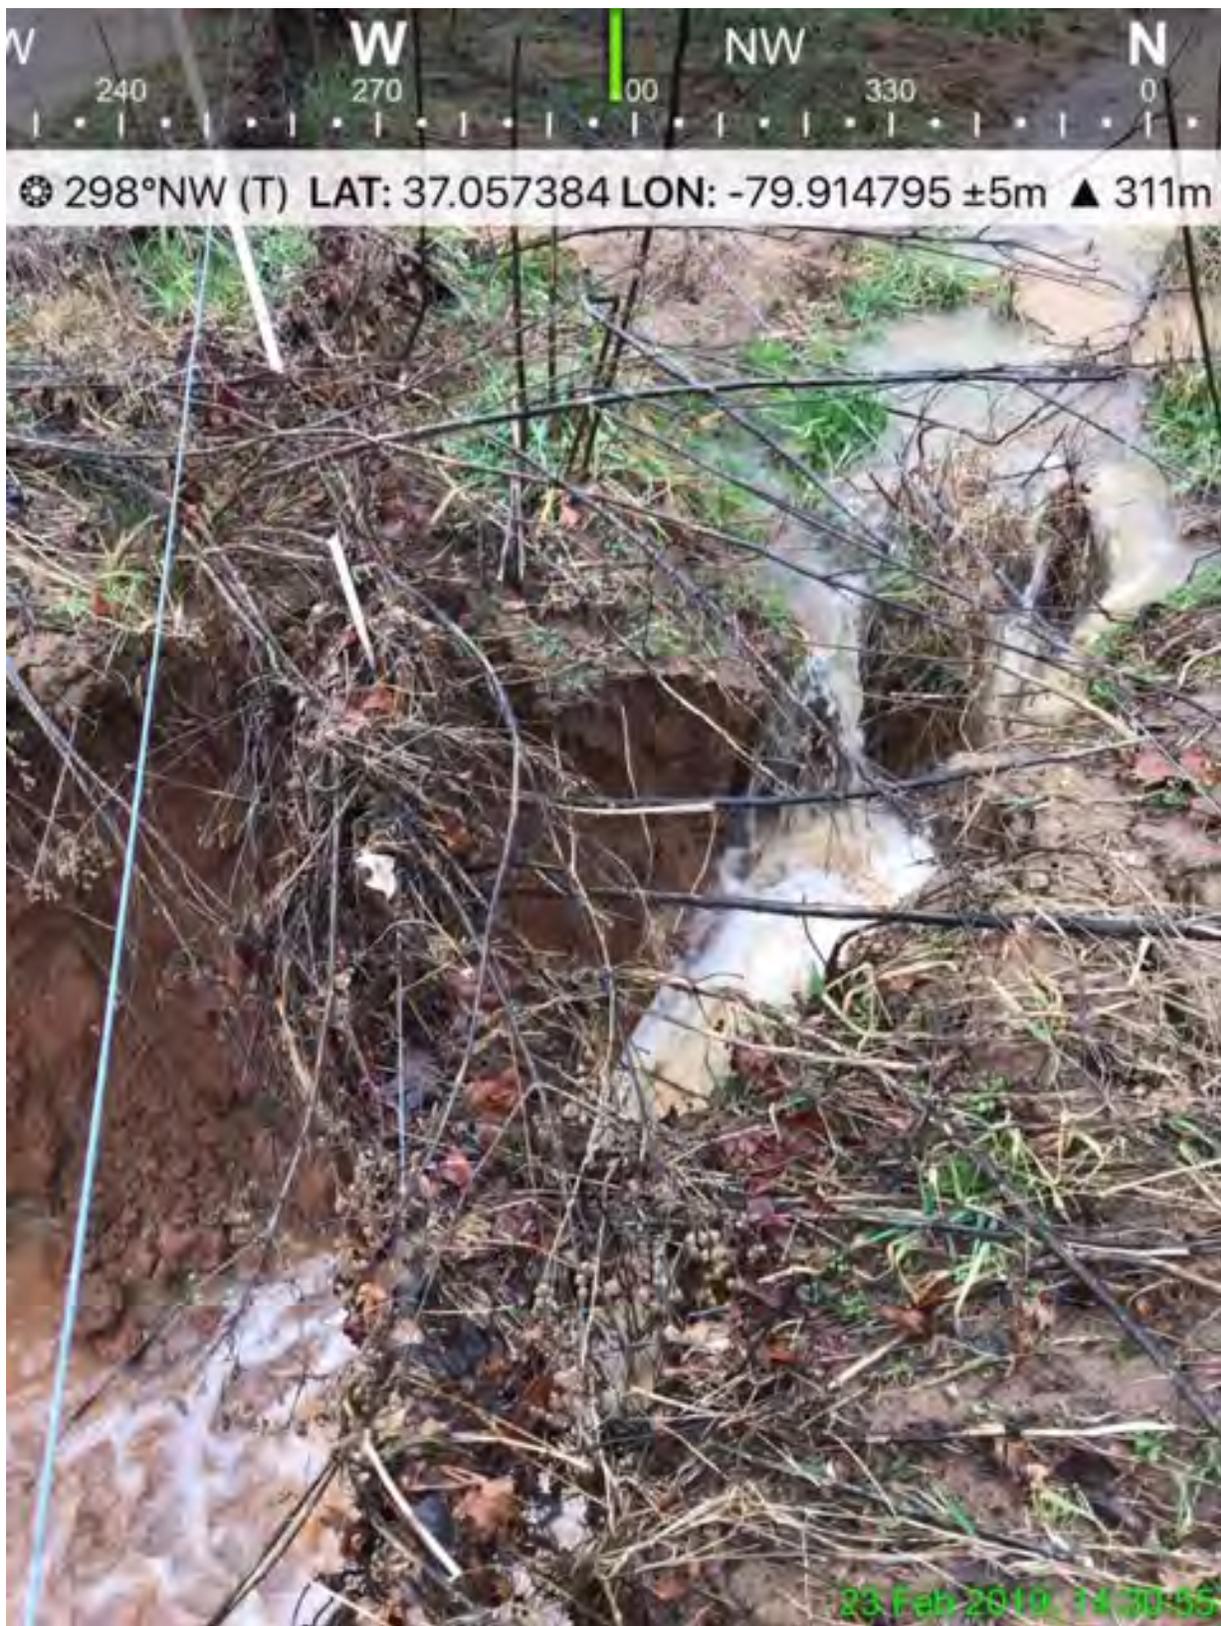
17. As of February 23, 2019, the gusher, which had a pipe effect through the stream bank, has eroded the bank to a full ditch condition with the sides of the bank collapsing around the ditch.

EXHIBIT F – A close-up view of the gusher eroding the creek bank on February 23, 2019. Notice the fence wire.

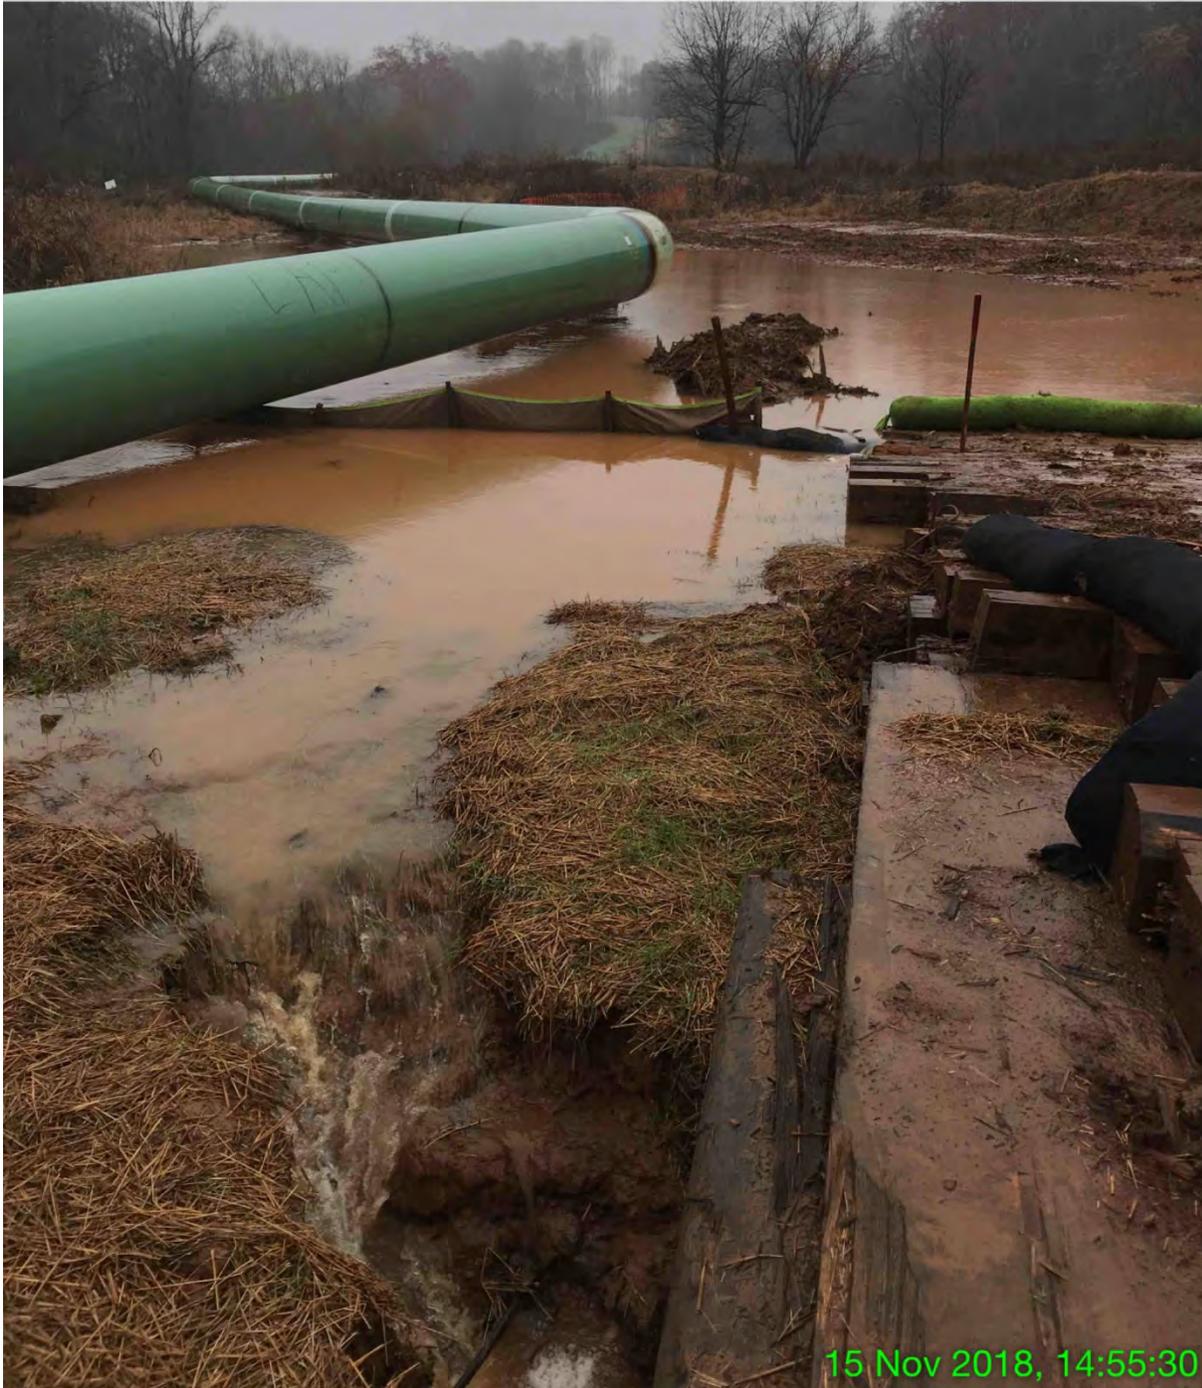
EXHIBIT G – The upstream side of the bridge over Little Creek. Muddy water flows under the bridge and out the downstream side of the bridge before entering the creek, seen in Exhibit H.

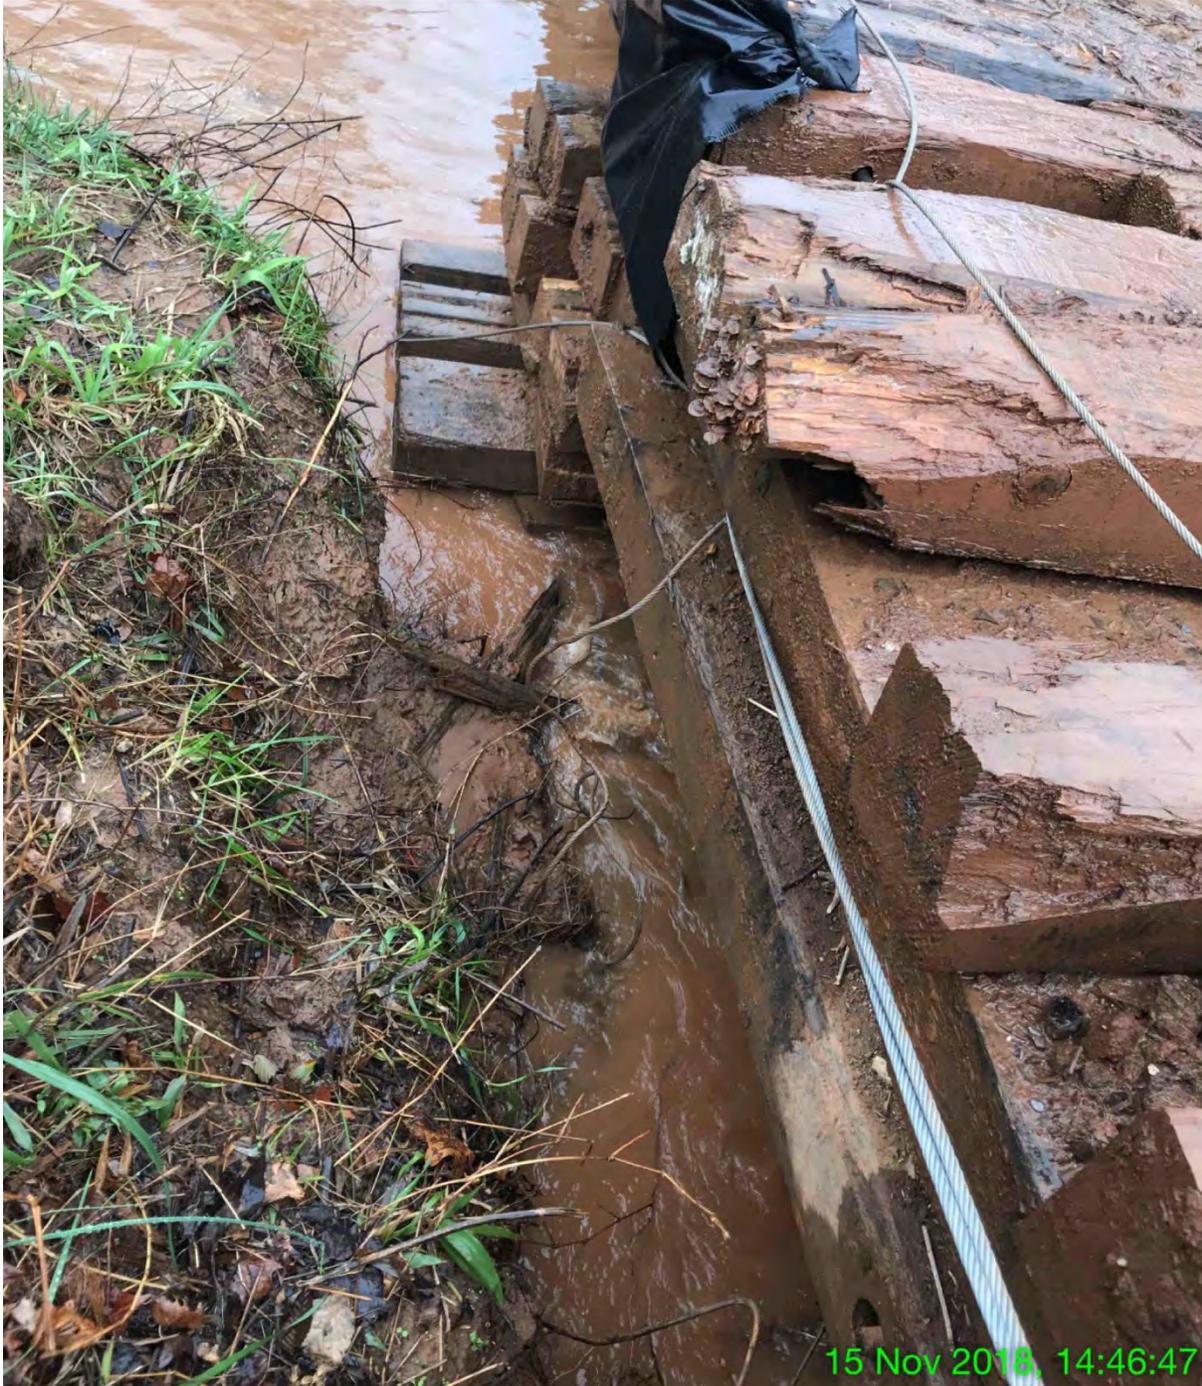
EXHIBIT H – The downstream side of the bridge over Little Creek. Muddy water flowing from the upstream side of the bridge, and under the bridge and into Little Creek with the creek almost full.

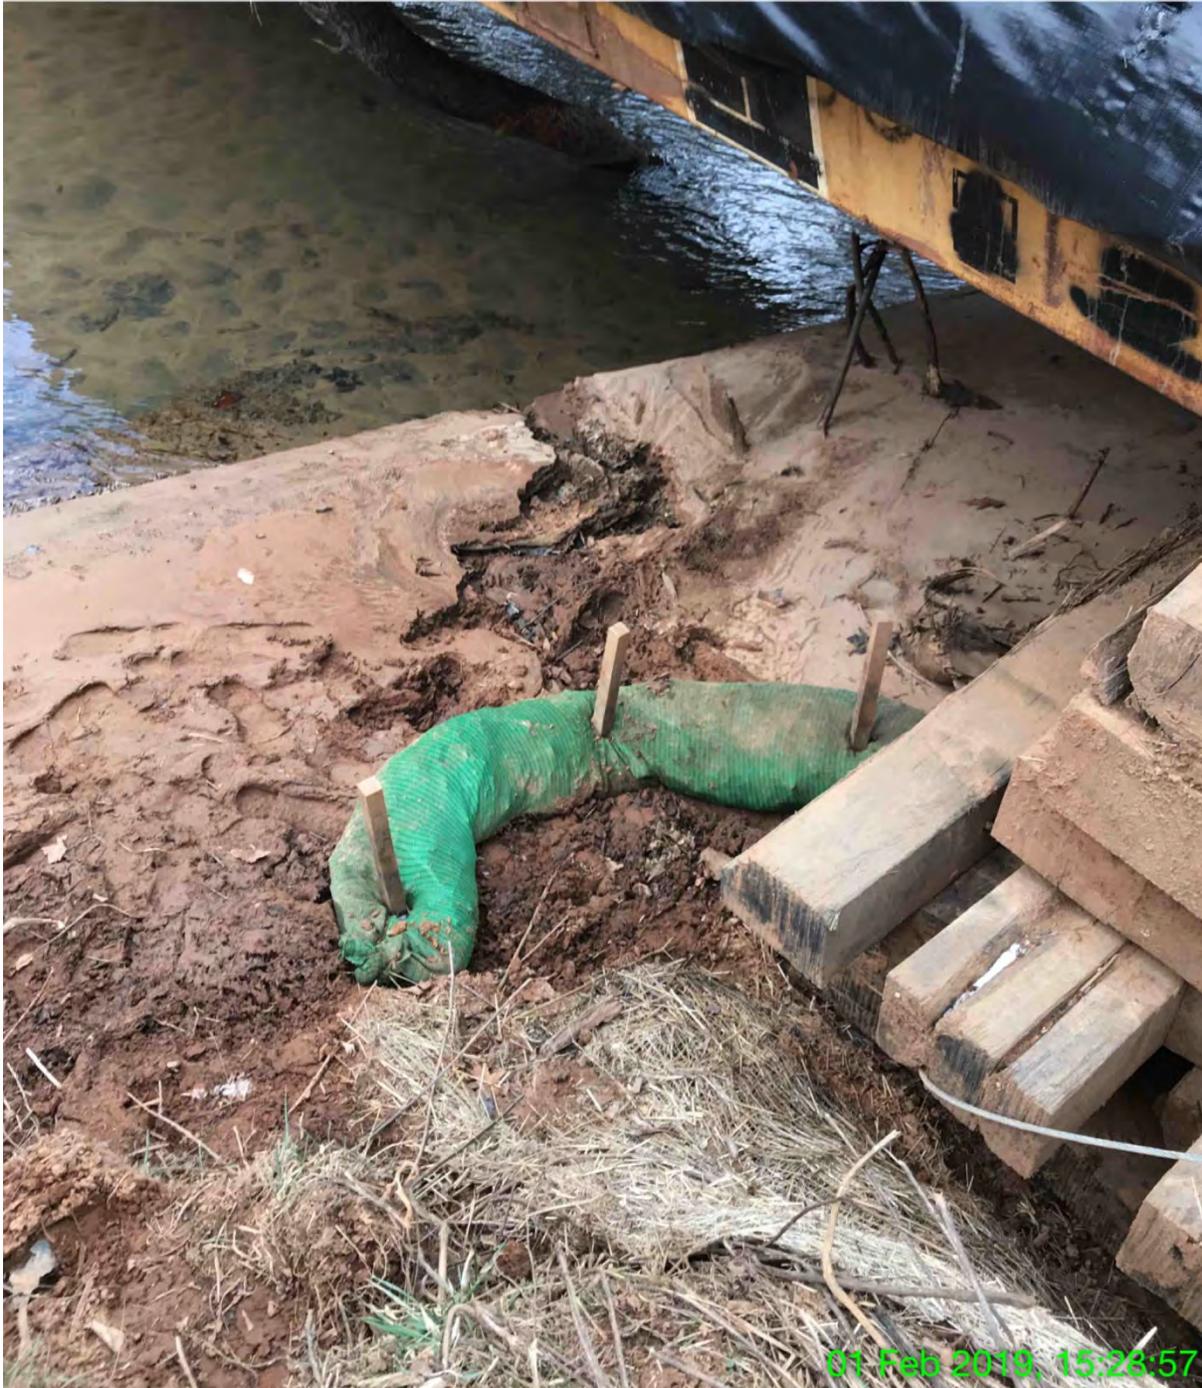
EXHIBIT I – The downstream side of the bridge over Little Creek which is the same location as Exhibit H above. The creek bottom which used to be rocky is covered in sediment. Sediment is piled on the banks. The erosion control sock had been recently installed when this photo was taken on February 1, 2019.

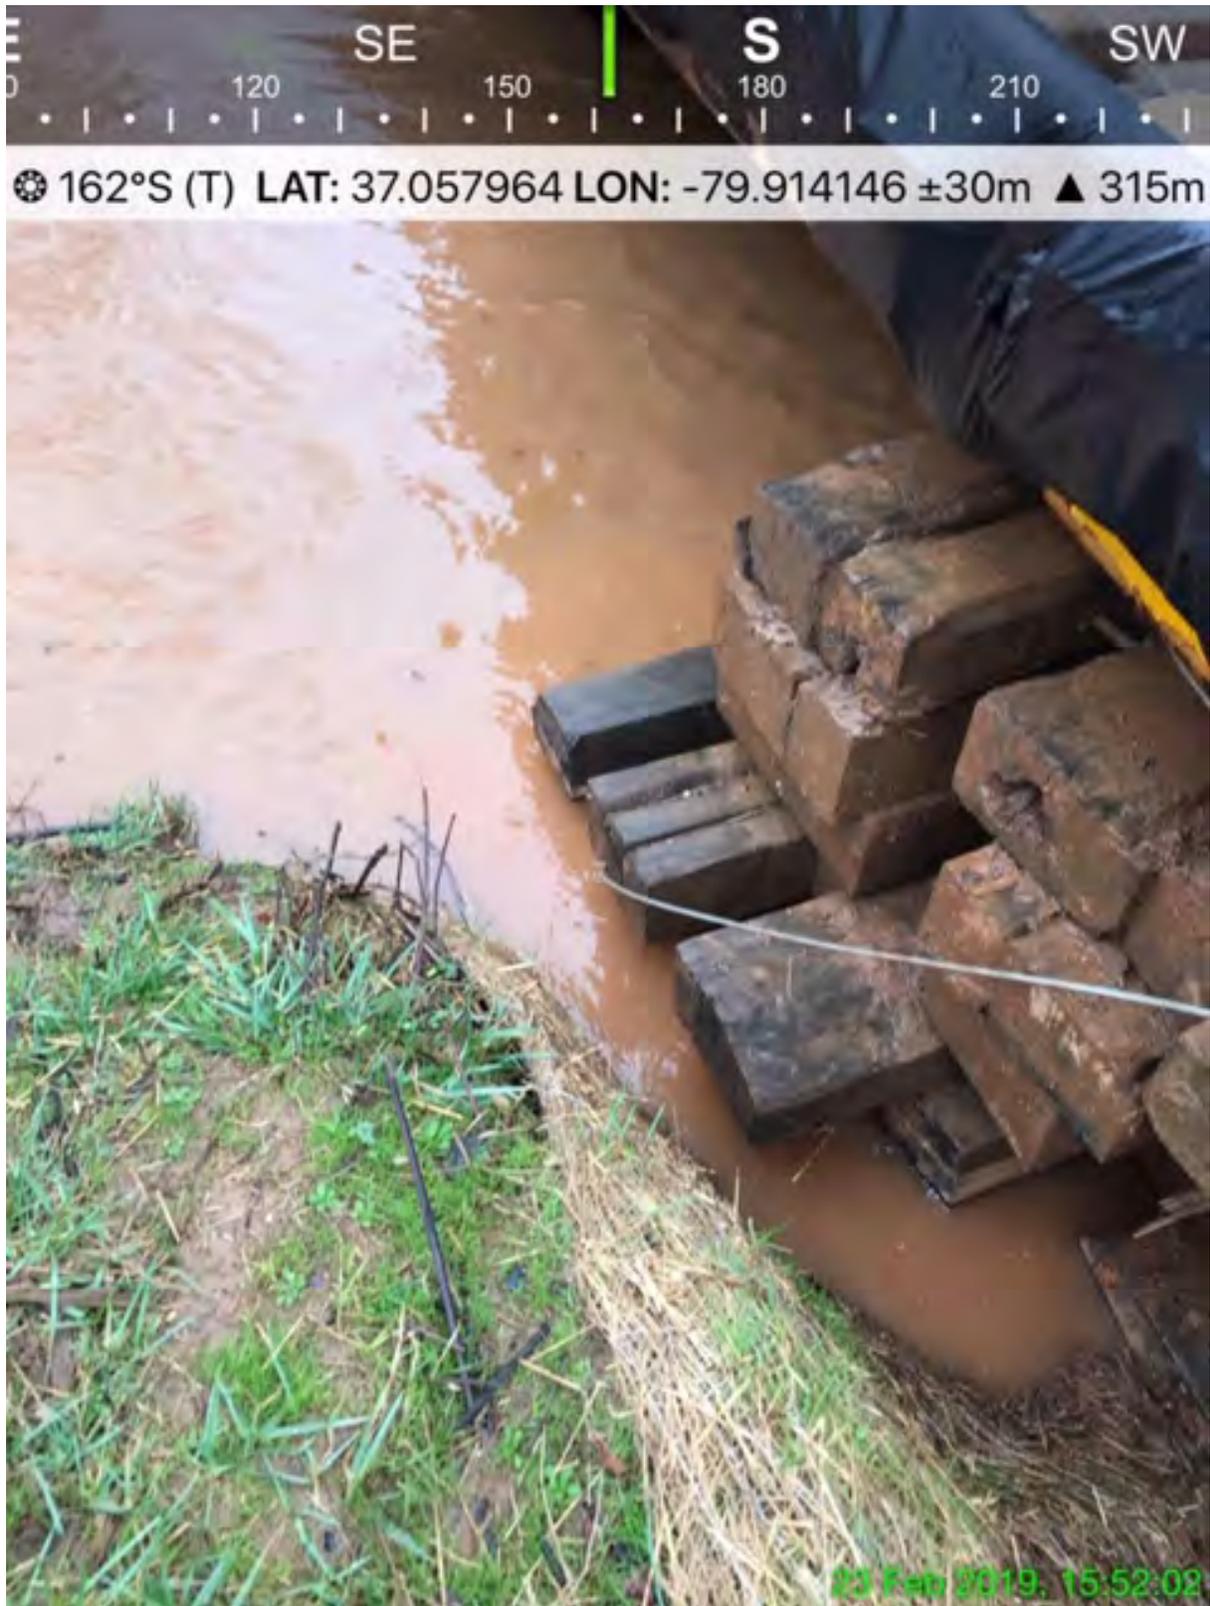
EXHIBIT J – The downstream side of the bridge across Little Creek on February 23, 2019. This is the same location as in Exhibits H and I.

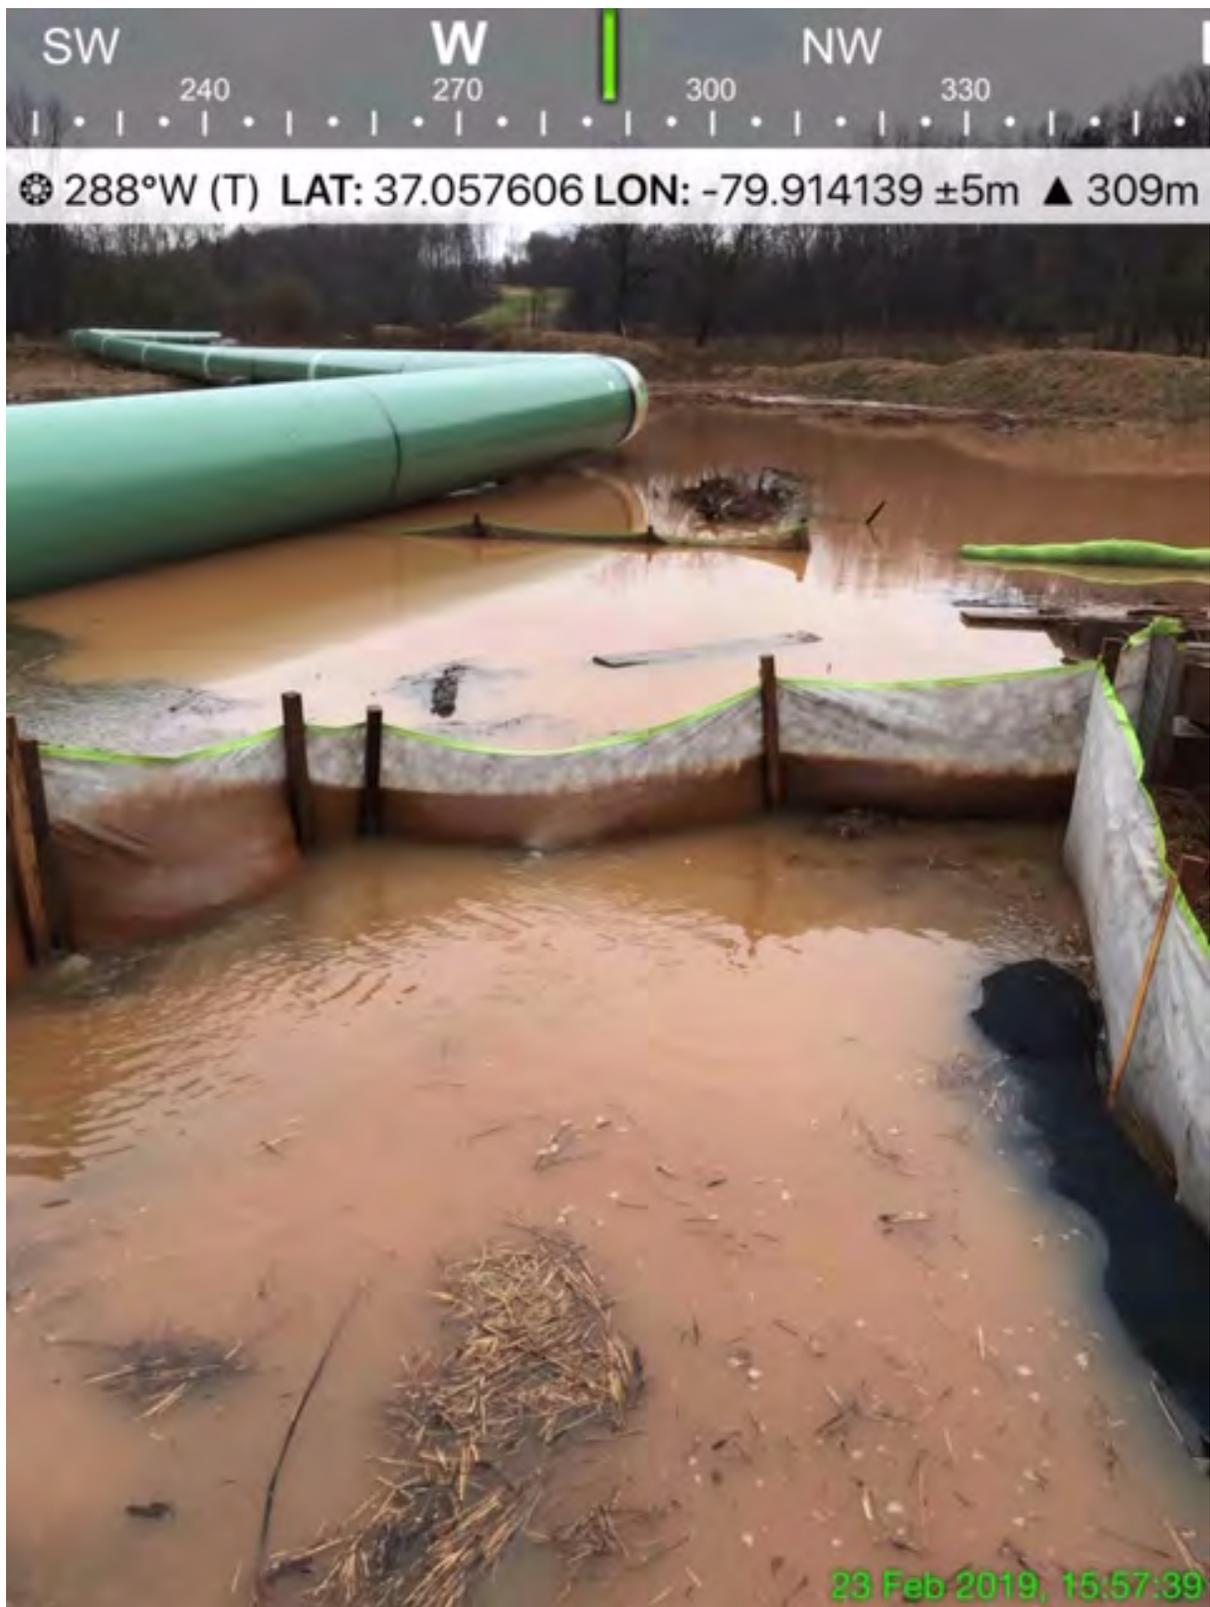
EXHIBIT K – The upstream side of the bridge over Little Creek on February 23, 2019. This is the same location as Exhibit G.
