The Angle Property

The following photographs portray damage and violations caused by MVP on land and waters at the Angle family's property in Franklin County. The problems stem from MVP's failure in a number of specific requirements.

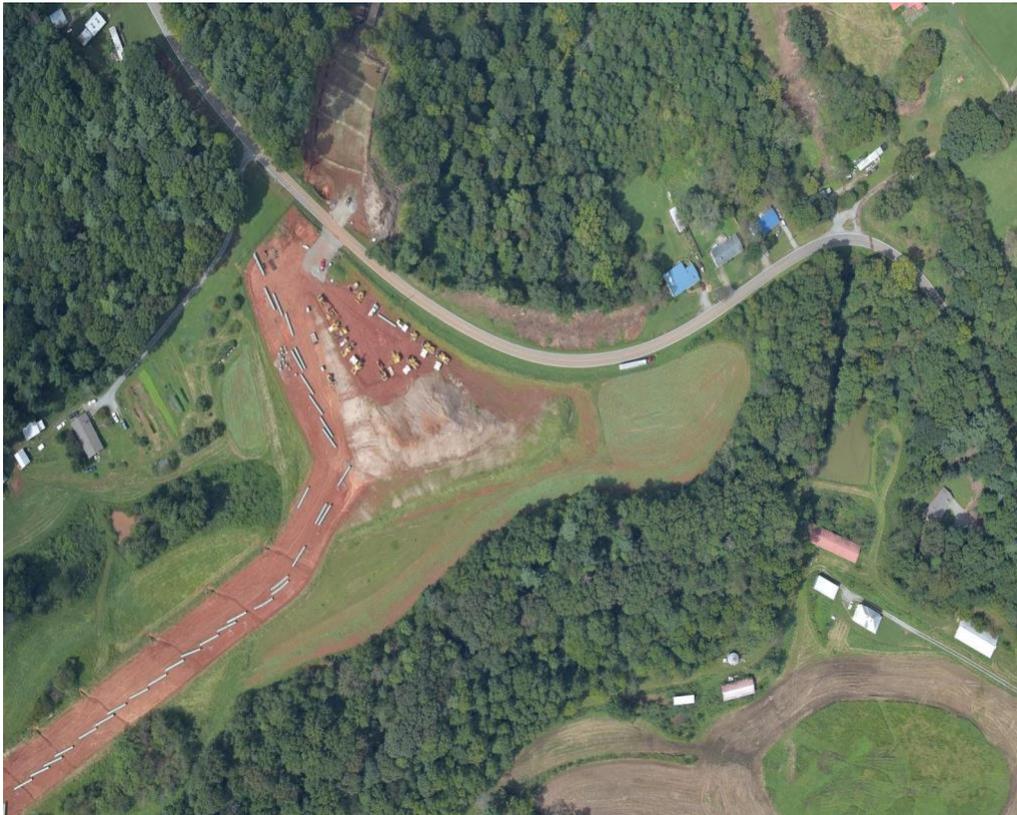
The aerial photo of the Angle farm below shows areas of bare soil present since at least September 2018.

Figure 1 - Aerial image of the Angle property September 18, 2018.

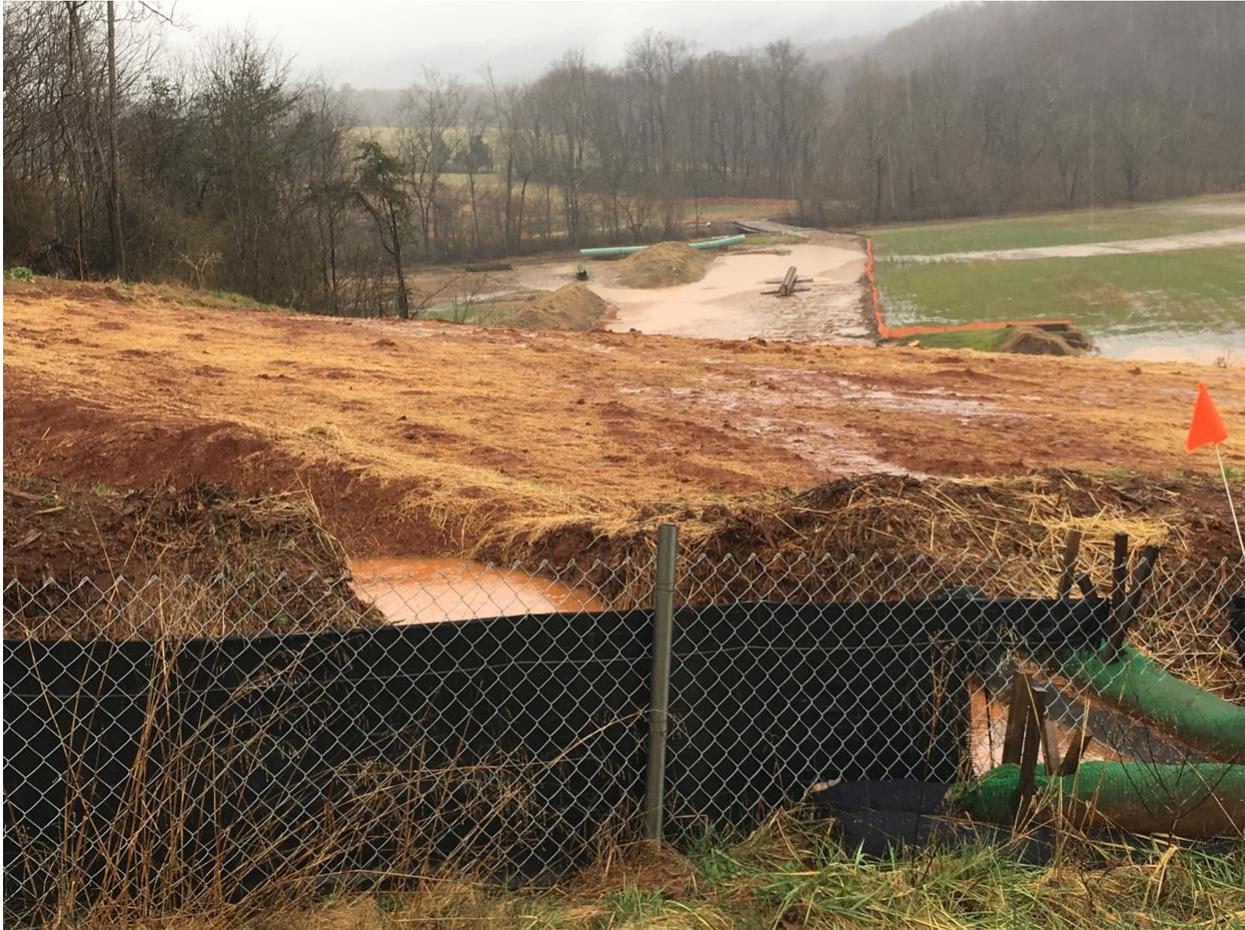
As shown in the photo below, much of the site remains bare to this day and the soils are still not stabilized, despite the fact that the pipe was installed and most of the trench covered in October 2018. While some straw is spread across the surface in the foreground, the portions in the floodplain below are entirely bare and parts are covered by a significant body of standing water.

Figure 2 - Angle property, February 23, 2019

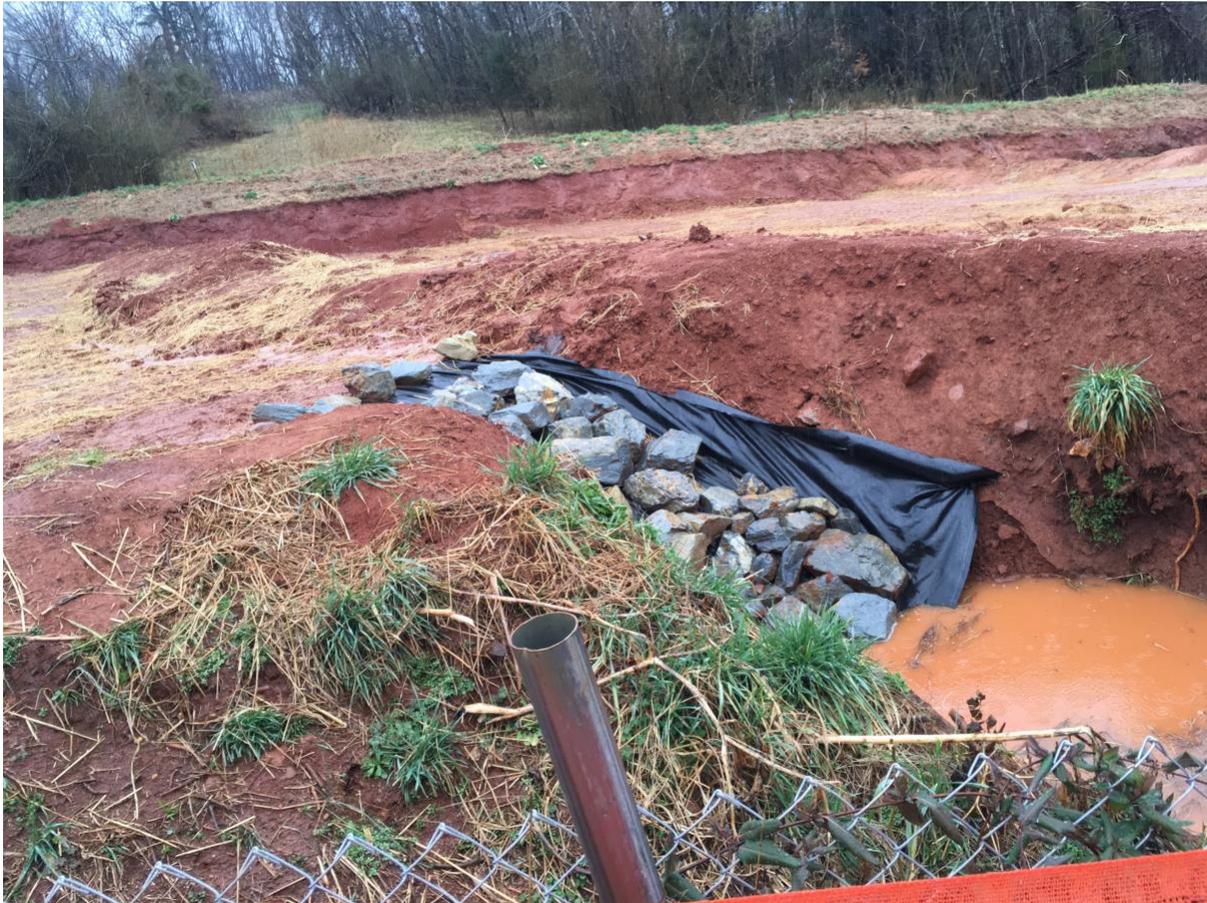
The photo below shows significant sections of bare, unstabilized soil that has been in that condition for around 4 months, since October 2018. In the foreground is a “water bar” which is intended to channel water across the right-of-way to the settling basin seen in the lower right corner. Note that this water diversion structure is itself unstabilized and contributing eroded soil to the flows leaving the site.

Figure 3 – Angle Property, February 23, 2019

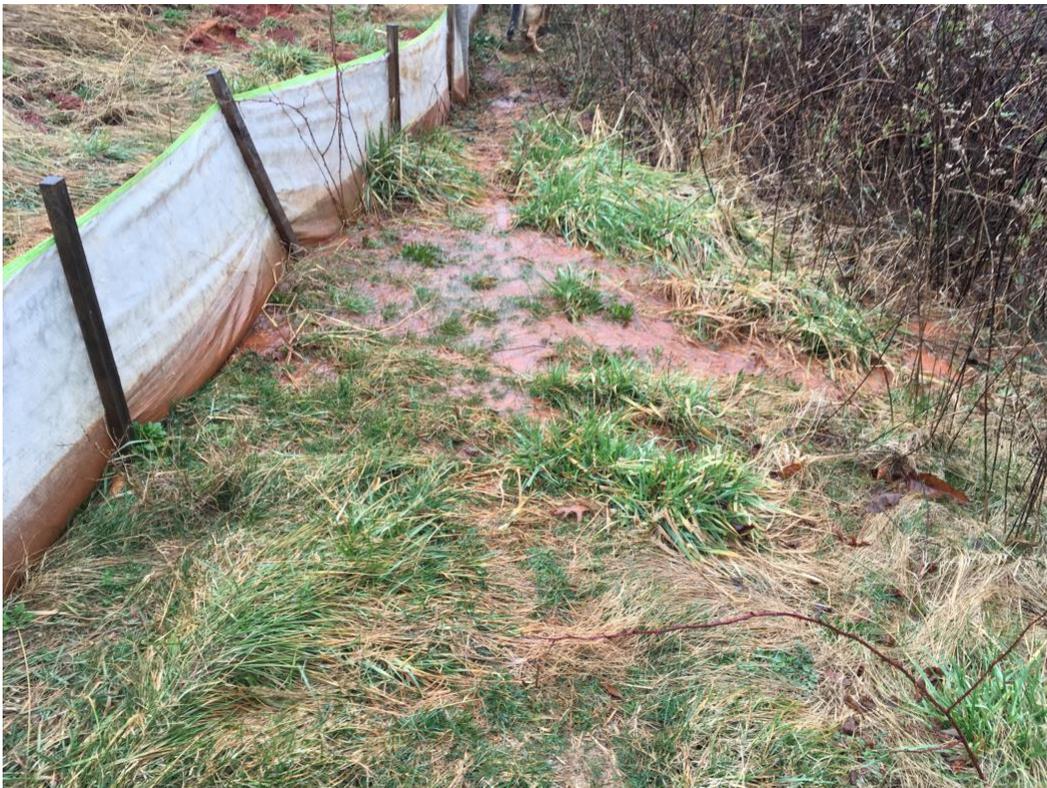
“Perimeter controls,” such as the white silt fencing seen below and other methods, are supposed to stop sediment from flowing out of the work area. The photo below, taken last weekend, shows one of a number of instances where the silt fence is failing

Figure 4 – Angle Property, February 23, 2019 (muddy water flowing under silt fence)

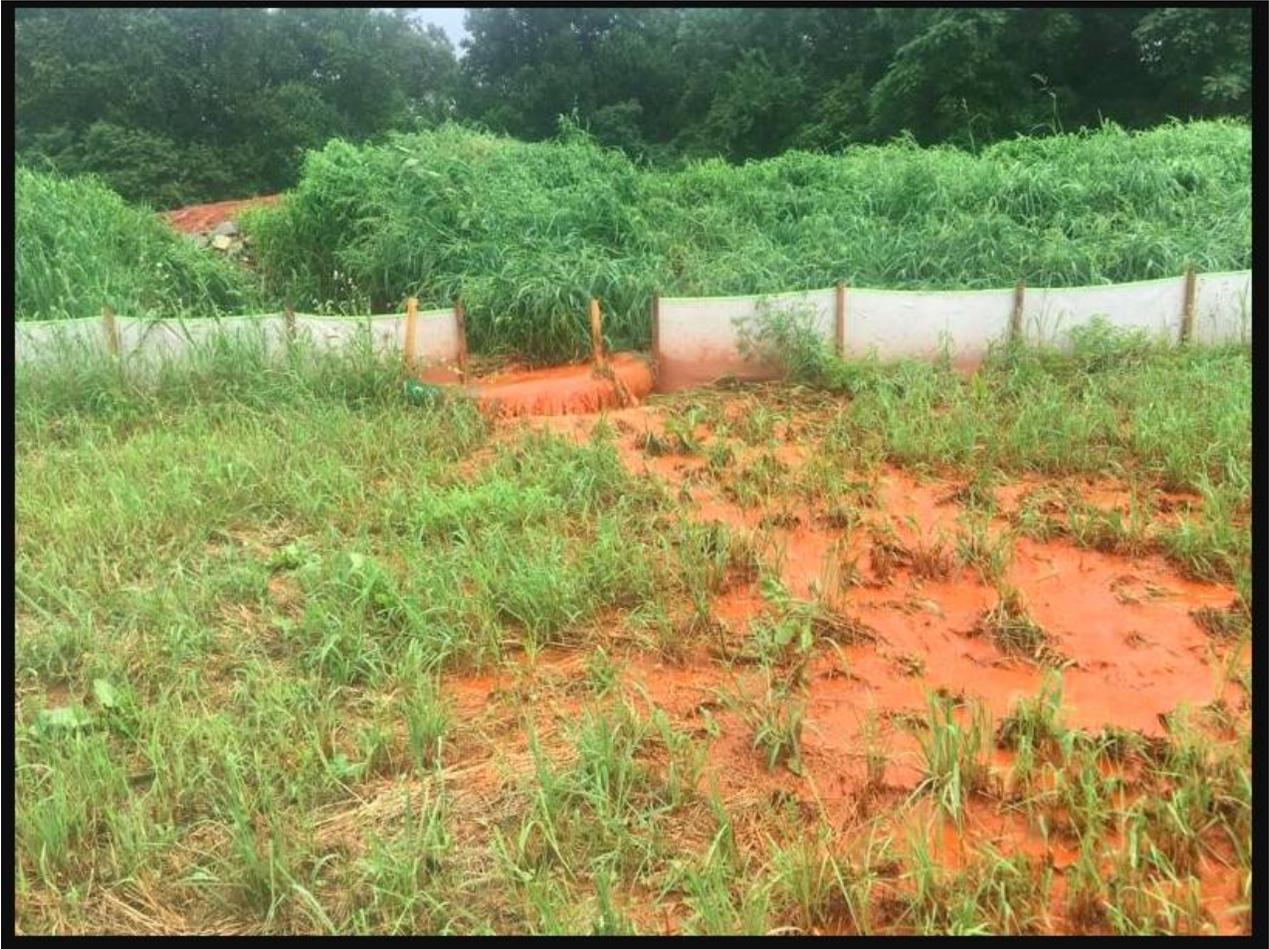
Below is a failure of an outlet protection structure.

Figure 5 - Angle Property, August 3, 2018 (outlet from water bar failing)

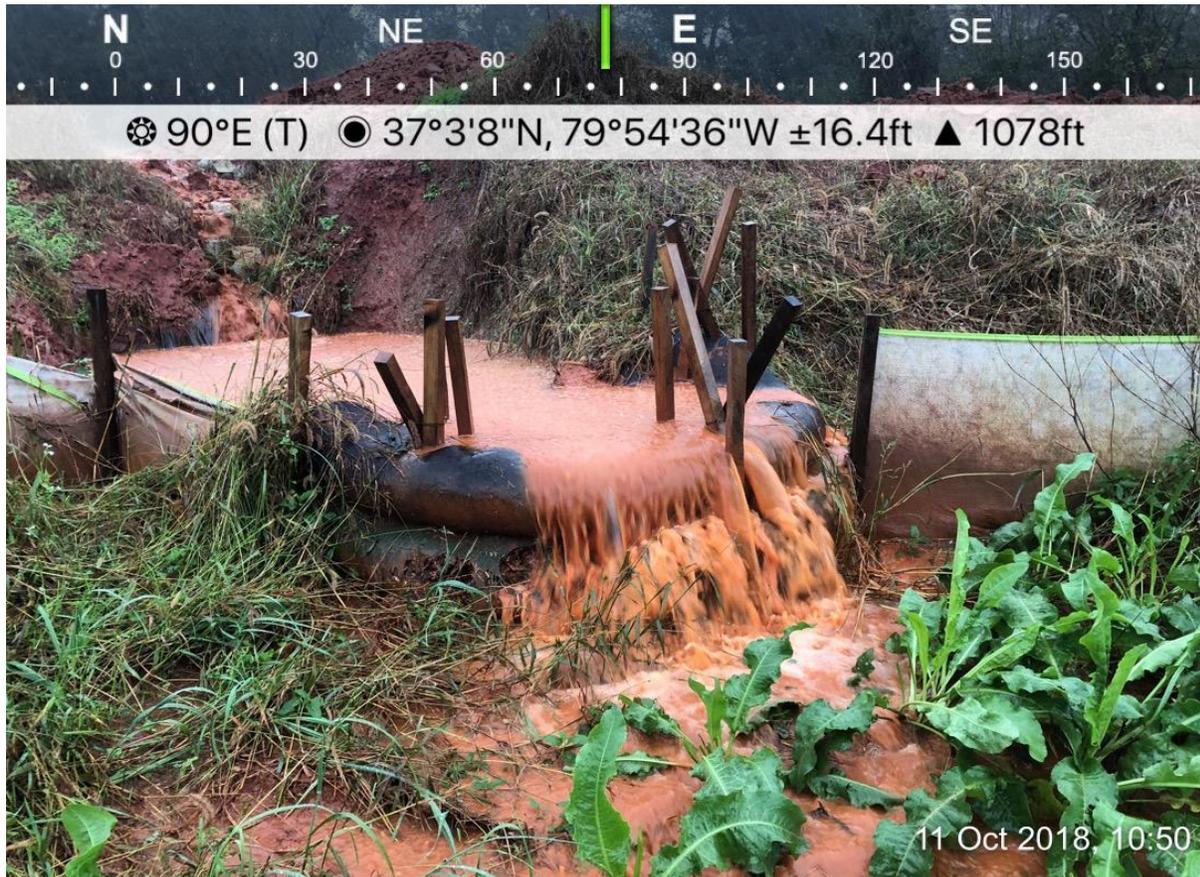
Another gross failure of an outlet protection structure.

Figure 6 – Angle property, October 11, 2018

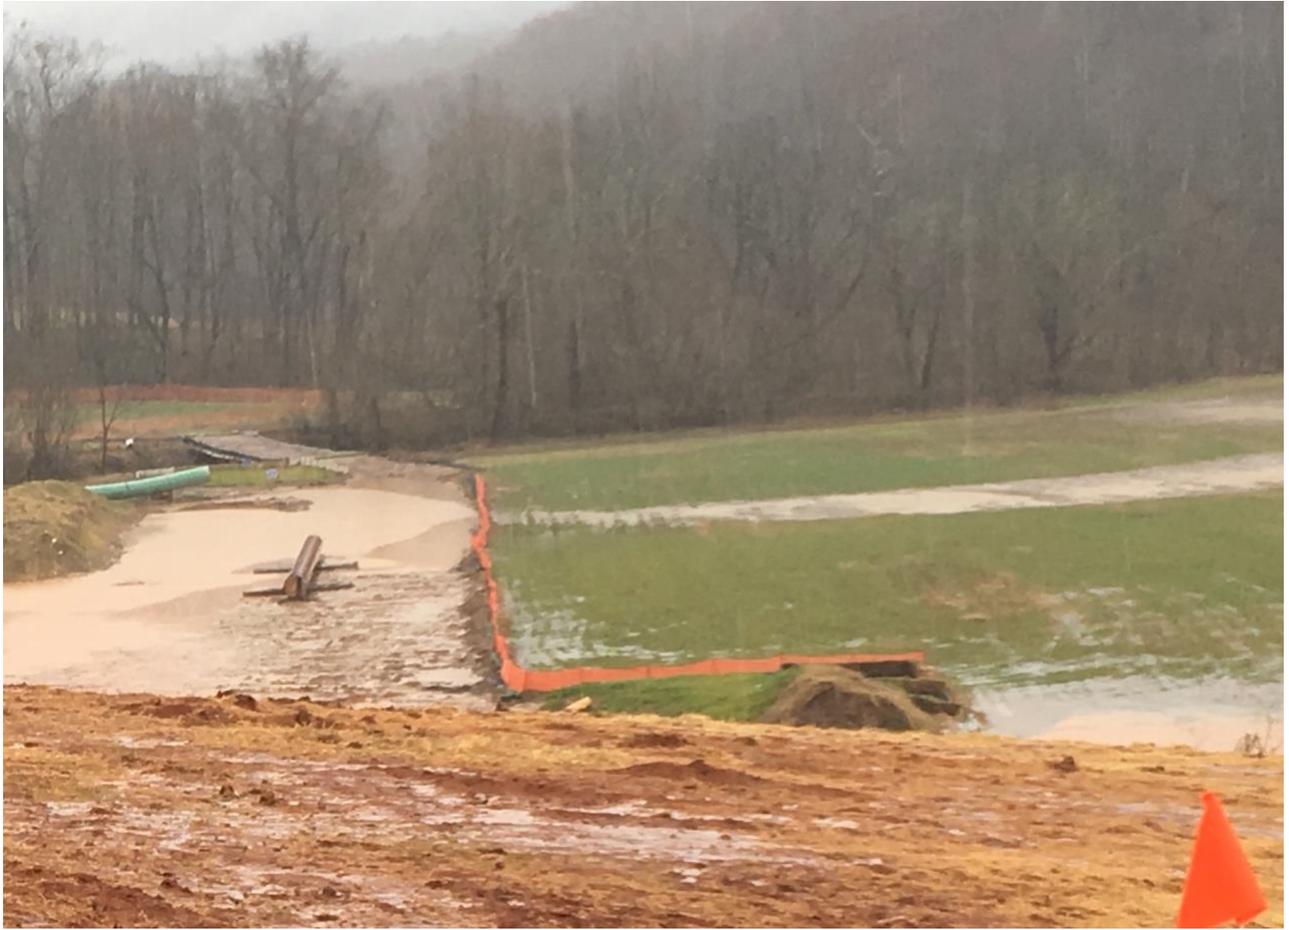
Below is a close-up of a section of Figure 2 above. Here you can see sediment-laden water flowing from the impounded area onsite, through an outlet in the perimeter silt fence on the right, and across the Angle's property in a plume that discharges to the Blackwater River in the far-ground.

Figure 7 – Angle Property, February 23, 2018

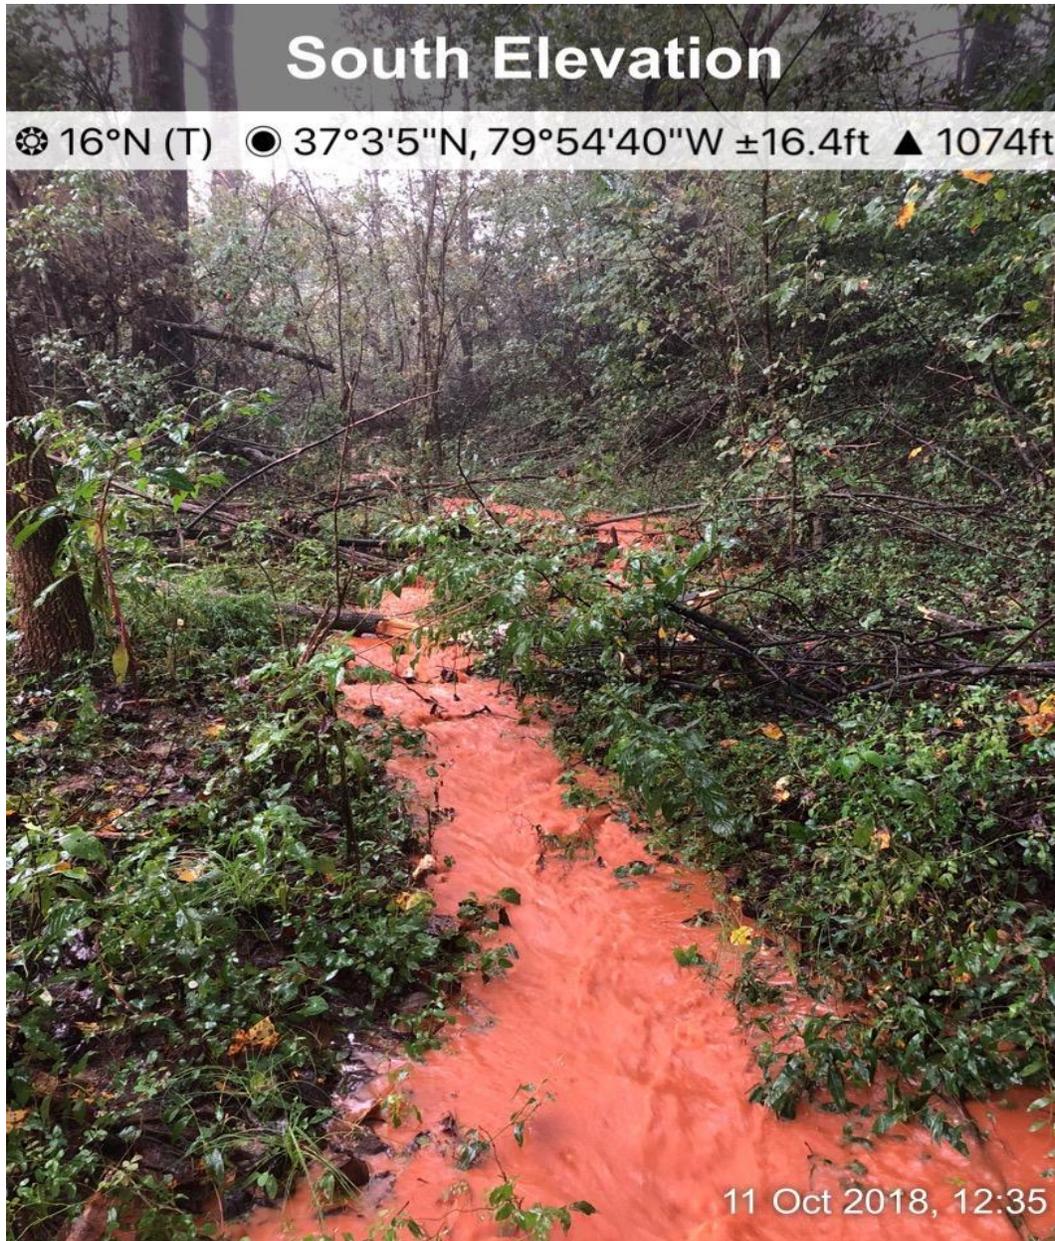
Sediment flowing from the work site flows across residents' land and into their streams and wetlands, when not controlled in accordance with the certification.

Figure 8 – Angle Property, October 11, 2018

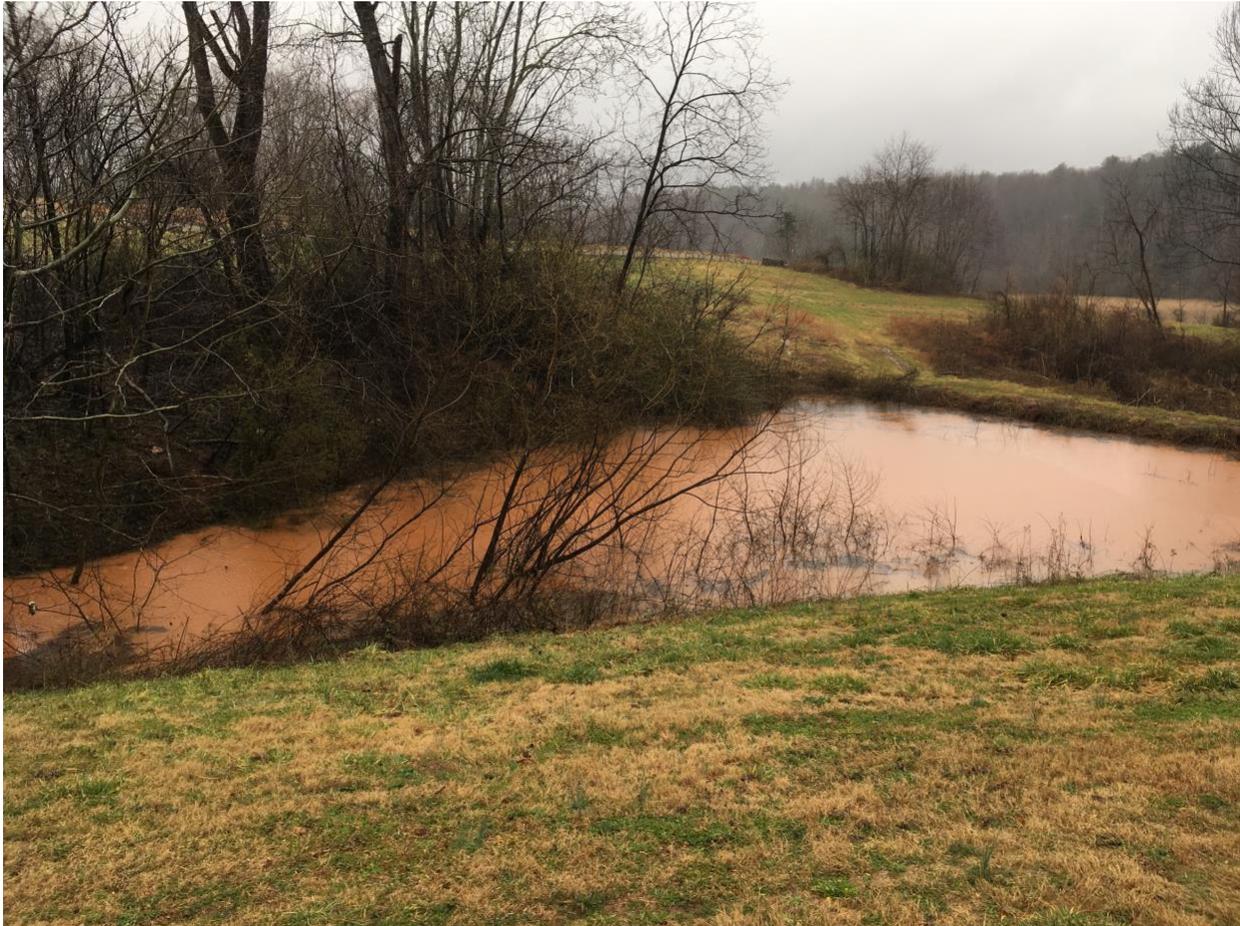
Some of the sediment flowing from the MVP work site has flowed down the slope off the west side of the right-of-way and into the Angle's pond and the intermittent stream that feeds it. This sediment pollution is a violation of water quality standards which will be long-lasting.

Figure 9 - Angle Pond, February 23, 2019 (facing east, right-of-way upslope in the background)
