Re: Enforcement of Consent Decree on Mountain Valley Pipeline and Assessment of Stipulated Penalties

Project Name:	Mountain Valley Pipeline	Inspector:	Marshall Willis
Inspection Date:	Tuesday, October 29, 2019	Project Contact:	Brian Clauto, Cory Chalmers
Spread I: Pittsylvania County	STA 15113+00 – 15221+11	Weather (Wet/Dry/Rain):	Wet

FIELD INSPECTION PHOTO LOG

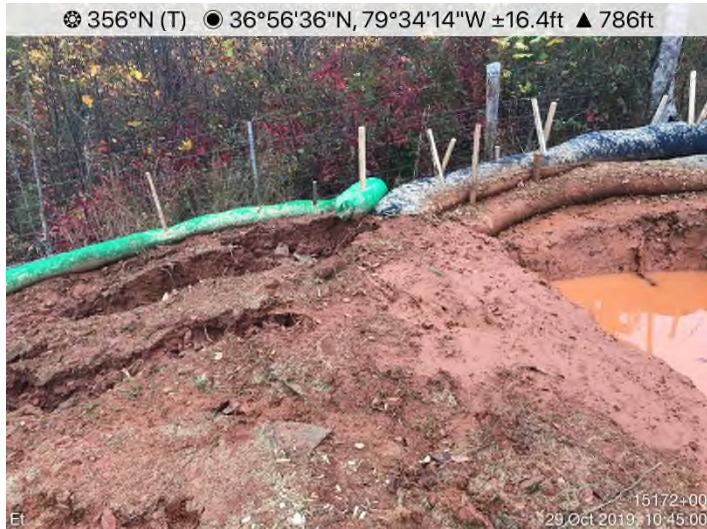
Fig. 1: **STA 15172+00** – End-treatment bypassed. CFS outlet higher than waterbar. Maintenance needed.

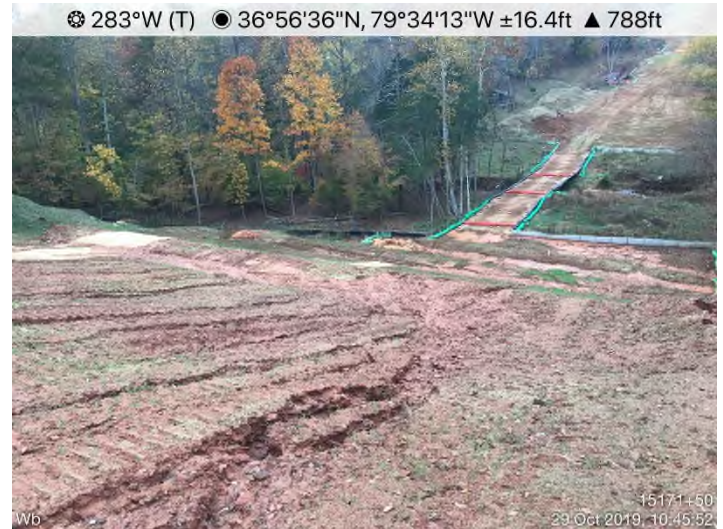
Fig. 2: **STA 15171+50 to 15169+58** – Waterbar maintenance needed.

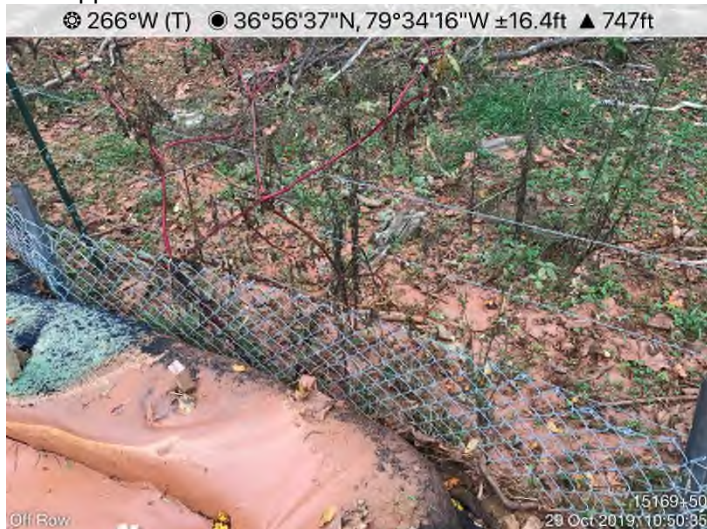
STA 15169+58: Sediment off ROW, controls overtopped.

Fig. 3: **STA 15169+58** – Sediment off ROW. Controls overtopped.

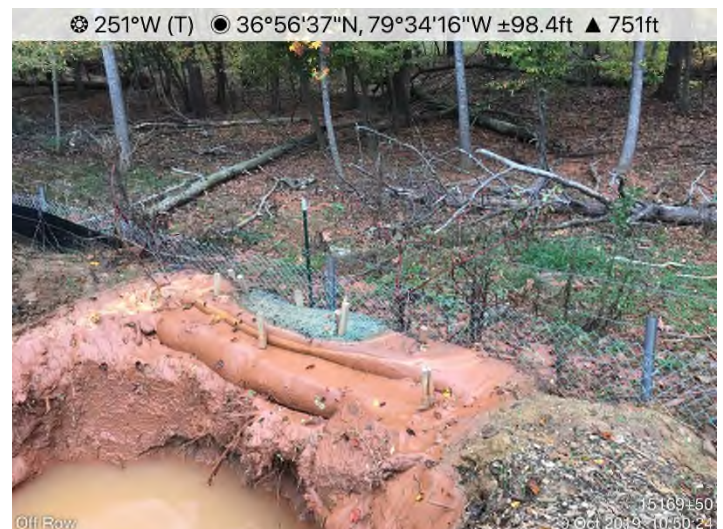
Fig. 4: **STA 15169+58** – CFS overtopped. Maintenance needed.

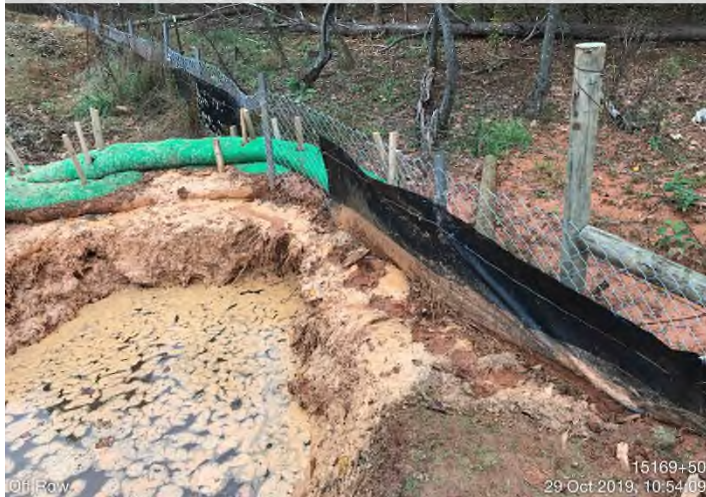
Fig. 5: **STA 15169+58** – Sediment off ROW. Sump discharges between CFS and SSF.

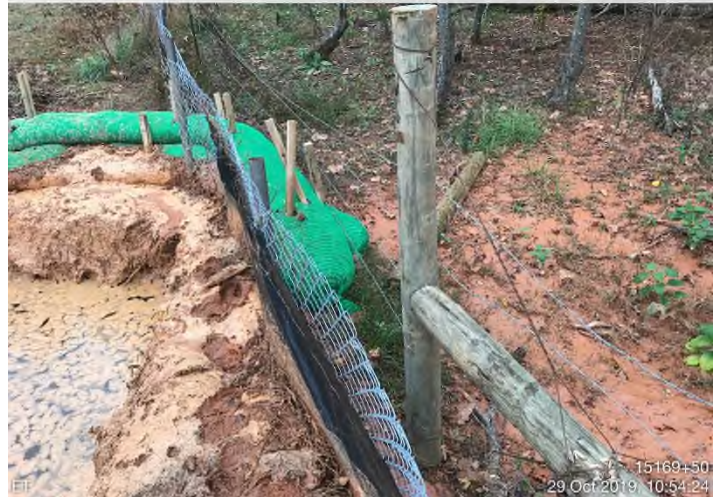
STA 15169+58: Sediment off ROW, sump discharge bypassed end-treatment.

Fig. 6: **STA 15169+58** – CFS maintenance needed. Sump discharge bypasses CFS end-treatment.

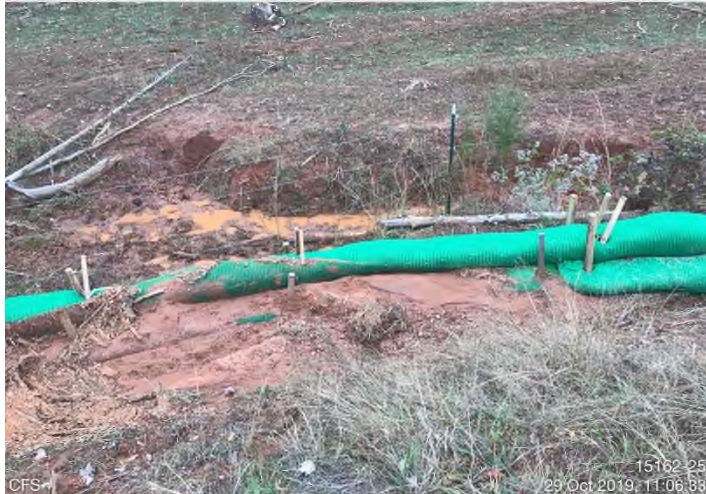
Fig. 7: **STA 15162+25** – CFS maintenance needed.

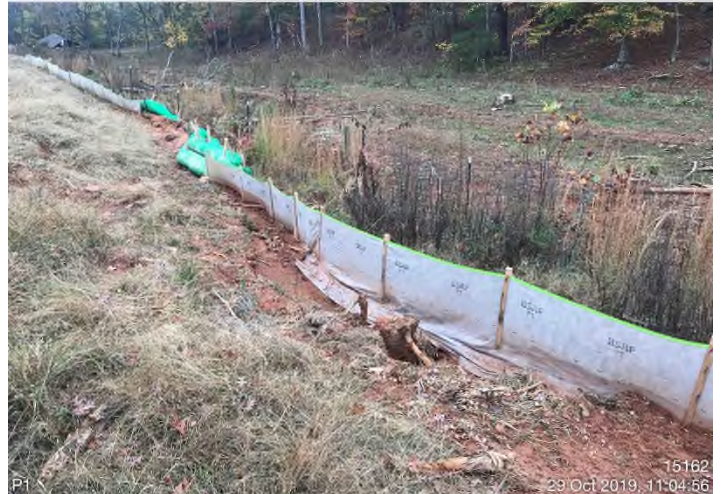
Fig. 8: **STA 15162+00** – P1 undermined from channelized flow.

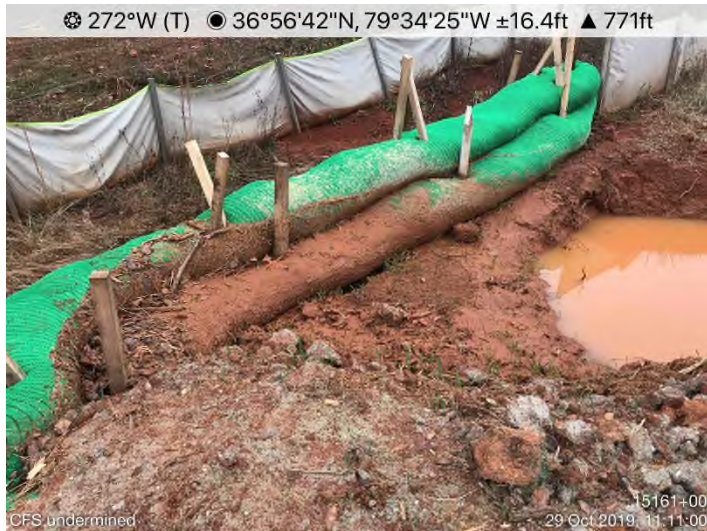
Fig. 9: **STA 15161+00** – CFS undermined.

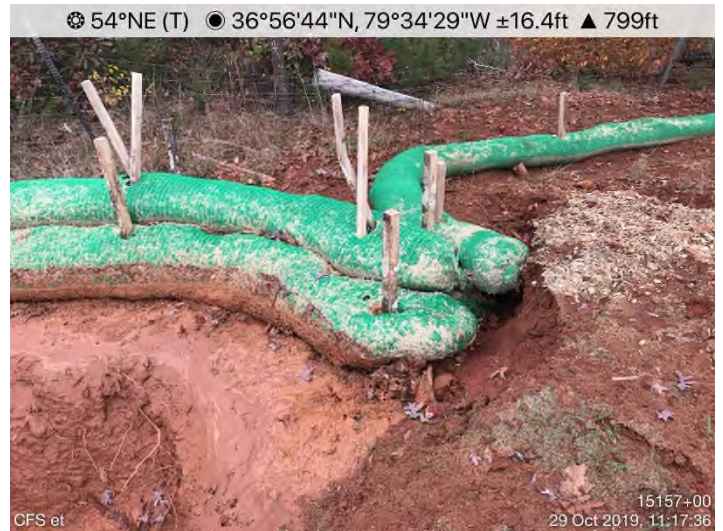
Fig. 10: **STA 15157+00** – CFS end-treatment bypassed. Maintenance needed.

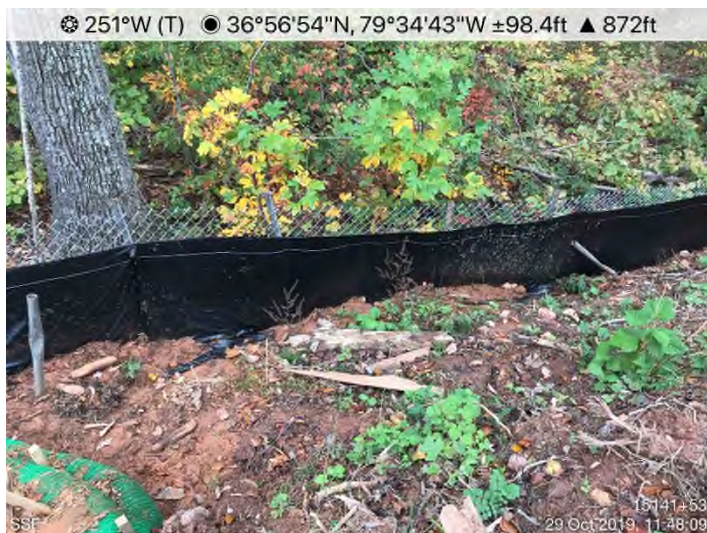
Fig. 11: **STA 15142+00** – SSF undermined.

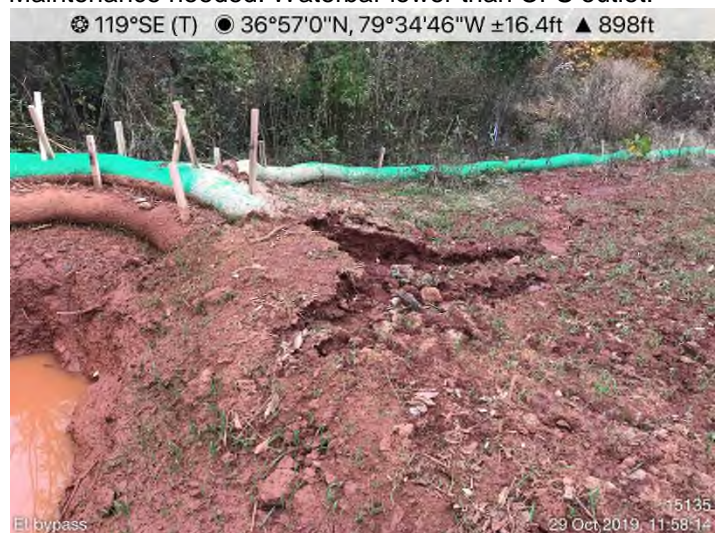
Fig. 12: **STA 15135+00** – CFS end-treatment bypassed. Maintenance needed. Waterbar lower than CFS outlet.

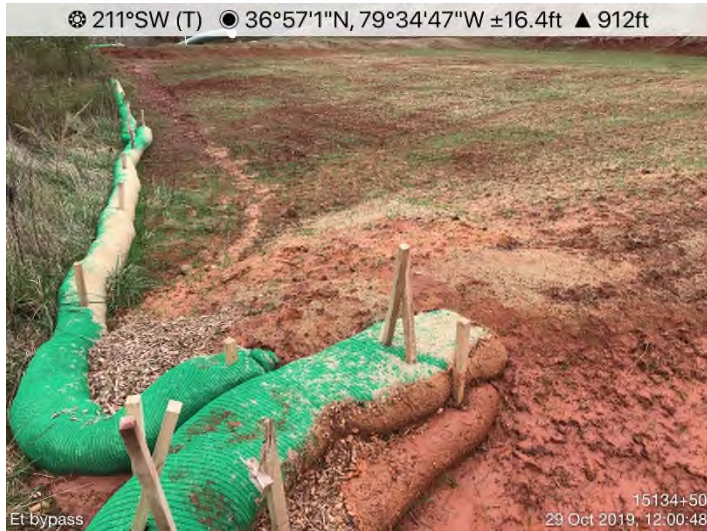
Fig. 13: **STA 15134+50** – CFS end-treatment bypassed. Maintenance needed. Waterbar lower than CFS outlet.

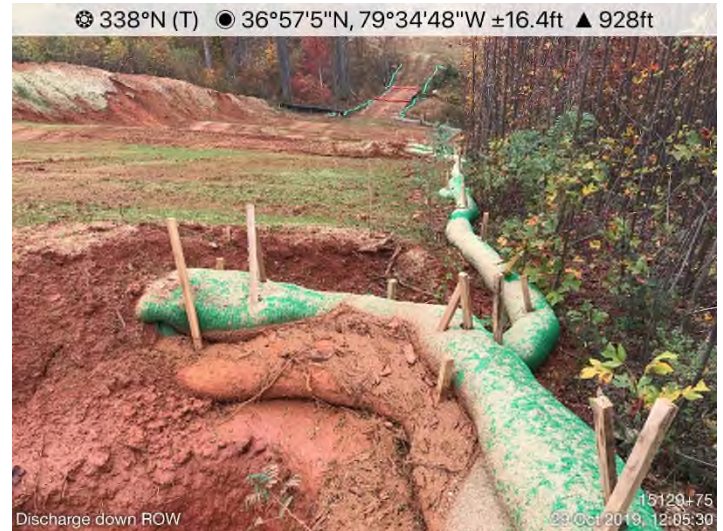
Fig. 14: **STA 15128+71** – Waterbar does not discharge off ROW. Maintenance needed.

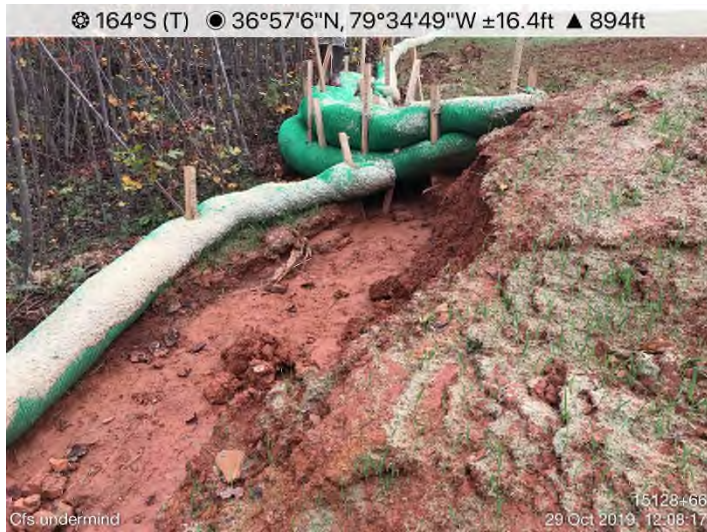
Fig. 15: **STA 15128+65** – CFS undermined. Maintenance needed.

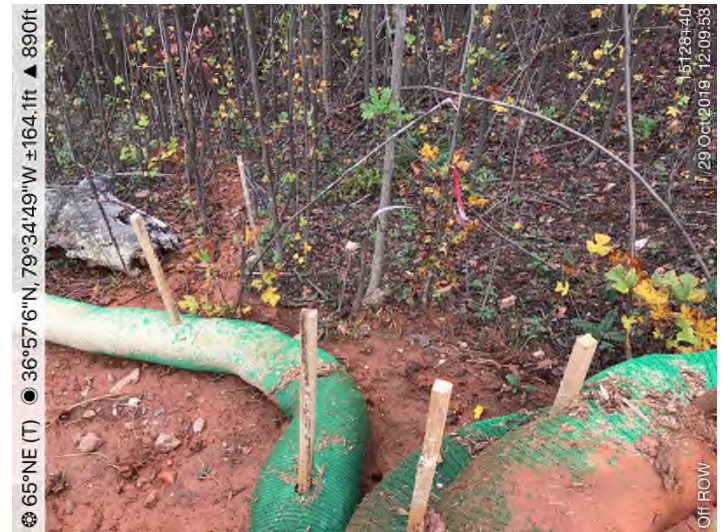
STA 15128+40: Sediment off ROW. Upslope control failure and incorrect installation of waterbar end treatments.

Fig. 16: **STA 15128+40** – Sediment off ROW due to upslope control failure and incorrect installation of waterbar end treatments.

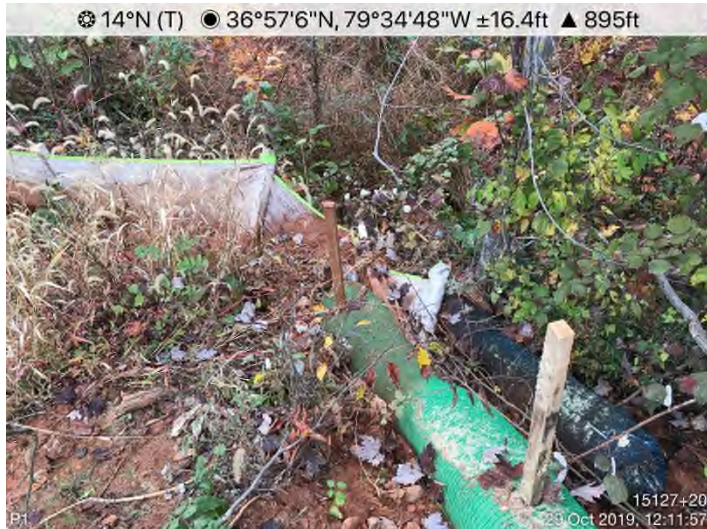
Fig. 17: **STA 15127+20** – P1 maintenance needed.

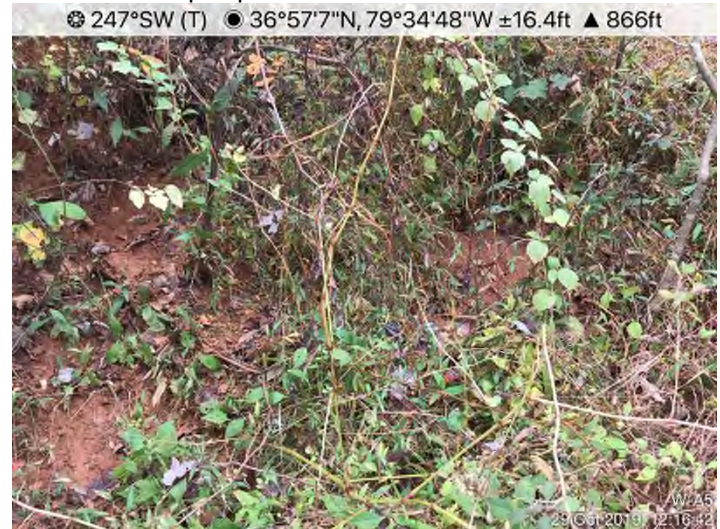
STA 15126+40: Sediment off ROW impacting Wetland W-A5 due to failed controls and overtopping of upslope waterbars.

Note that the sediment discharge at STA 15126+40 directly impacted a wetland "due to failed controls and overtopping upslope waterbars." This is among the most serious violations of the decree. It must be acknowledged though that *every* case where sediment is deposited off-site is an invasion of the property rights of landowners and represents a clear threat that the sediment will migrate to a stream or wetland in subsequent storms. Therefore, each of these events should be treated very seriously - they must not be considered as routine and minor events just because waterbodies are not immediately damaged by them.

Fig. 18: **Wetland W-A5** – Sediment off ROW impacting wetland W-A5 due to control failure and incorrect installation of upslope controls.

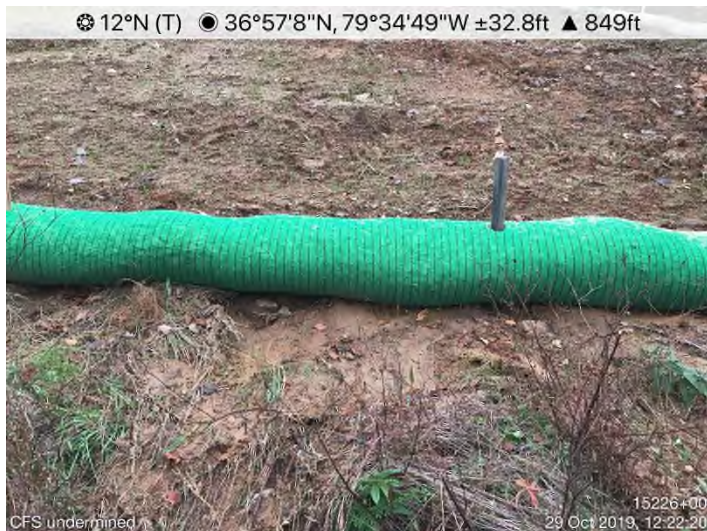
Fig. 19: **STA 15126+00** – CFS undermined.

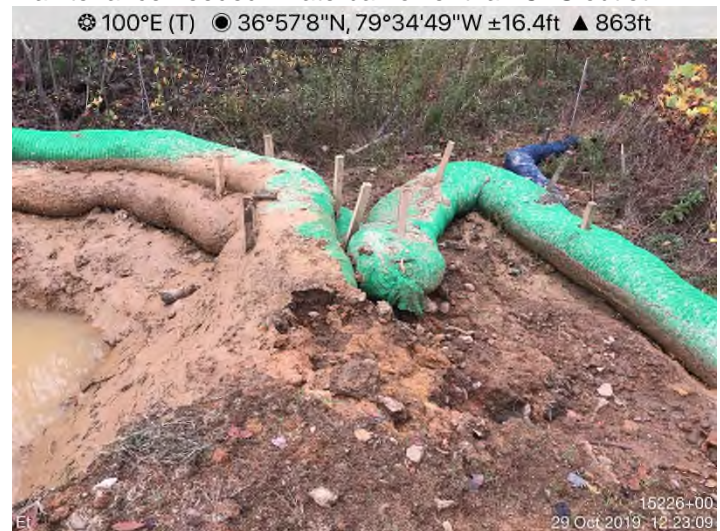
Fig. 20: **STA 15126+00** – CFS end-treatment bypassed. Maintenance needed. Waterbar lower than CFS outlet.

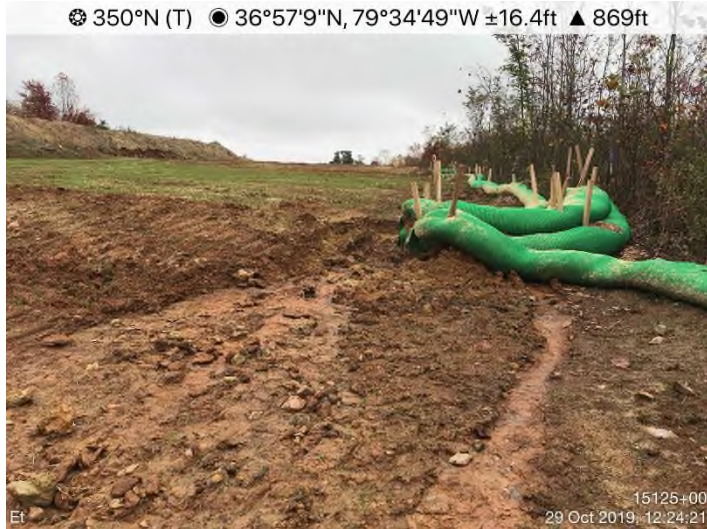
Fig. 21: **STA 15125+00** – CFS end-treatment bypassed. Maintenance needed. Waterbar lower than CFS outlet.

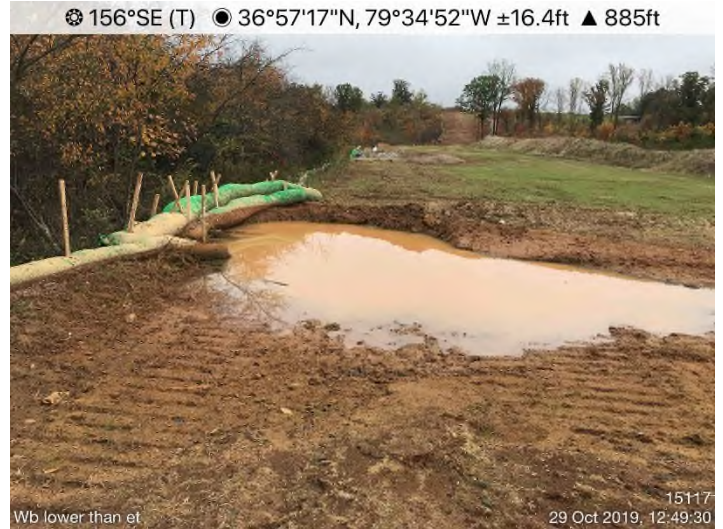
Fig. 22: **STA 15117+00** – CFS end-treatment bypassed. Maintenance needed. Waterbar lower than CFS outlet.

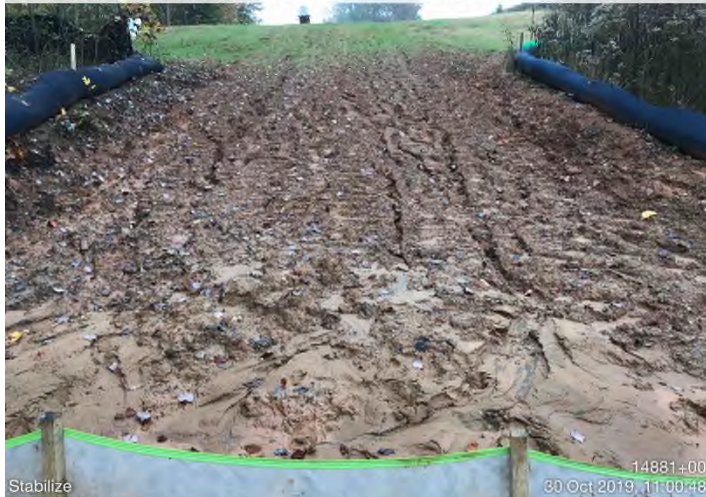
Fig. 9: **STA 14881+00** – Stabilize slope/repair erosion adjacent to S-CD8.

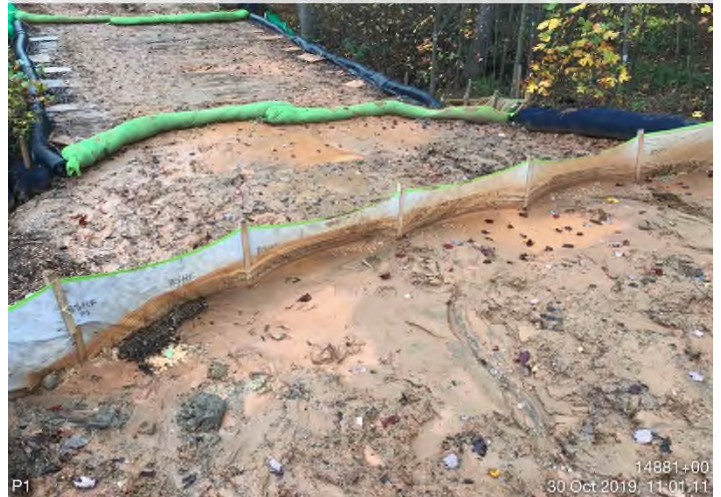
Fig. 10: **STA 14881+00** – P1 maintenance needed.

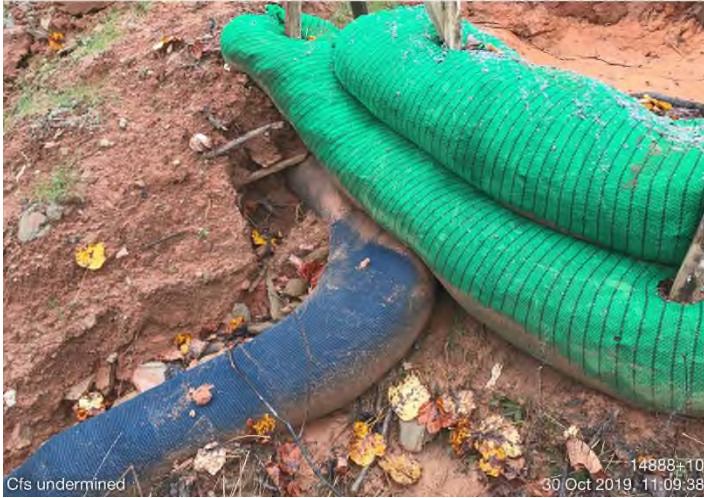
Fig. 13: **STA 14888+10** – CFS undermined. End-treatment discharges onto ROW.

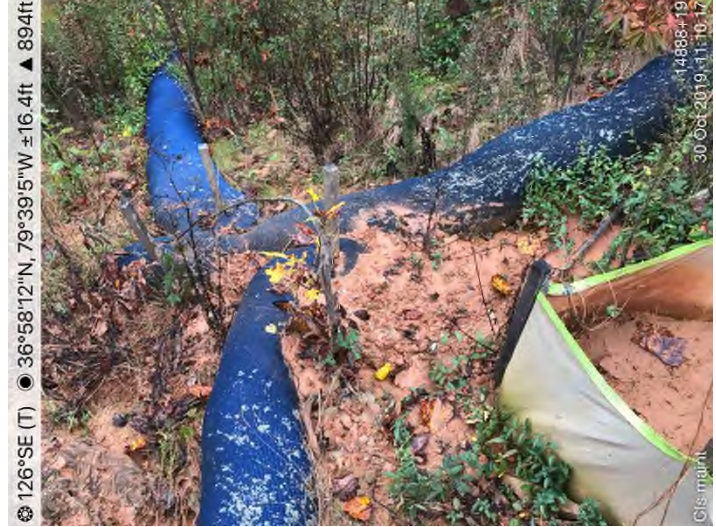
Fig. 14: **STA 14888+19** – CFS maintenance needed.

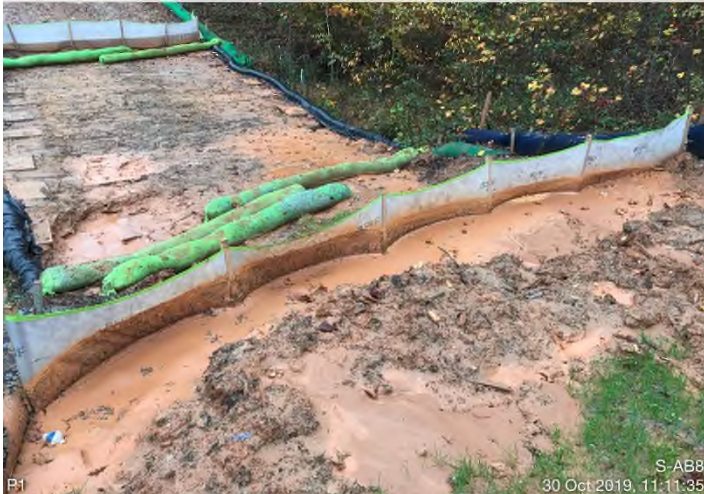
Fig. 15: **STA 14888+60**– P1 maintenance needed.

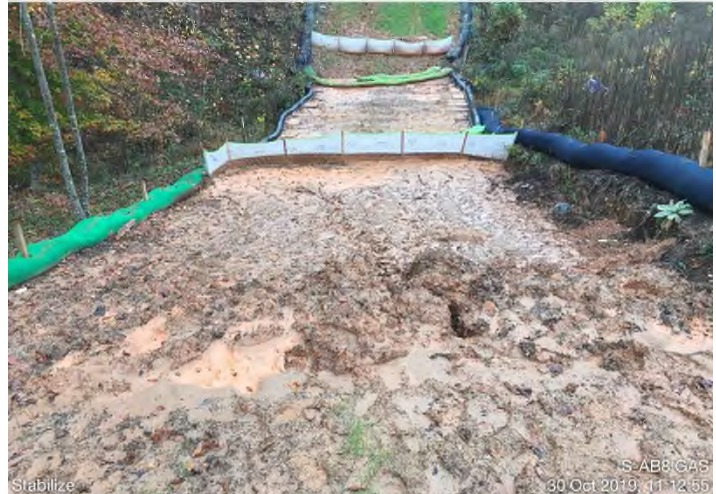
Fig. 16: **STA 14888+75** – Stabilize slope/repair erosion adjacent to S-AB8.

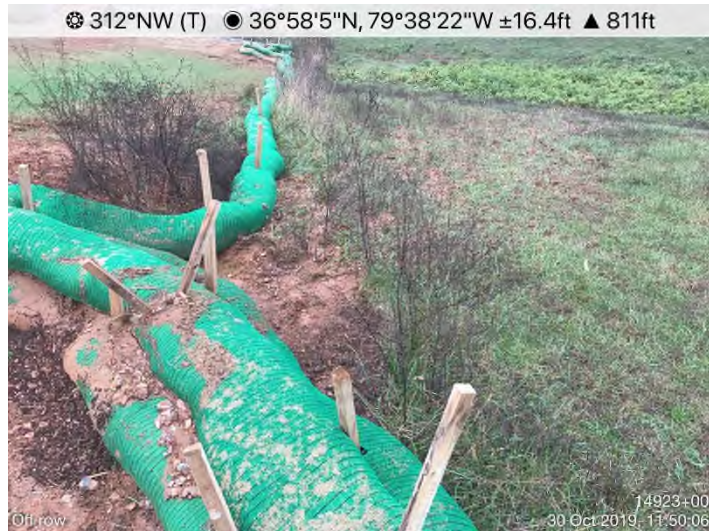
STA 14923+00: Sediment off ROW. Upslope waterbar failure at 14923+50.

Fig. 25: **STA 14923+00** – Sediment off ROW.

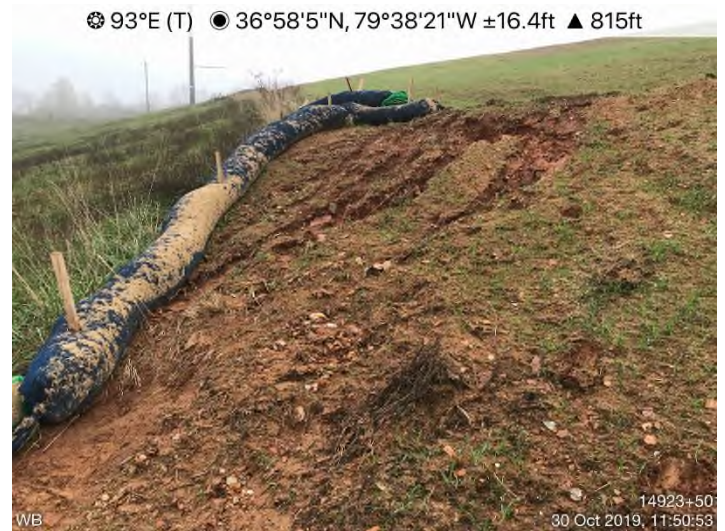
Fig. 26: **STA 14923+50** – Waterbar maintenance needed.
