A REPORT BY WILD VIRGINIA

FEBRUARY 2023

# MOUNTAIN VALLEY PIPELINE POLLUTION IN VIRGINIA WATERSHEDS

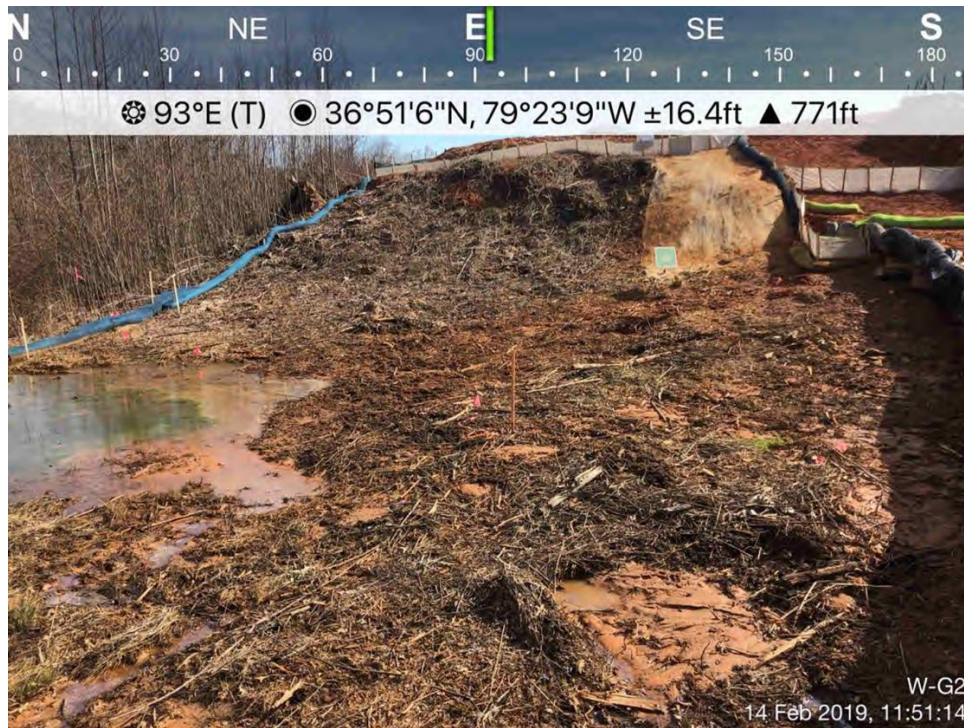
**Figure 3** - Sediment deposited in wetland W-G2, adjacent to Little Cherrystone Cr., February 12, 2019, Action Log ID 1888, Source: MBP [deadline for removal of sediment extended "due to wet ROW conditions," removed after 10 days]

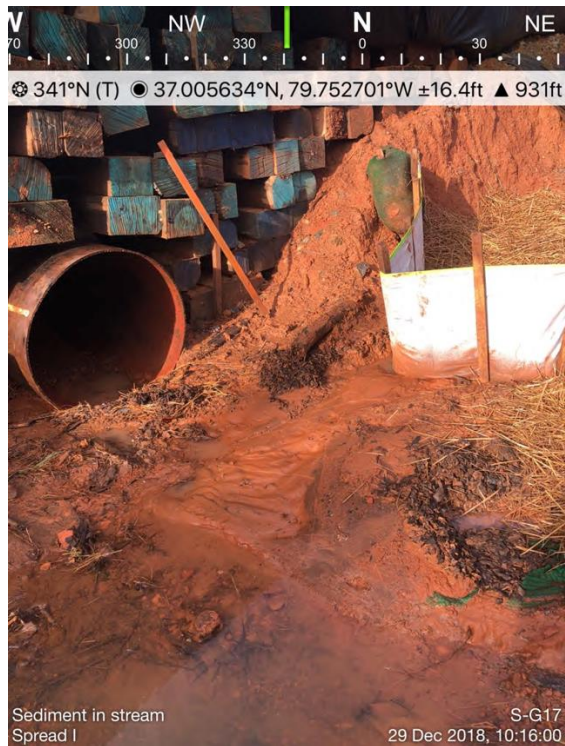
**Figure 4** - Sediment deposited in UT Blackwater River, December 29, 2018, Action Log ID 1562, Source: MBP

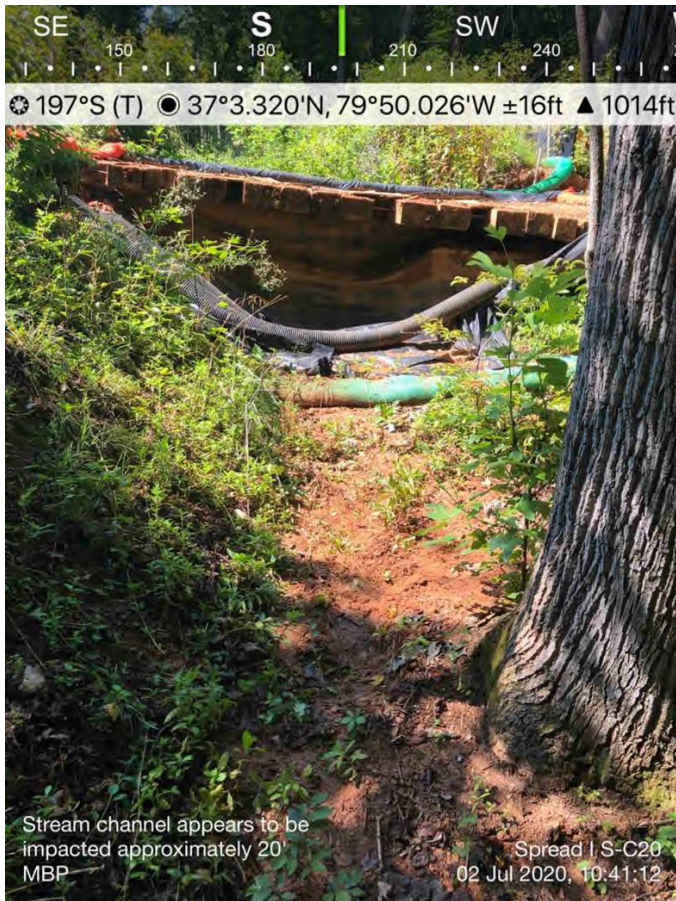
**Figure 5** - Sediment deposited in UT to Maggodee Creek, July 2, 2020, Action Log ID 4313, Source: MBP. [report states deposits 2.5 inches deep, 3 ft. wide, covering approx. 20 linear feet of bed; deposits in place five days before removal.]

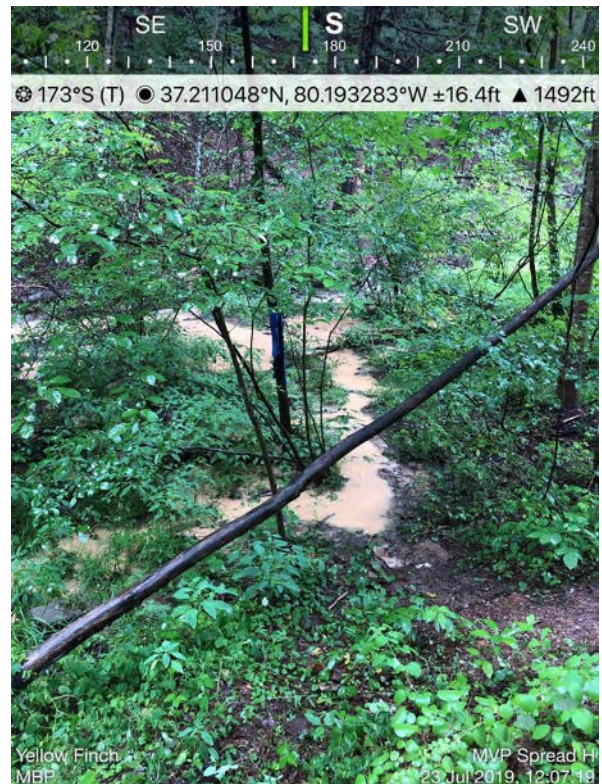
**Figure 6** - Sediment deposited in UT to Roanoke River, July 23, 2019, Action Log ID 3301, Source: MBP [failure to recover sediment without landowner agreement, after 72 days sediment had washed away]

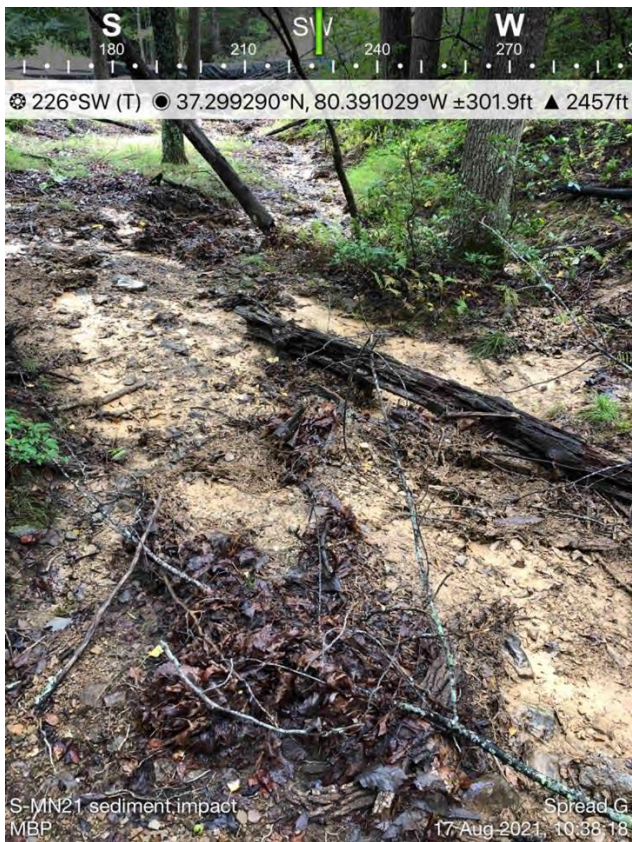
**Figure 7** - Sediment deposited in UT to Mill Creek and on adjacent property, August 16, 2021, Action Log ID 5035, deadline to clean up extended while seeking landowner permission [report states impacts extend approx. 75 linear feet upstream and 100 linear feet downstream; landowner denied permission to access impacted areas; approx. 3 months later, inspector reported sediment deposits no longer visible.

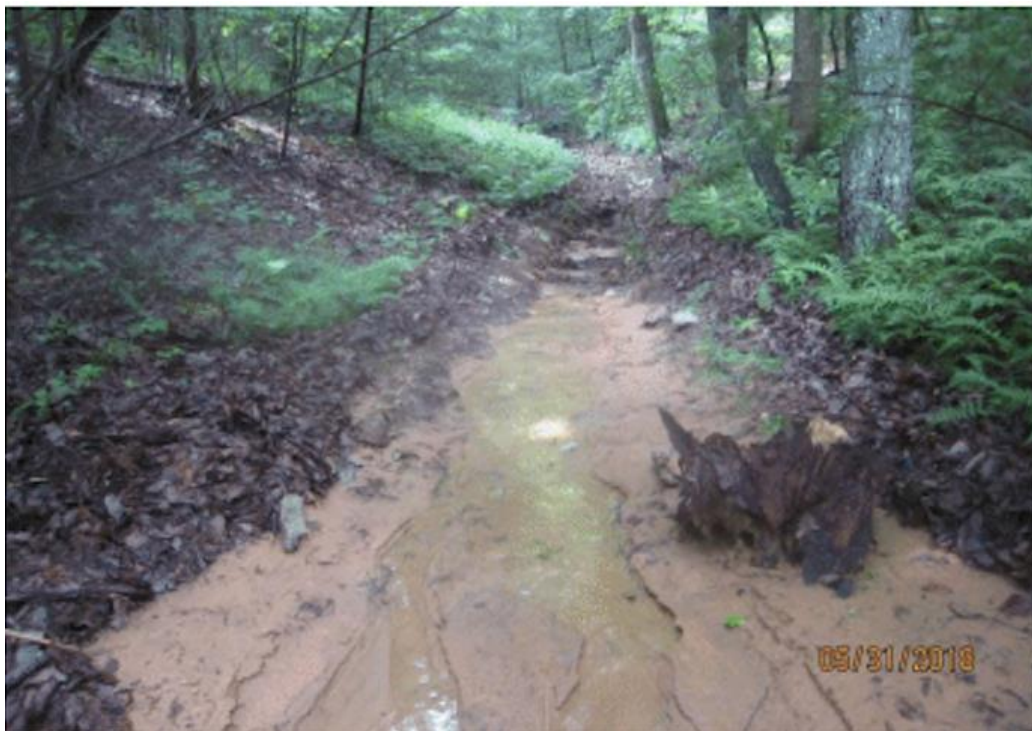
**Figure 8** - Sediment deposited in UT to Blackwater River, May 31, 2018, DEQ VWP inspection rpt. [sediment in streambed approx. 1,690 linear feet of stream impacted with deposits up to 5 inches deep; impacted area approx. 685 feet from ROW]

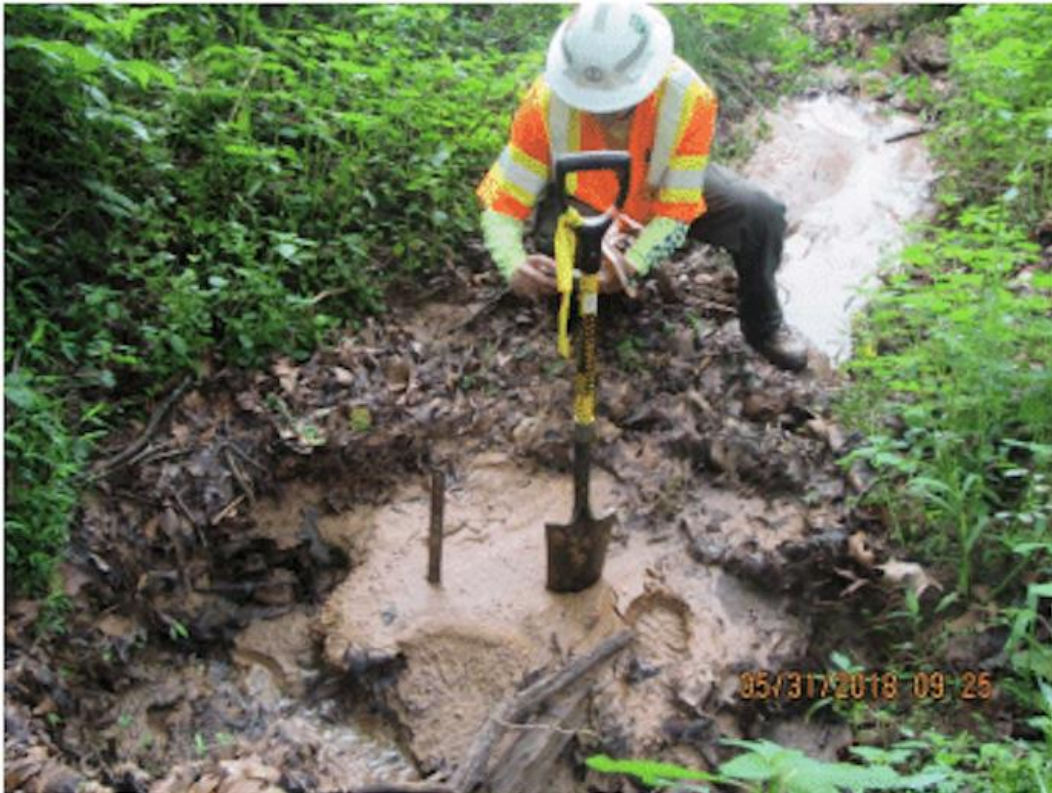
**Figure 9** - Sediment deposited in UT to Blackwater River, May 31, 2018, DEQ VWP inspection report, Source: DEQ [sediment covered approx. 1,110 linear feet of streambed, up to 7 inches deep]

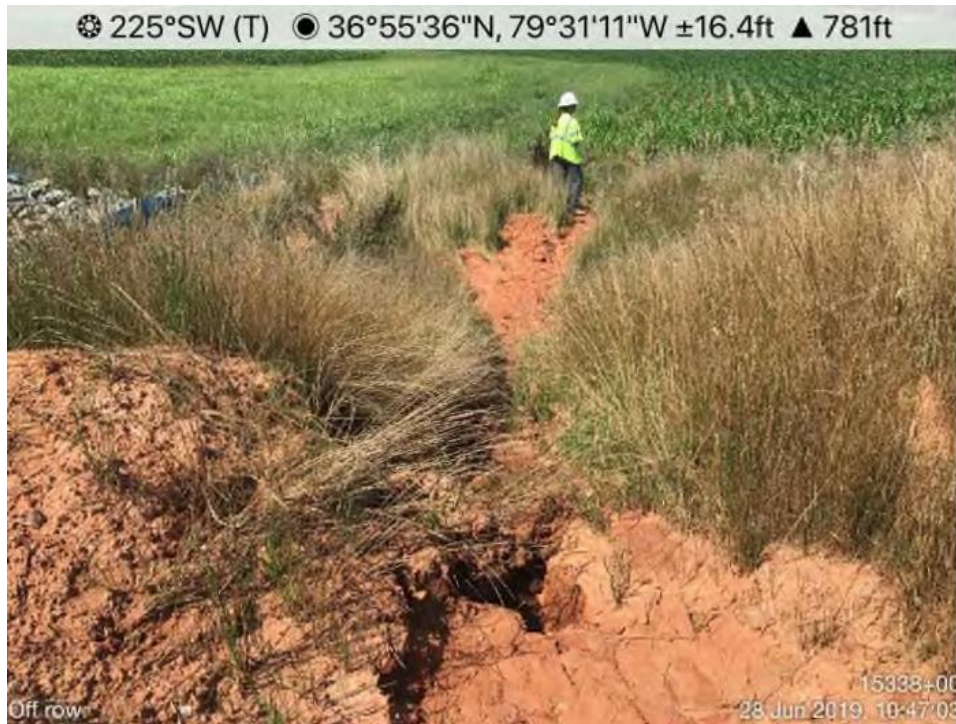
**Figure 10** - Sediment deposits off ROW onto a farm field, near UT to Harpen Creek, June 28, 2019, DEQ Inspec. Rpt. Spread I, Source: DEQ

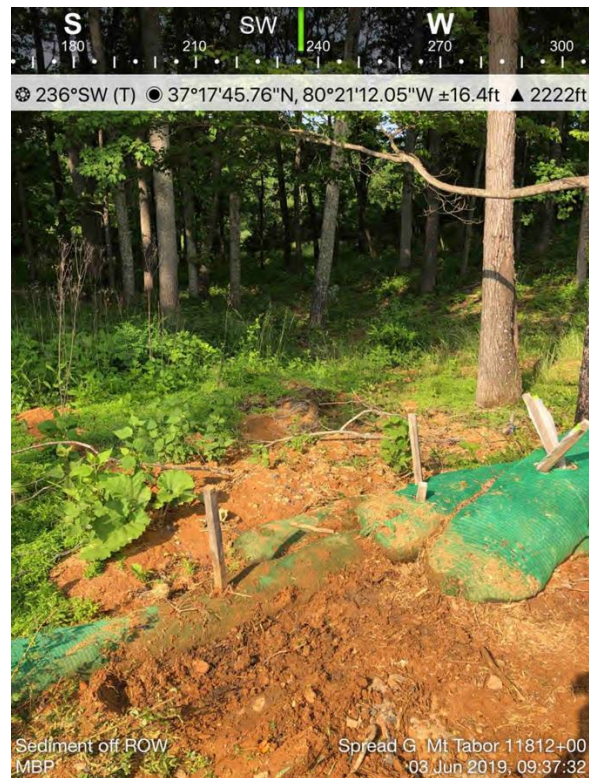
**Figure 11** - Sediment deposited off ROW, June 3, 2019, Action Item ID 2844, near Dry Run, Source: MBP

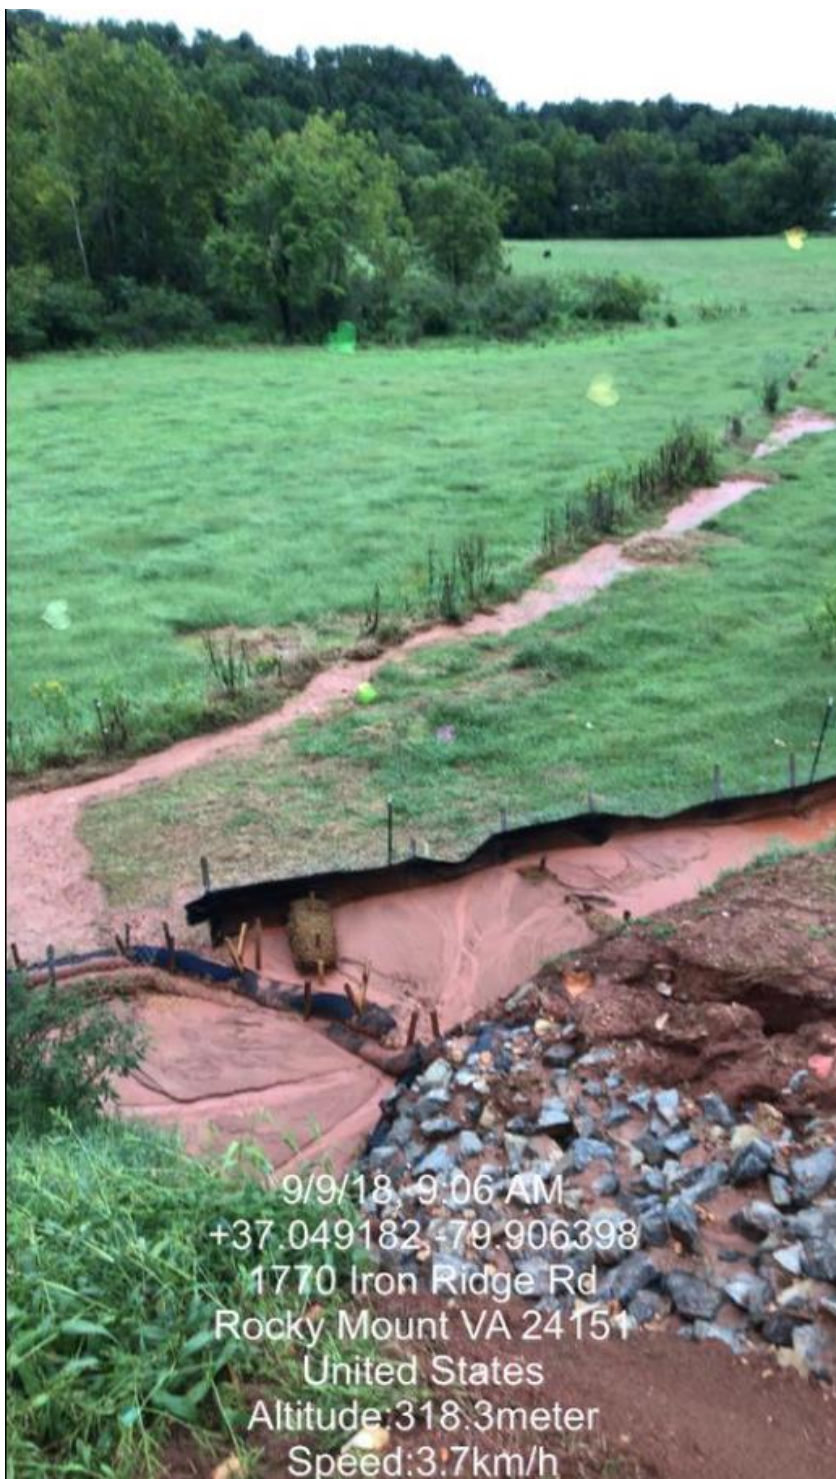
**Figure 12** - Sediment off ROW near UT to Little Creek, September 9, 2018, Source: citizen observer, accessible at [Virginia Pipeline Violations Facebook page](#)

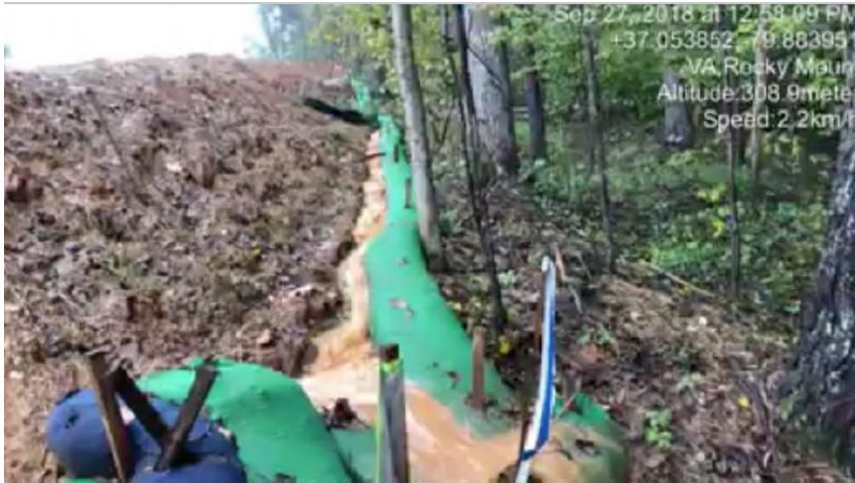
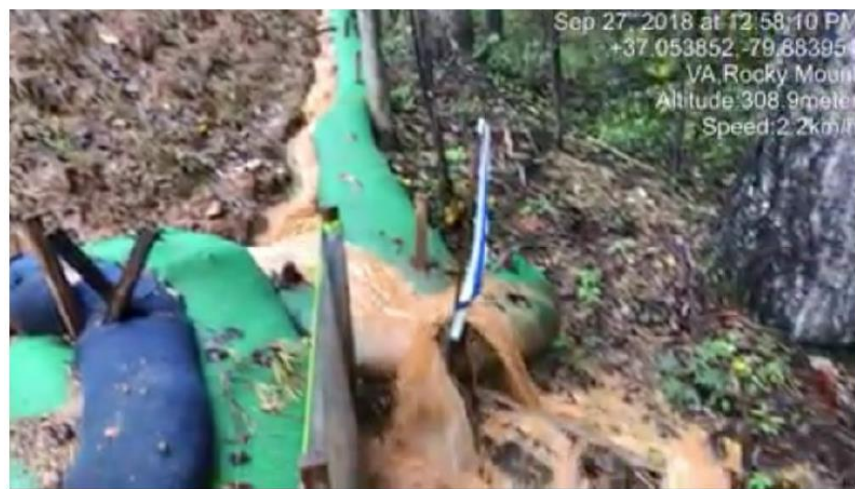
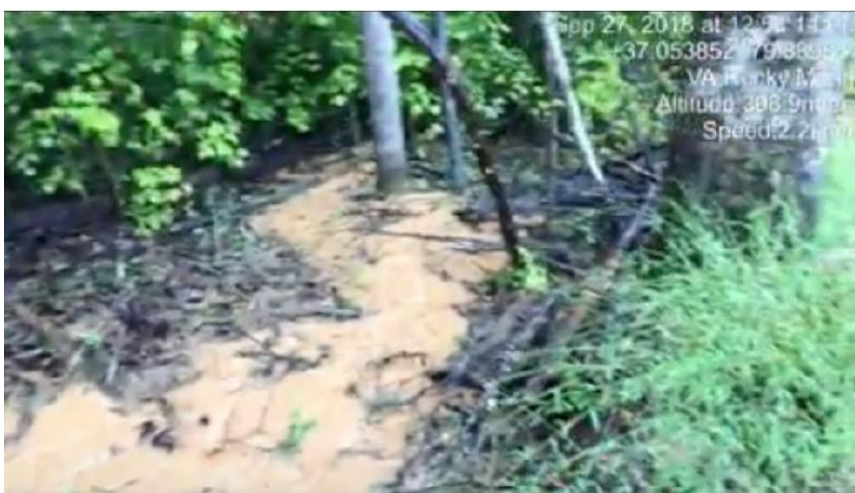
**Figures 13 - 15 -**

The timing of these three incidents refutes frequent claims by Mountain Valley and by agency officials that MVP pollution problems happened primarily during the first year of construction and were largely due to one period of especially heavy storms. These videos, dated respectively September 27, 2018, August 22, 2019, and November 11, 2020, show that sediment-laden waters have poured off of MVP sites frequently and repeatedly and that even after three or more years, Mountain Valley has not taken measures adequate to stop these polluted discharges.

September 27, 2018

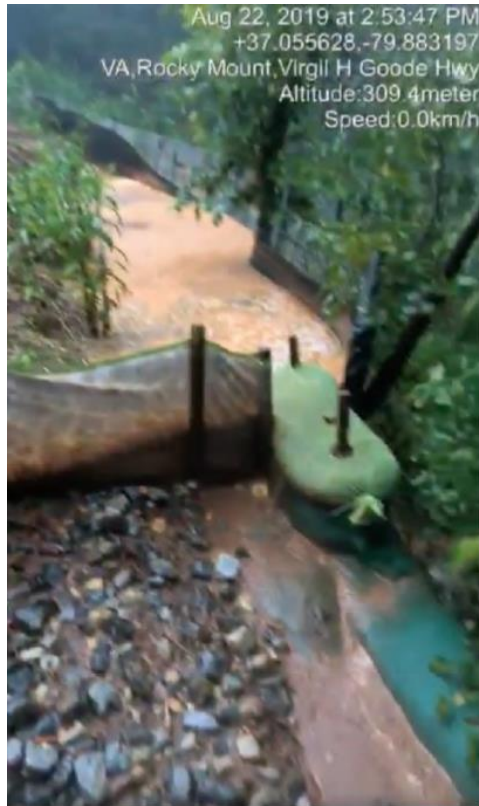
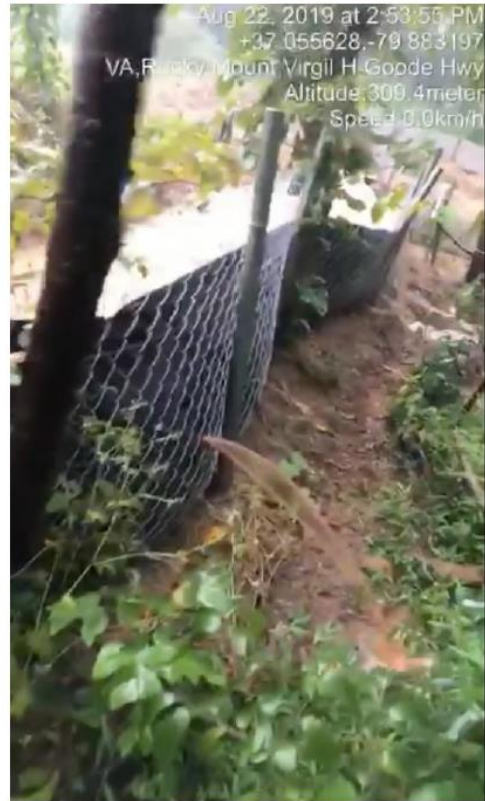
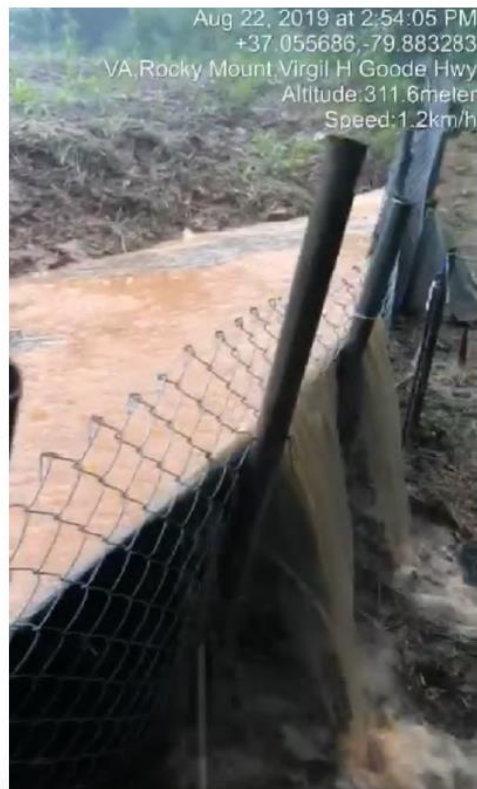
**Figures 16 - 18 - August 22, 2019**  
Sediment-laden water flowing over, around, and through super silt fence and leaving the MVP ROW, several hundred feet upslope of the Blackwater River.  
Taken from a [video accessible at Virginia Pipeline Violations Facebook page](#)

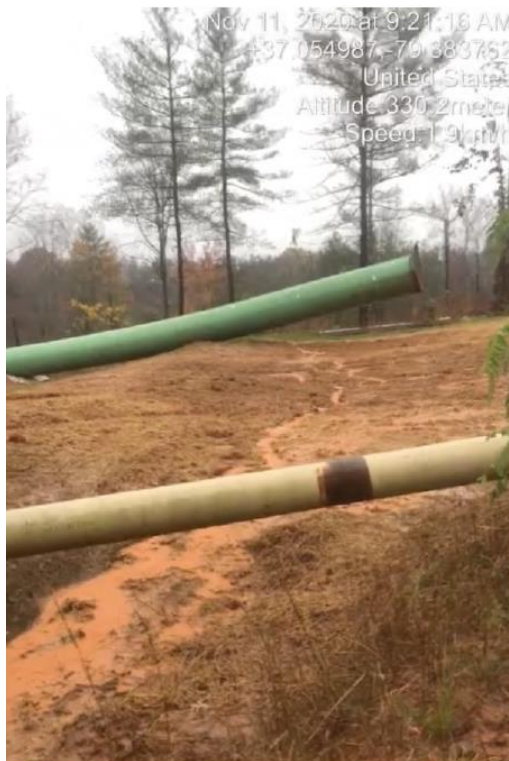
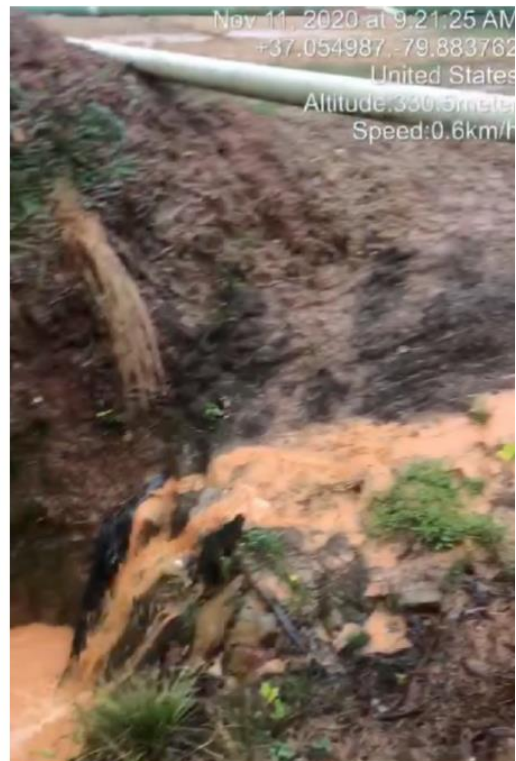
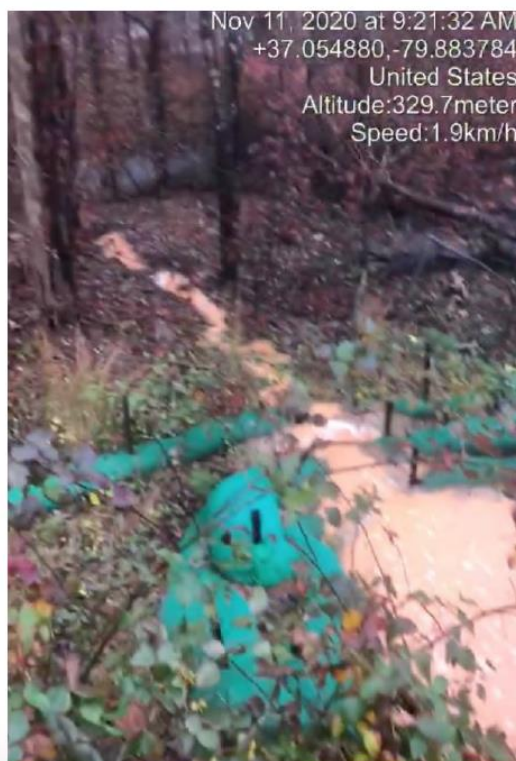
**Figures 19 - 21** - November 11, 2020, Sediment-laden water overwhelming an end treatment and leaving the MVP ROW, several hundred feet upslope of the Blackwater River.  
Taken from a [video accessible at Virginia Pipeline Violations Facebook page](#)

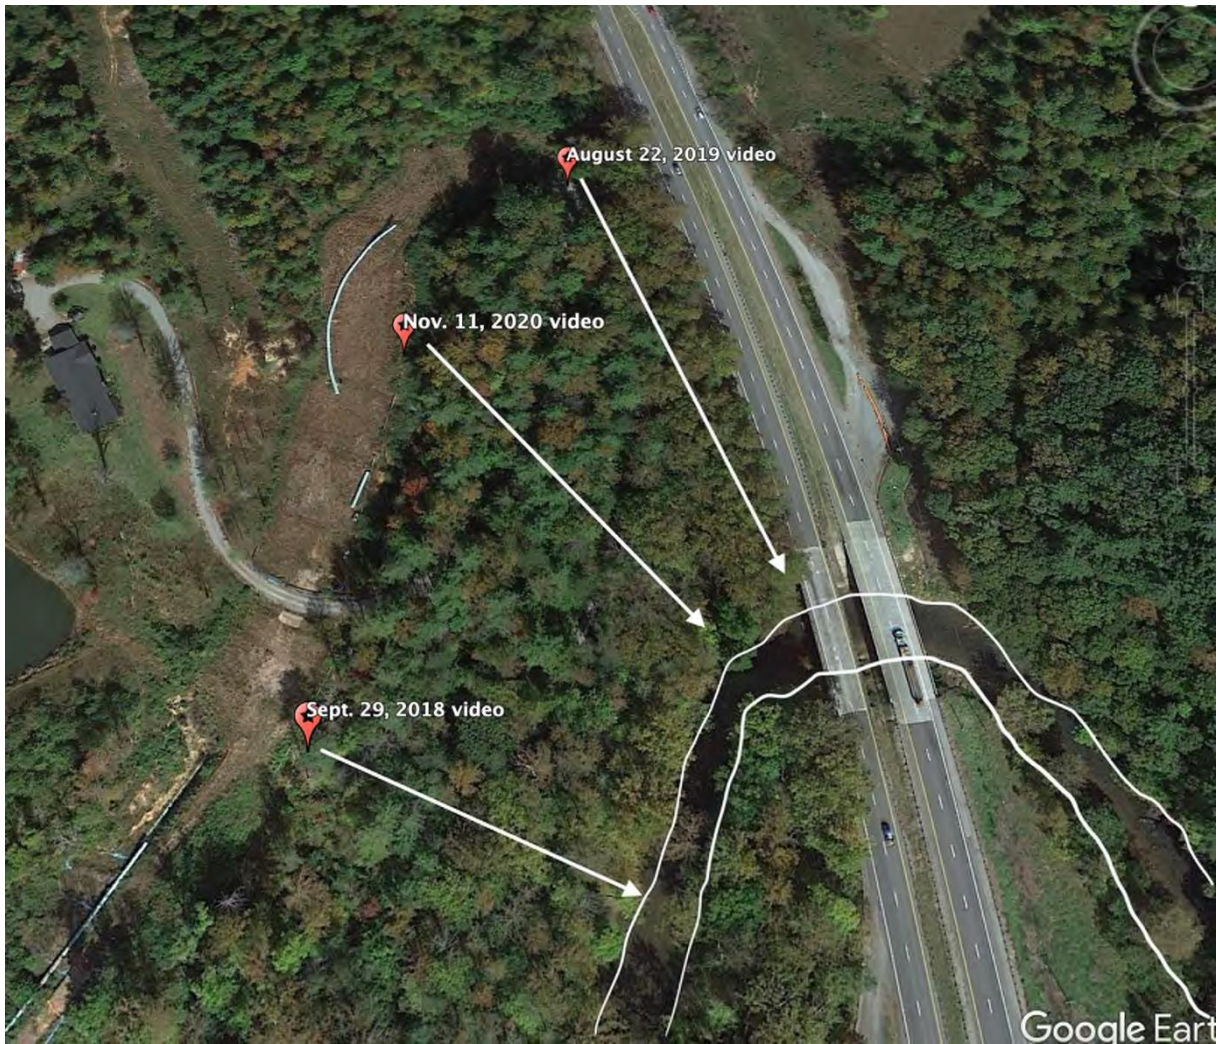
**Figure 22** - Satellite image annotated to show locations at which videos depicted on previous pages were filmed and their relation to the Blackwater River. White arrows show approximate flows paths of water flowing off the MVP ROW.

The three sites shown in these images all lie within less than a thousand feet of each other, along a stretch of the MVP ROW in Franklin County. As shown in the annotated satellite image in Figure 22, the pipeline site and the three discharges shown lie up a relatively steep slope from the Blackwater River. Measurements show that the distance of water flow from the pipeline ROW to the stream would be between 300 and 500 feet in this area.

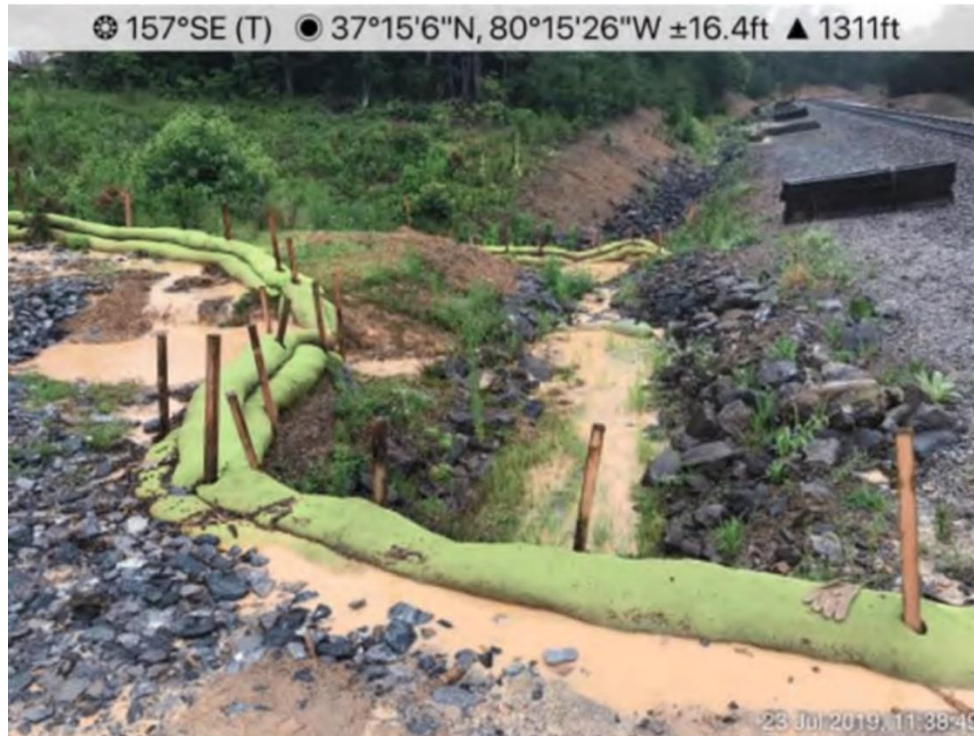
**Figure 23** - Sediment-laden water undermining compost filters socks and discharging to a UT of Bradshaw Creek, July 23, 2019, DEQ Complaint inspection report, Source: DEQ [Bradshaw Creek is within the range of the Endangered Roanoke Logperch]

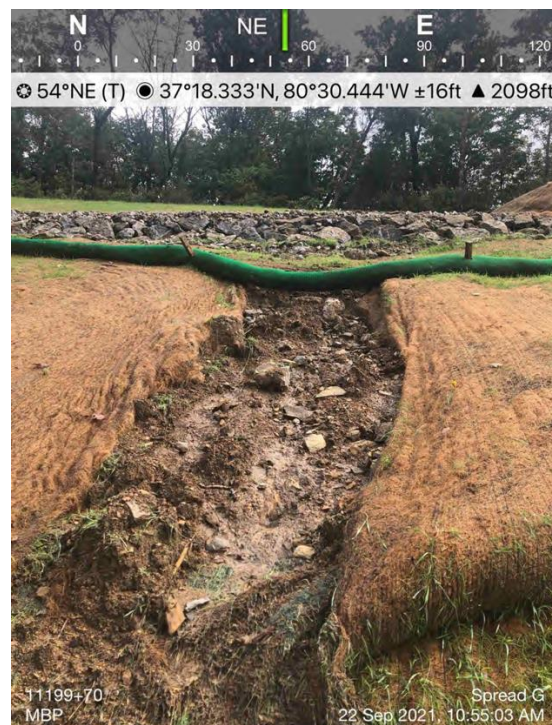
**Figure 24** - Compost filter sock undermined near Sinking Creek, September 22, 2021, Action Log ID 5196, Source: MBP

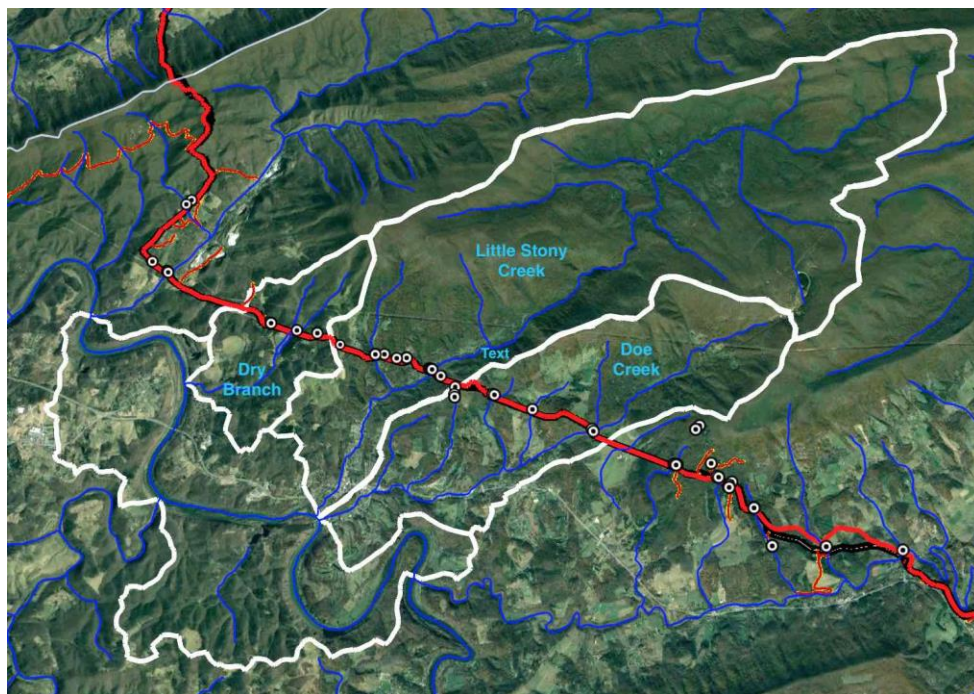
**Figure 25** - Annotated satellite image showing Little Stony Creek HUC-12 area and separate watersheds within that area.

In the supplemental materials submitted to the Corps to discuss cumulative impacts, Mountain Valley provides standard figures for project and non-project impacts within the Little Stony Creek-New River HUC 12 (050500020304),<sup>40</sup> an area of greater than 45 square miles (mi<sup>2</sup>).<sup>41</sup> As shown in the annotated satellite image below, this HUC-12 area actually contains three watersheds draining to significant tributaries that flow into the New River. In addition, there is a section of the HUC 12 outside these three watersheds of approximately 10 mi<sup>2</sup> in size.<sup>42</sup>

The three watersheds within this HUC-12 area, include Little Stony Creek, Doe Creek, and Dry Branch. Each of these three stream systems to the north of the New River will be impacted by the MVP. Those areas outside these watersheds will not be affected by the MVP

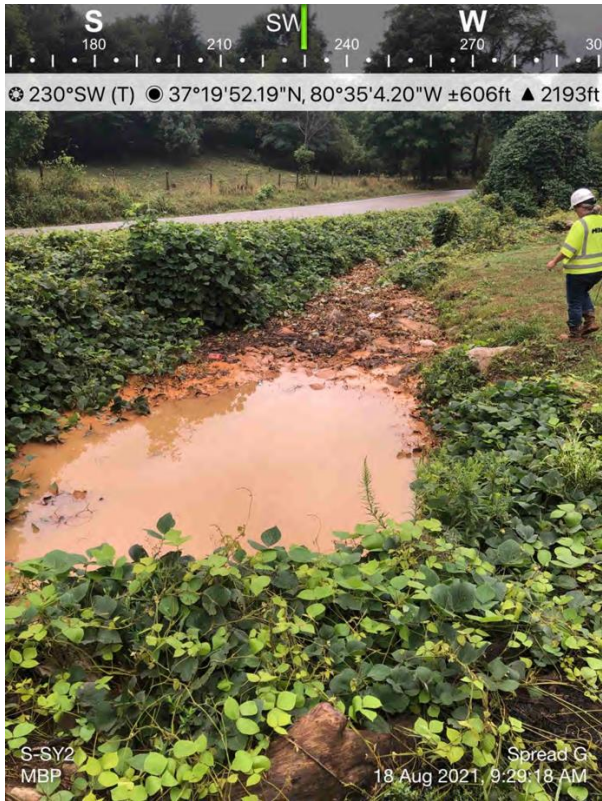
**Figure 26** - Sediment deposited in Doe Creek, August 18, 2021, Action Log ID 5068, Source: MBP

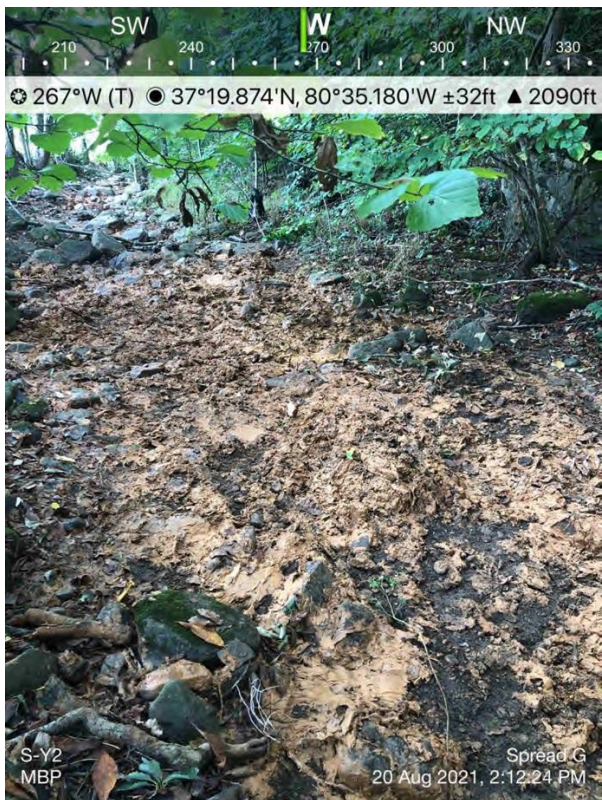
**Figure 27** - Sediment deposited off MVP ROW near Doe Creek, August 18, 2021, Action Log ID 5068, Source: MBP

[Inspectors first identified this pollution incident on August 18, 2021 and the MBP report lists the "item corrected date" as September 2, 2021, fifteen days after the stream impact occurred.]

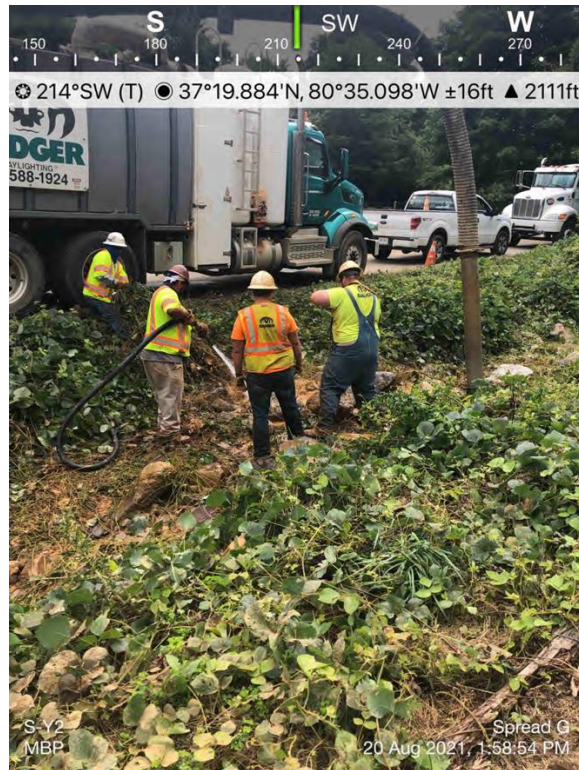
**Figure 29** - Workers removing sediment from a landowner's property after the pollution "overwhelmed perimeter controls" at MVP sites. Action Log ID 5067. Source: MBP

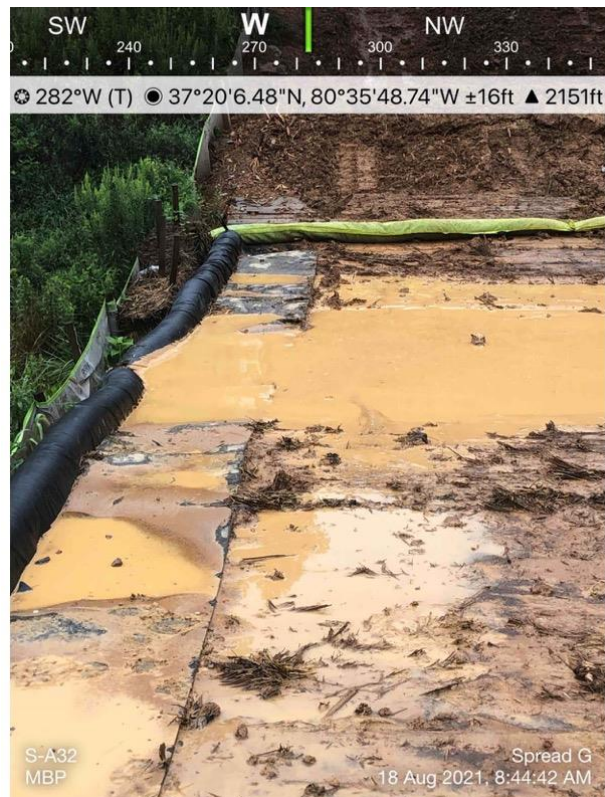
**Figure 31** - Sediment deposited in UT to Doe Creek, August 18, 2021, Action Log ID 5065, Source: MBP

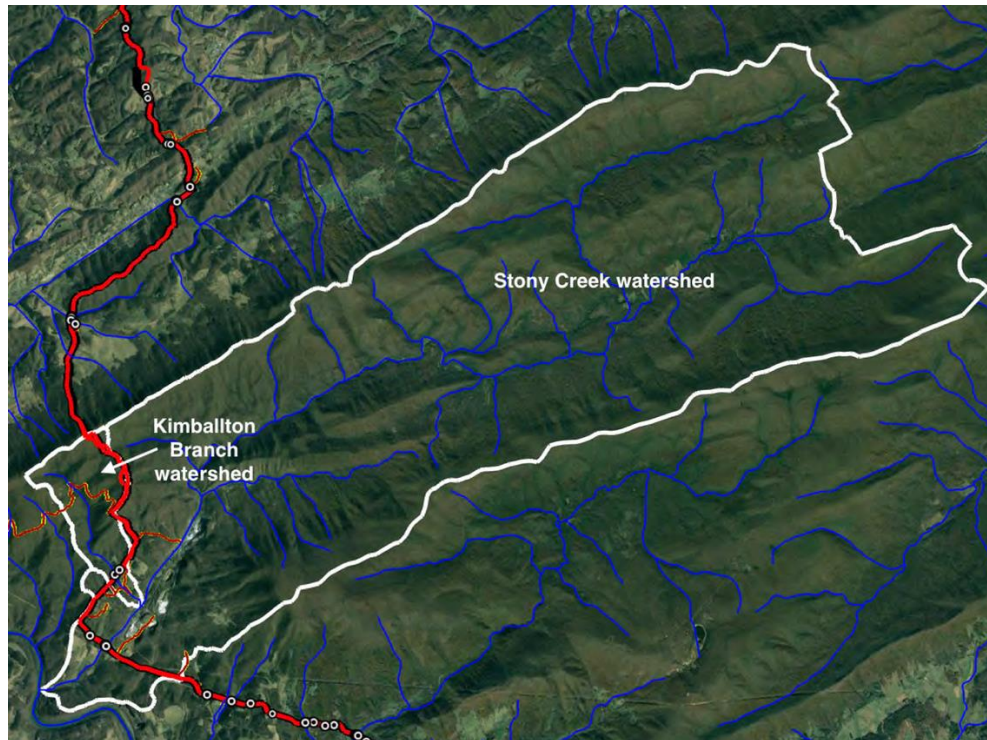
**Figure 32** - Stony Creek HUC-12 (050500020305) and Kimballton Branch watershed. Created with Google Earth Plus with data from National Hydrography Dataset. Red line depicts MVP pipeline ROW; proposed new discharges shown by circles.

This small watershed lies within the Stony Creek HUC-12 unit. The entire HUC covers an area of 31,289 acres<sup>49</sup> but the Kimballton Branch drainage is just 1,117 acres in size,<sup>50</sup> approximately 3.6 percent of the area for which Mountain Valley has purportedly assessed cumulative impacts. Yet, as shown in the annotated aerial photo below, a large percentage of the pipeline's path through the Stony Creek drainage will disturb land and discharge to waterbodies via two proposed crossings that fall within the Kimballton Branch watershed.

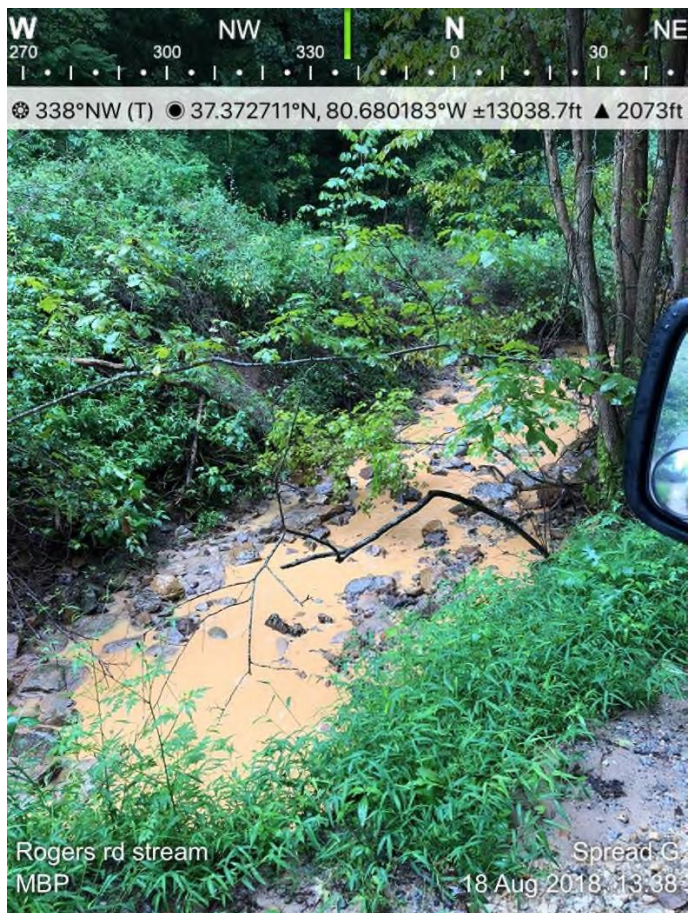
**Figure 33** - Sediment deposited in Kimballton Branch, August 18, 2018, Action Log ID 604, Source: MBP

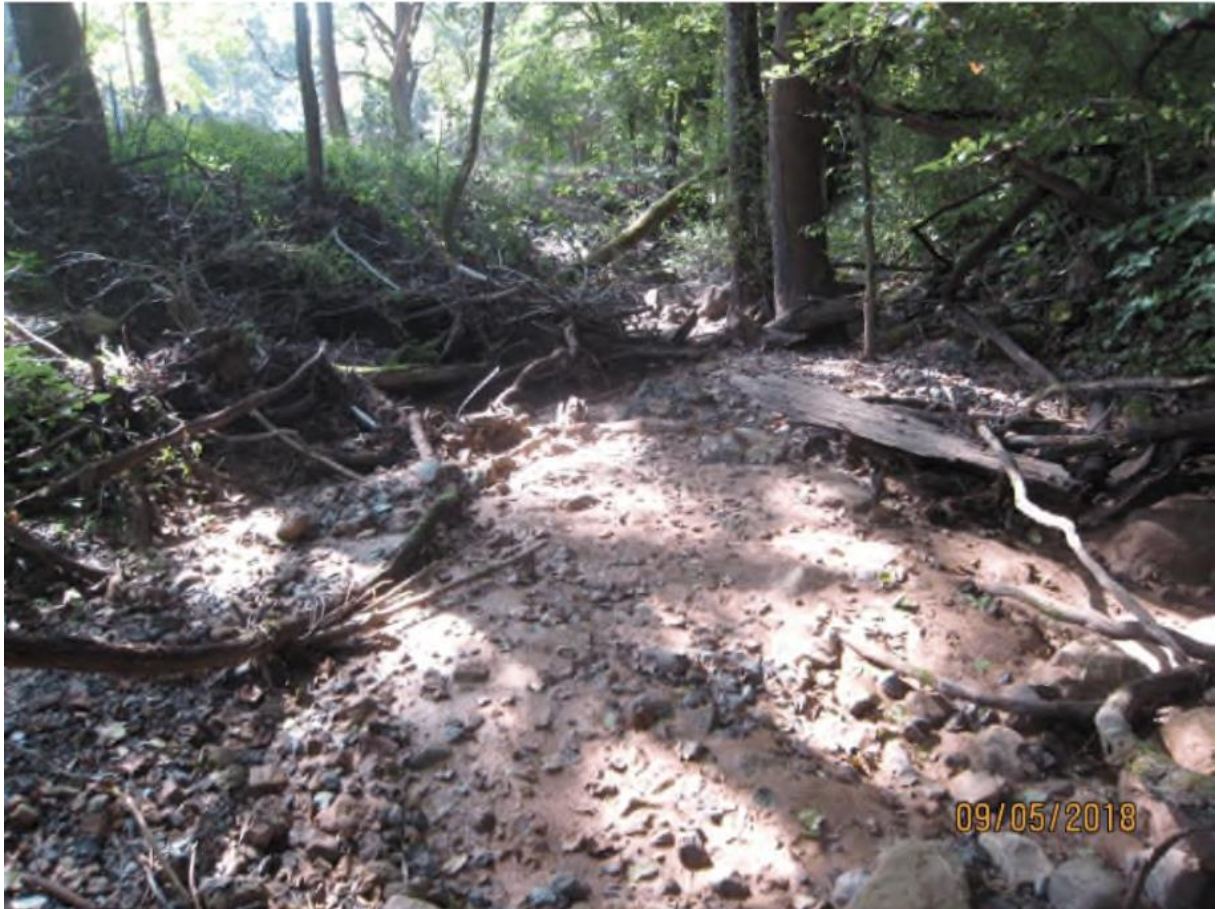
**Figure 34** - Sediment deposited in Kimballton Branch, September 5, 2018, VWP inspection report, Spread G, Source: DEQ [Approx. 630 linear feet of Kimballton Branch stream channel impacted by sedimentation. Deposits up to 9 inches depth. Report indicates that aquatic life movement substantially disrupted.]

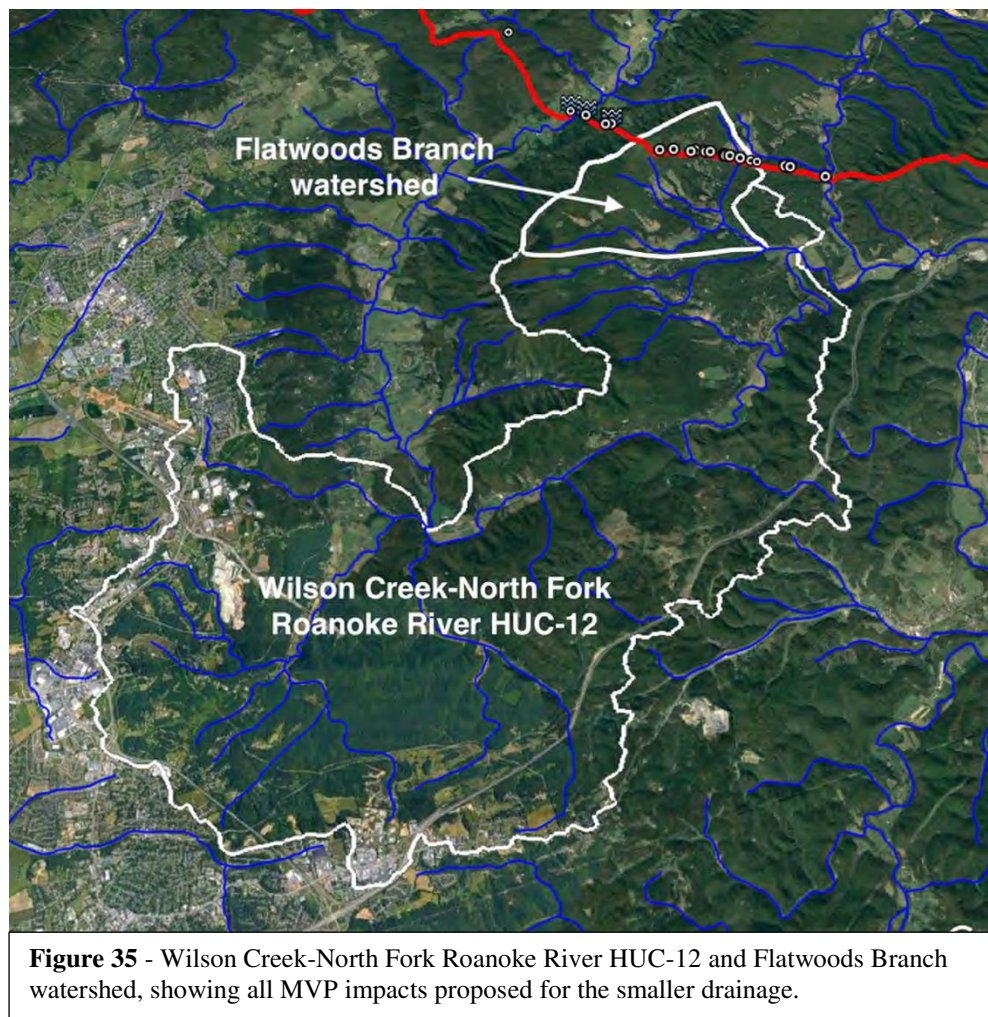
More than 1.6 miles of the pipelines path runs through the Flatwoods Branch watershed, descending nearly 1,000 feet in elevation, from the ridge of Paris Mountain to the Flatwoods crossings.

The watershed of Flatwoods Branch lies within the Wilson Creek-North Fork Roanoke River HUC-12 (030101010202), which is 25,895 acres in size. The Flatwoods drainage comprises just about 11% of the HUC, measuring 2,787 acres. As shown in Figure 35, all of MVP's proposed crossings and the ROW within this HUC area fall within the Flatwoods Branch watershed. Thus, the rational scale on which to base a cumulative impacts analysis is the one drainage that will be so heavily impacted.

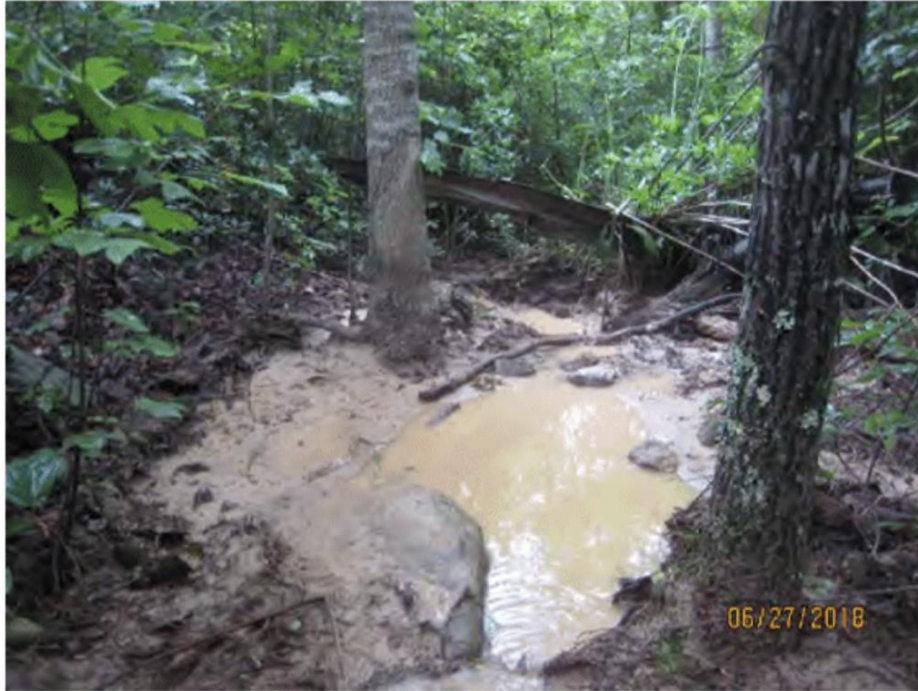
**Photo 1:** Sedimentation within "SMM-15" ~160' downstream of LOD; Depth = 3"  
**Orientation:** Downstream

**Figure 36-** Sediment deposits in UT Flatwoods Branch, June 27, 2018, VWP  
 Inspection Report, Source: DEQ [original photo caption retained]

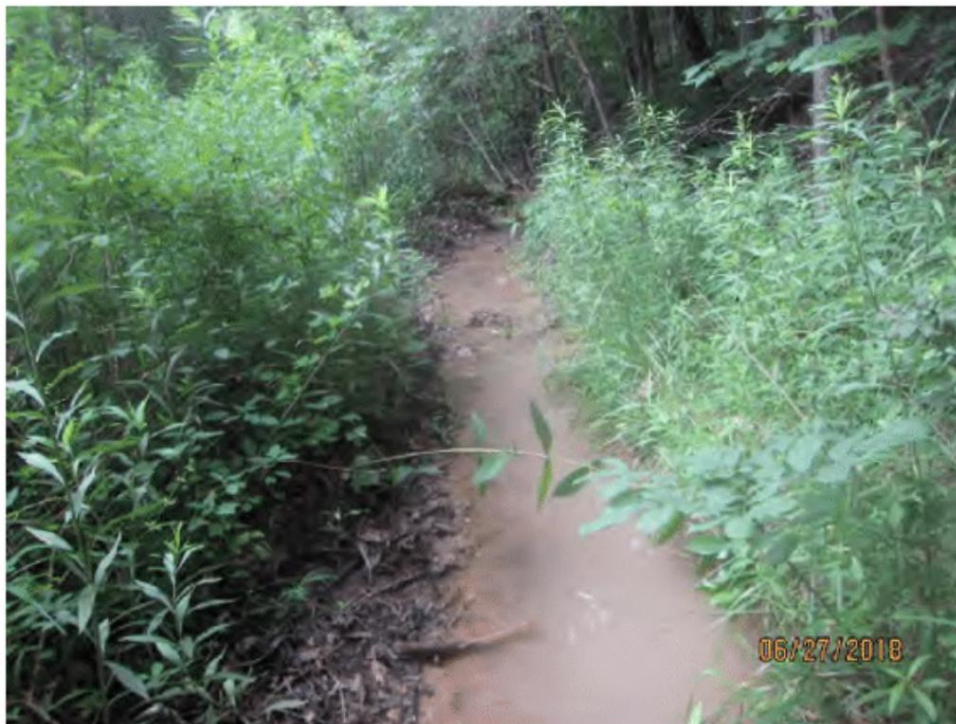
**Photo 4:** Sediment in stream ~3,485' from LOD near access road; Depth = 2"  
**Orientation:** Downstream

**Figure 37-** Sediment deposits in UT Flatwoods Branch, June 27, 2018, VWP  
 Inspection Report, Source: DEQ [original photo caption retained]
