A REPORT BY WILD VIRGINIA

FEBRUARY 2023

# MOUNTAIN VALLEY PIPELINE POLLUTION IN VIRGINIA WATERSHEDS

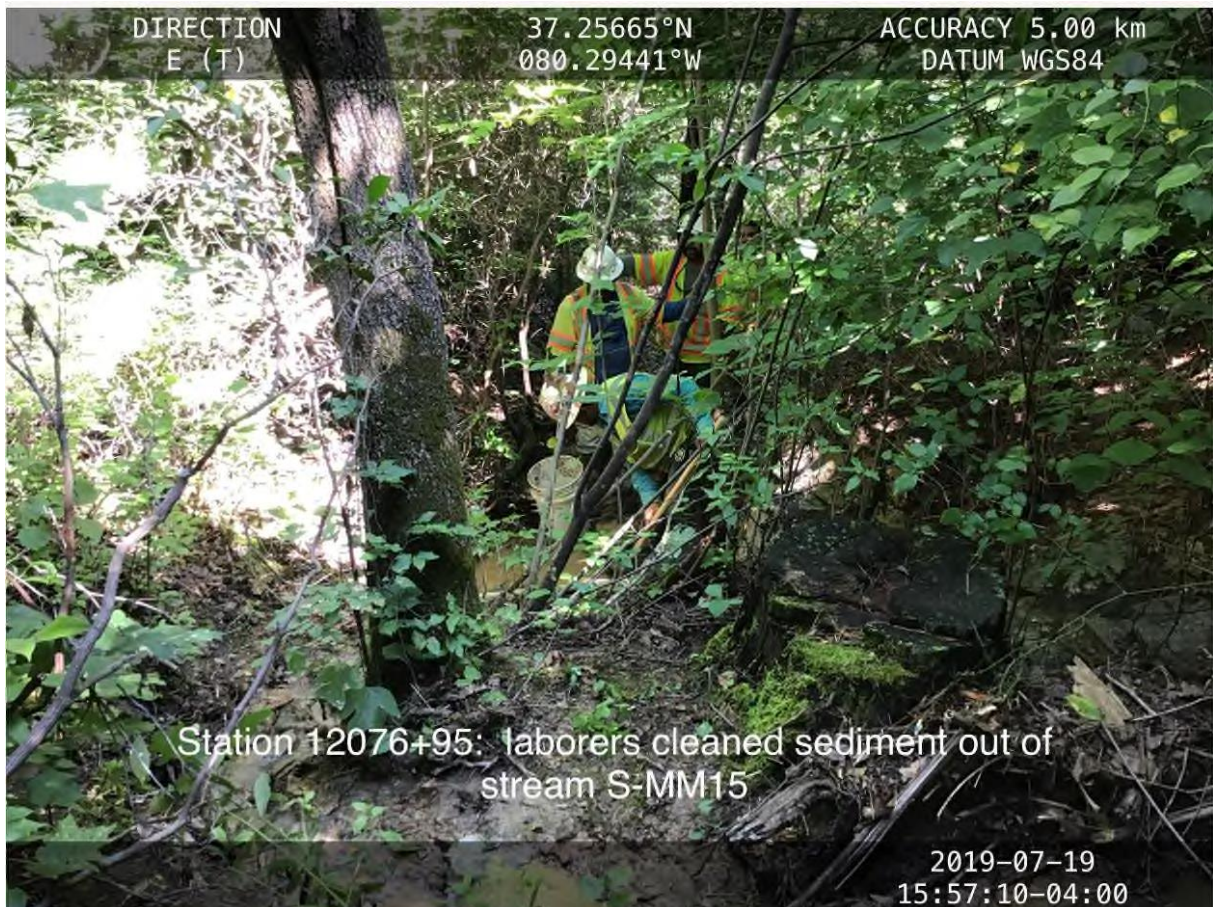
**Figure 38** - Sediment deposited in UT Flatwoods Branch, July 19, 2019, Action Item Log ID 3248, Source: MBP [This is an example of what inspectors often term "remediation" through physial removal of sediments from the stream, using shovels and buckets.]

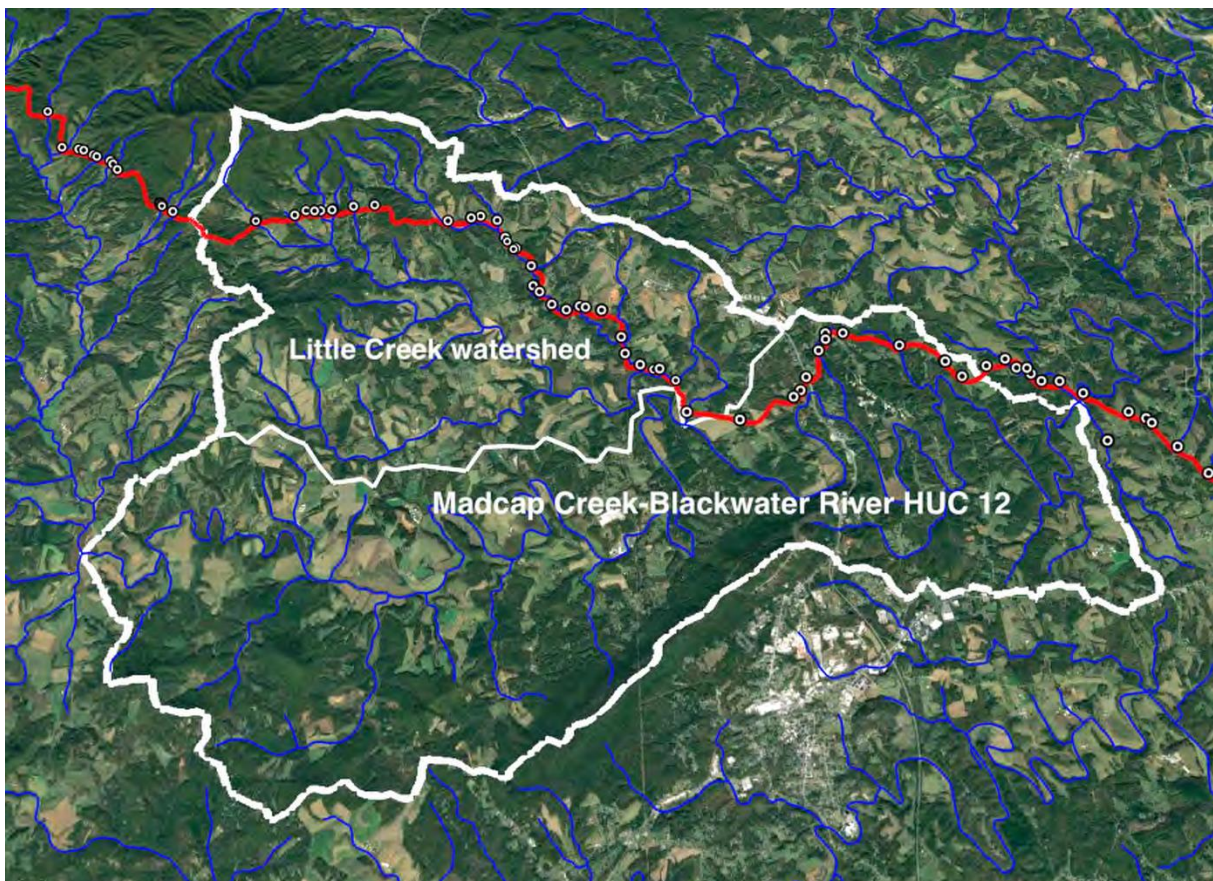
**Figure 39** - Annotated satellite image showing Madcap Creek HUD-12 and the Little Creek watershed that form part of the HUD area.

While the Madcap Creek-Blackwater HUC is not an appropriate area for this purpose, it may be argued that a useful analysis of combined impacts can be made for the the Little Creek watershed. As shown in the image below, the concentration of pipeline features, both ROW acreage and proposed new discharges, is highly concentrated in this drainage. All sediment discharges from the MVP and other sources in the watershed may affect the downstream portions of Little Creek, to its mouth at the Blackwater River, and there are likely significant biological linkages in this system of headwaters and larger stream segments.

Within the Little Creek watershed, Mountain Valley proposes 51 new discharges (43 to streams and 8 to wetlands). These would affect Little Creek, its largest tributary Teels Creek, and numerous other unnamed tributaries to these two streams. This is an extraordinary number of new pollution sources concentrated in one drainage.

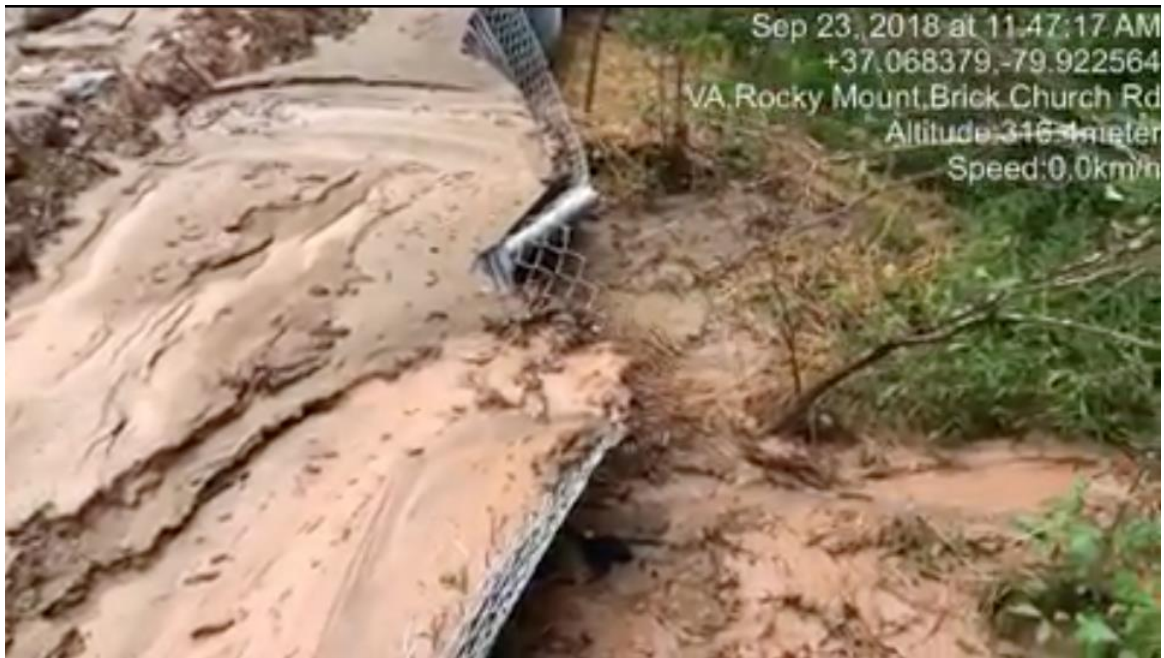
**Figure 39** - Sediment deposits off ROW, at UT to Teels Creek, September 23, 2018, Source: citizen monitor

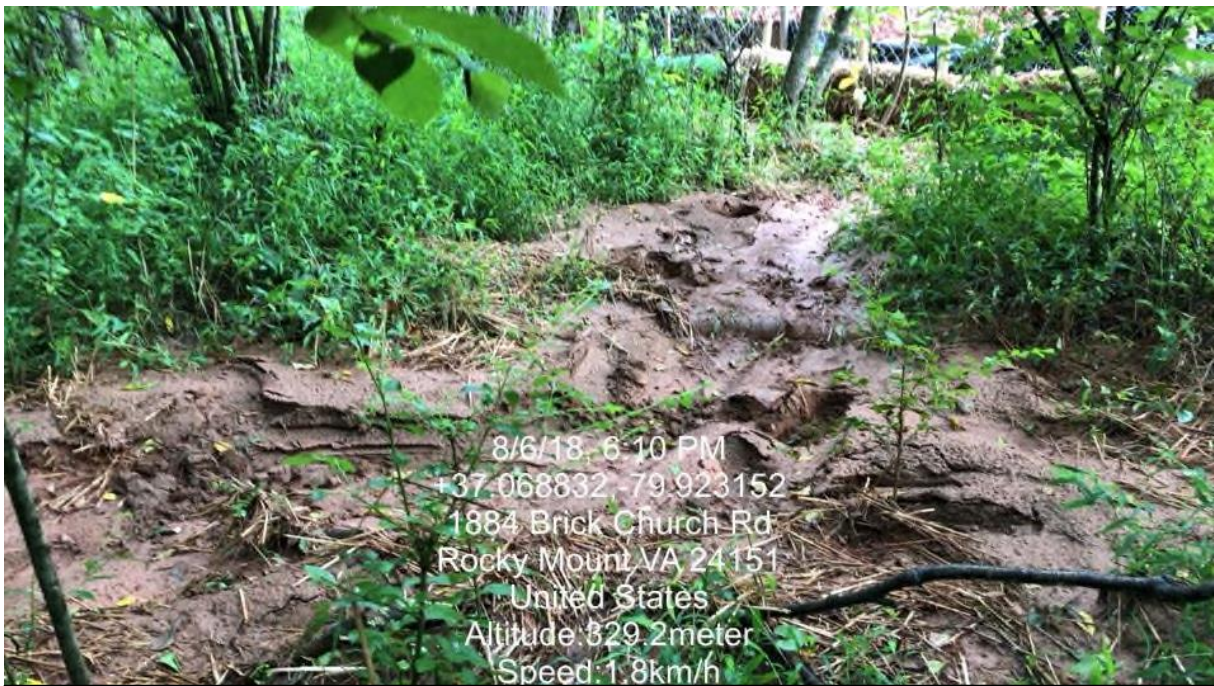
**Figure 40** - Sediment deposits off ROW, at UT to Teels Creek, September 23, 2018, Source: citizen monitor

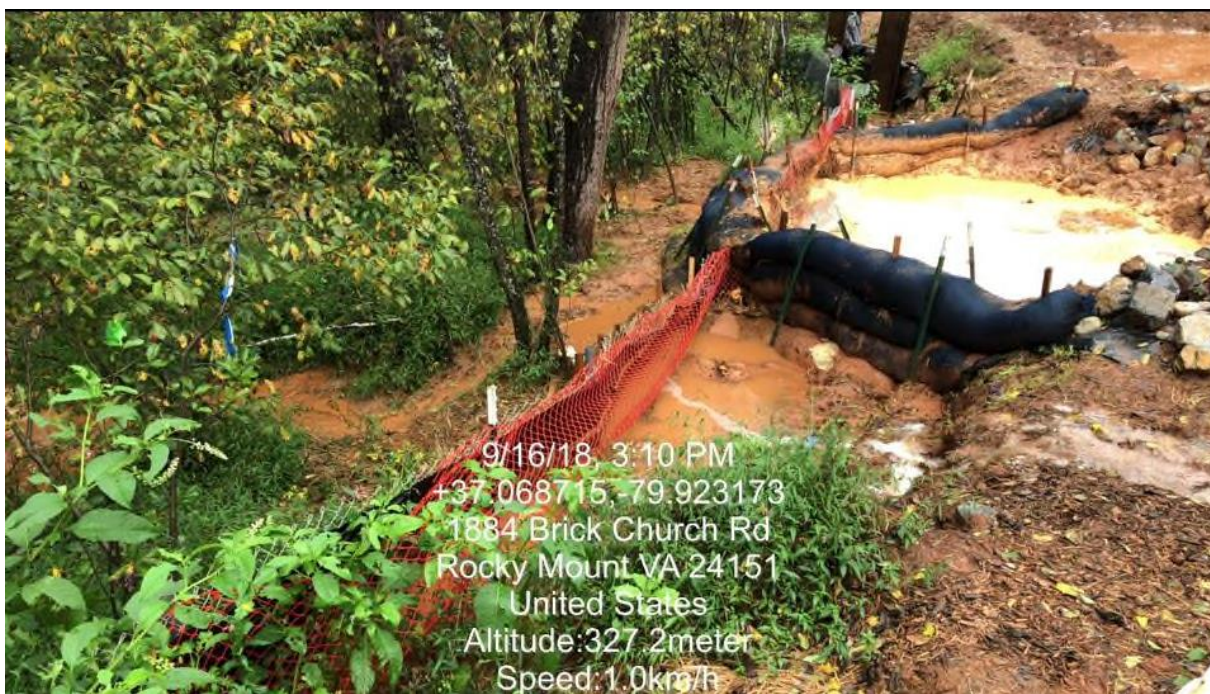
**Figure 41** - Sediment deposits off ROW, at UT to Teels Creek, September 23, 2018, Source: citizen monitor.

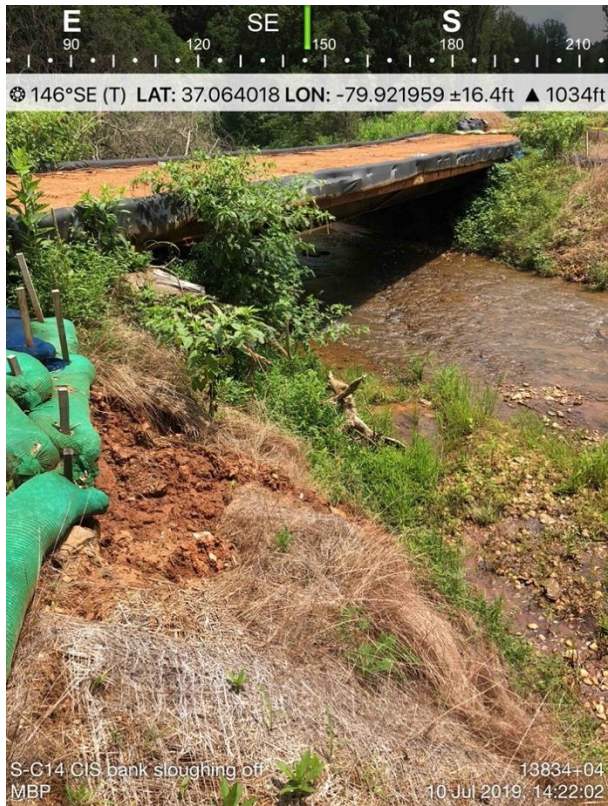
**Figure 42** - Stream bank eroded at MVP site, Teels Creek, July 10, 2019, Action Log ID 3187, Source: MBP

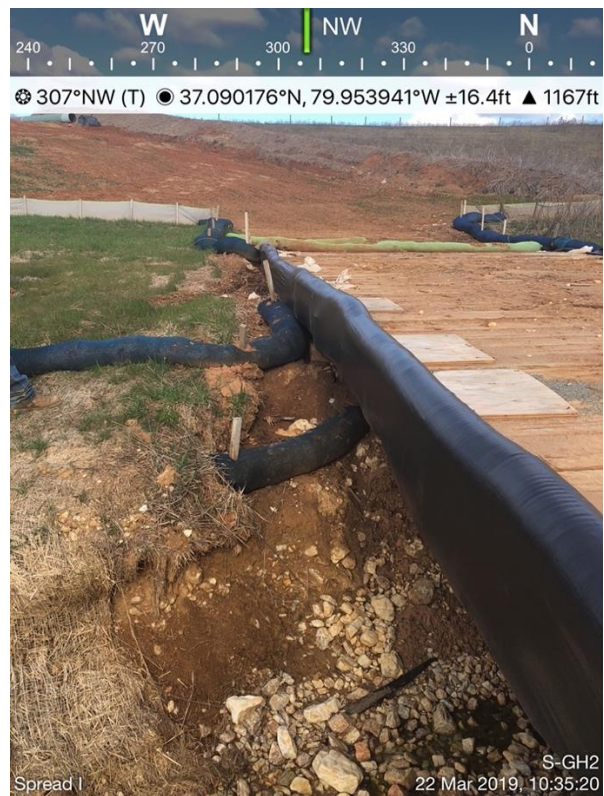
**Figure 43** - Stream bank eroded at MVP site, UT Teels Creek, July 10, 2019, Action Log ID 2313, Source: MBP

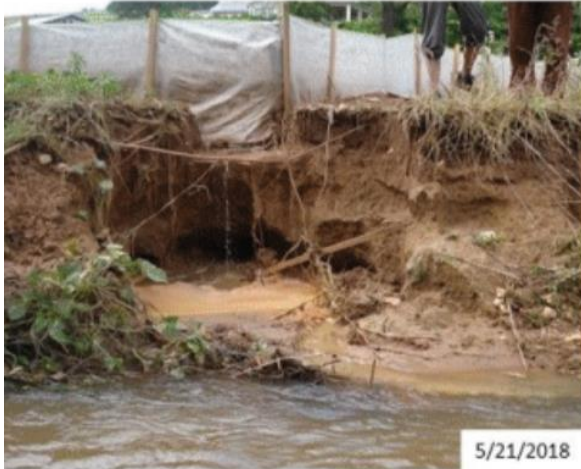
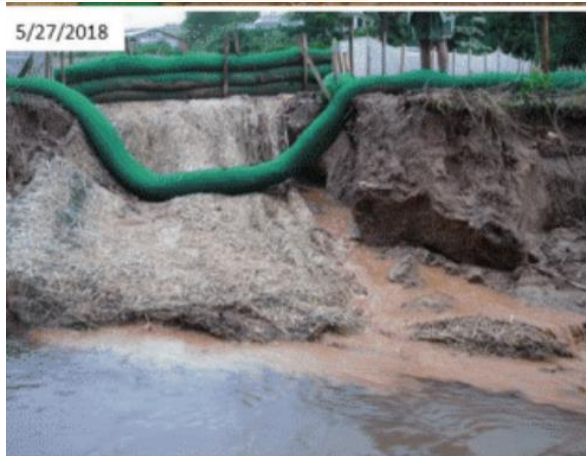
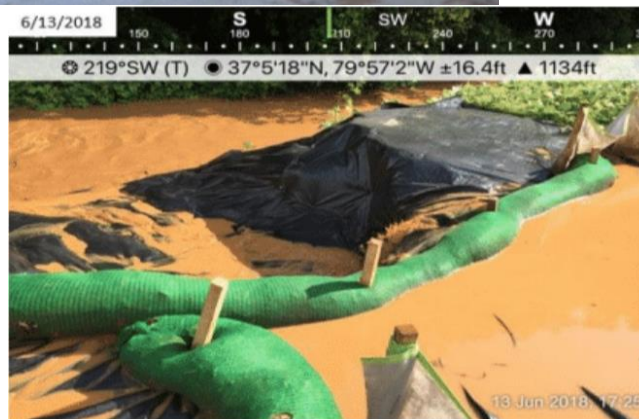
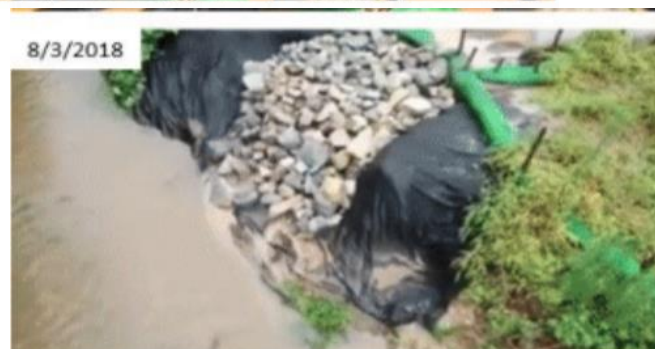
**Figure 44** - A series of views of a collapsing stream bank on Teels Creek and Mountain Valley's attempts to repair the damage over several months in 2018. Source: Mountain Valley Watch Report, Appendix F to this report.

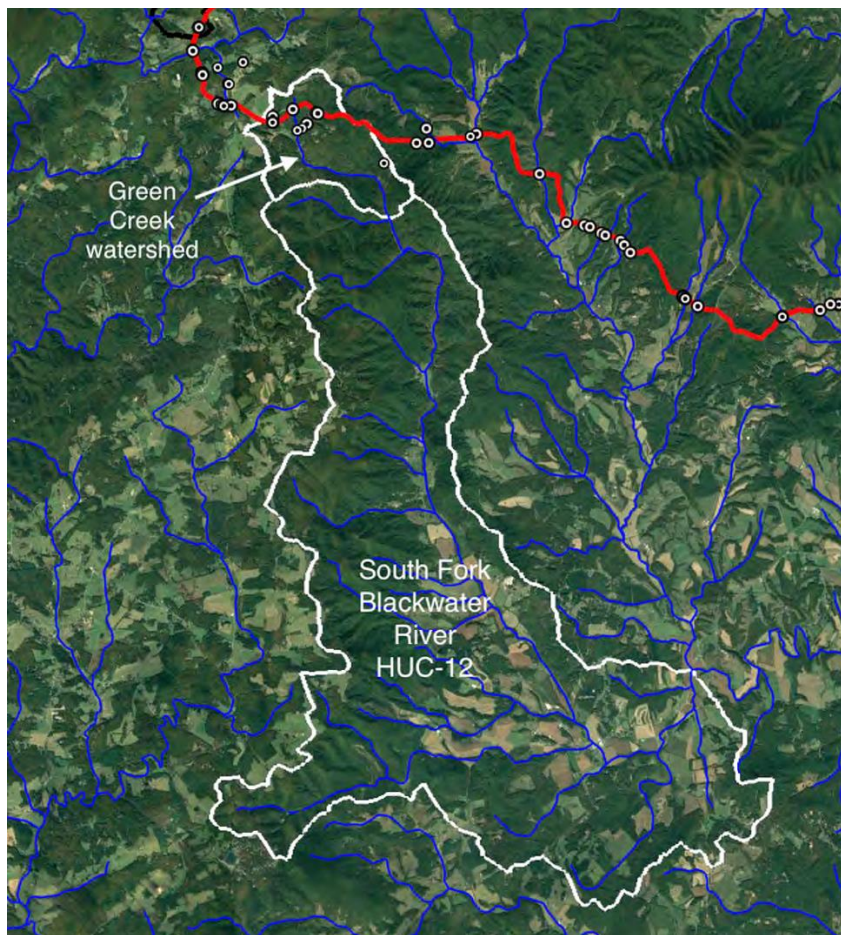
**Figure 45** - Annotated satellite image of South Fork Blackwater River HUC-12 and Green Creek watershed, with MVP ROW and discharge only in the headwaters.

The entirety of the pipeline ROW within the HUC-12 unit passes across this watershed for a distance of about 1.23 miles and there are fourteen new discharges proposed - 9 to streams and 5 to wetlands.<sup>63</sup> As shown on Figure 45, all of the pipeline's impacts would occur in just the very headwater section of the watershed. This concentration of impacts in just one small drainage makes it imperative that any cumulative impacts analysis focus on this area.

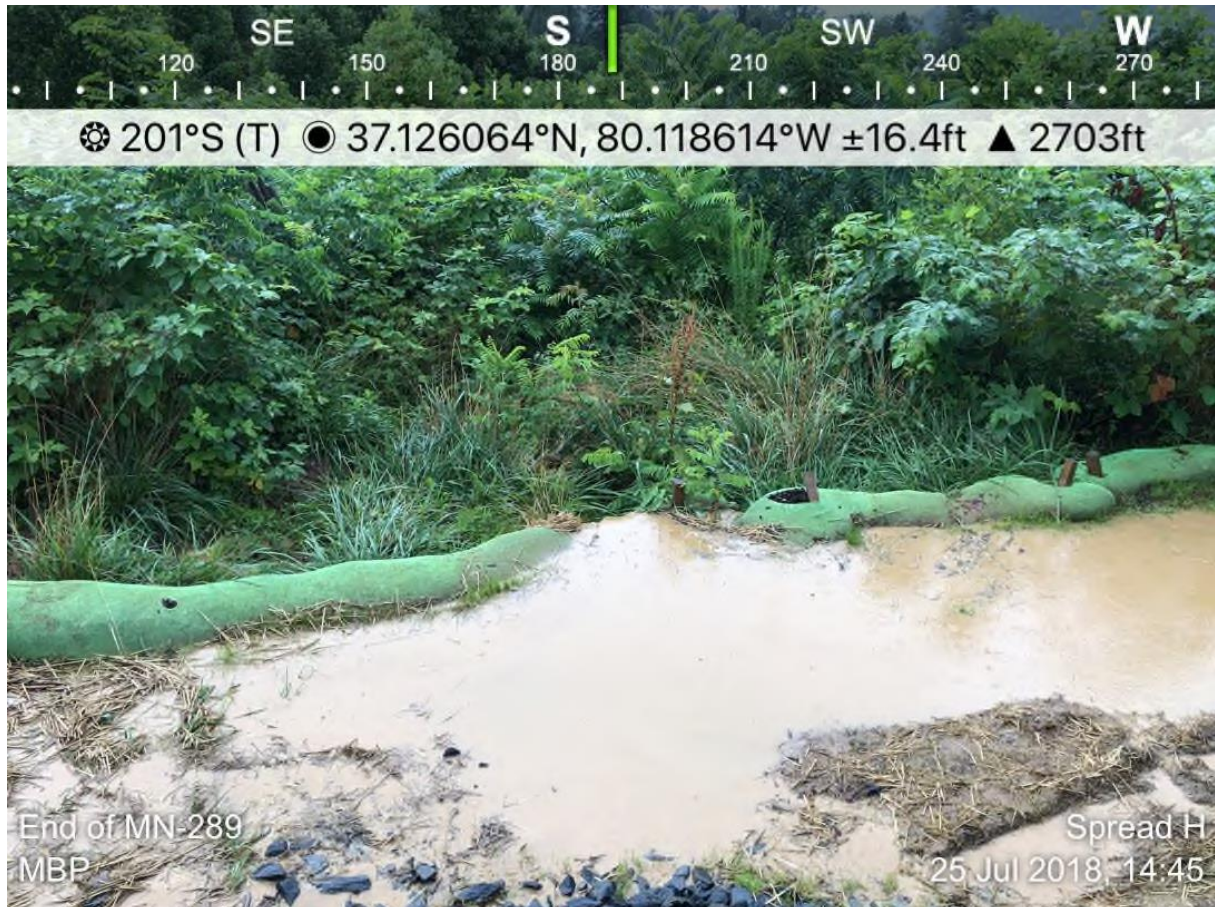
**Figure 46** - Sediment-laden water overtopping perimeter control, July 25, 2018, Action Log ID 458, Source: MBP [an additional compost filter sock was added 10 days after this situation was observed]

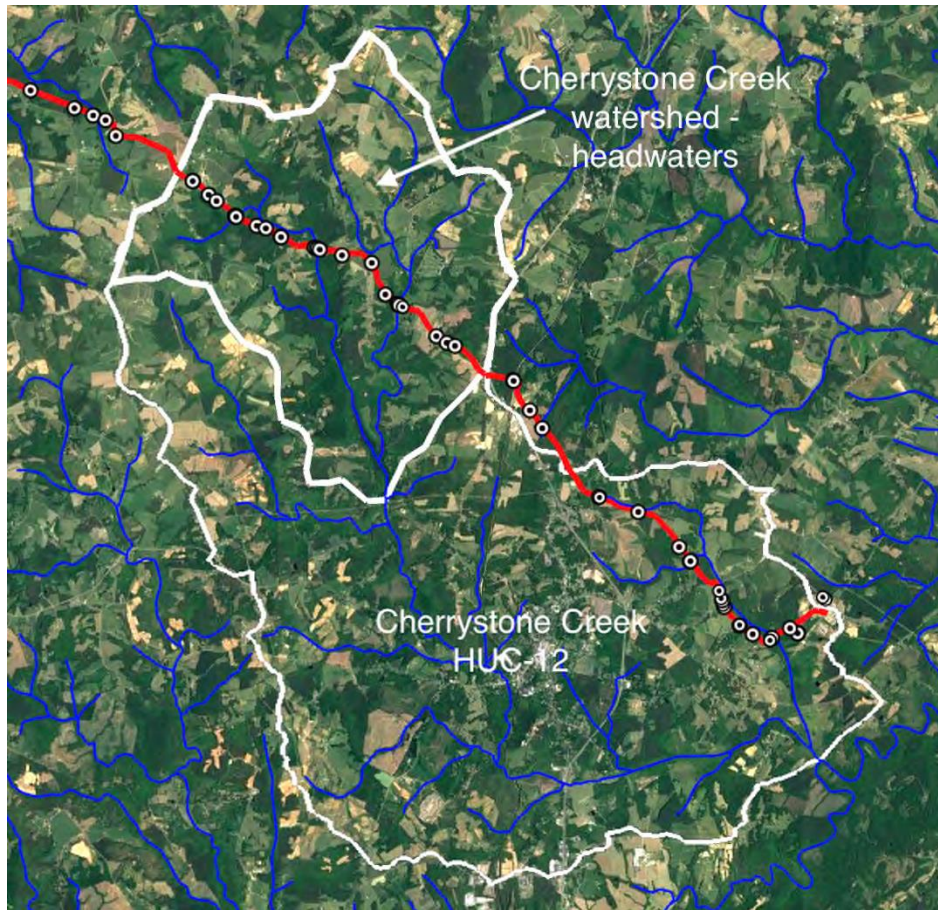
**Figure 47** - Annotated satellite image of Cherrystone Creek HUC-12 and upper Cherrystone Creek watershed.

The Cherrystone Creek HUC-12 unit is a watershed measuring 29,138 acres in size.<sup>64</sup> The upper Cherrystone watershed examined here covers an area of 8,720 acres or about 30% of the HUC-12 area. Of 48 new discharges proposed in the HUC area (34 to streams and 14 to wetlands),<sup>65</sup> 28 (21 stream and 7 wetland) are within this headwater drainage. An analysis of the combined new discharges in the Cherrystone HUC unit may be useful, since the mainstem Creek is affected in two sections.

However, an analysis of combined effects in the upper watershed is vital for a number of reasons. Nearly four and a half miles of the pipeline's ROW crosses the upper watershed and both the Creek itself and nearly every other significant tributary, including the largest, Pole Bridge Branch, is crossed by the pipeline ROW.

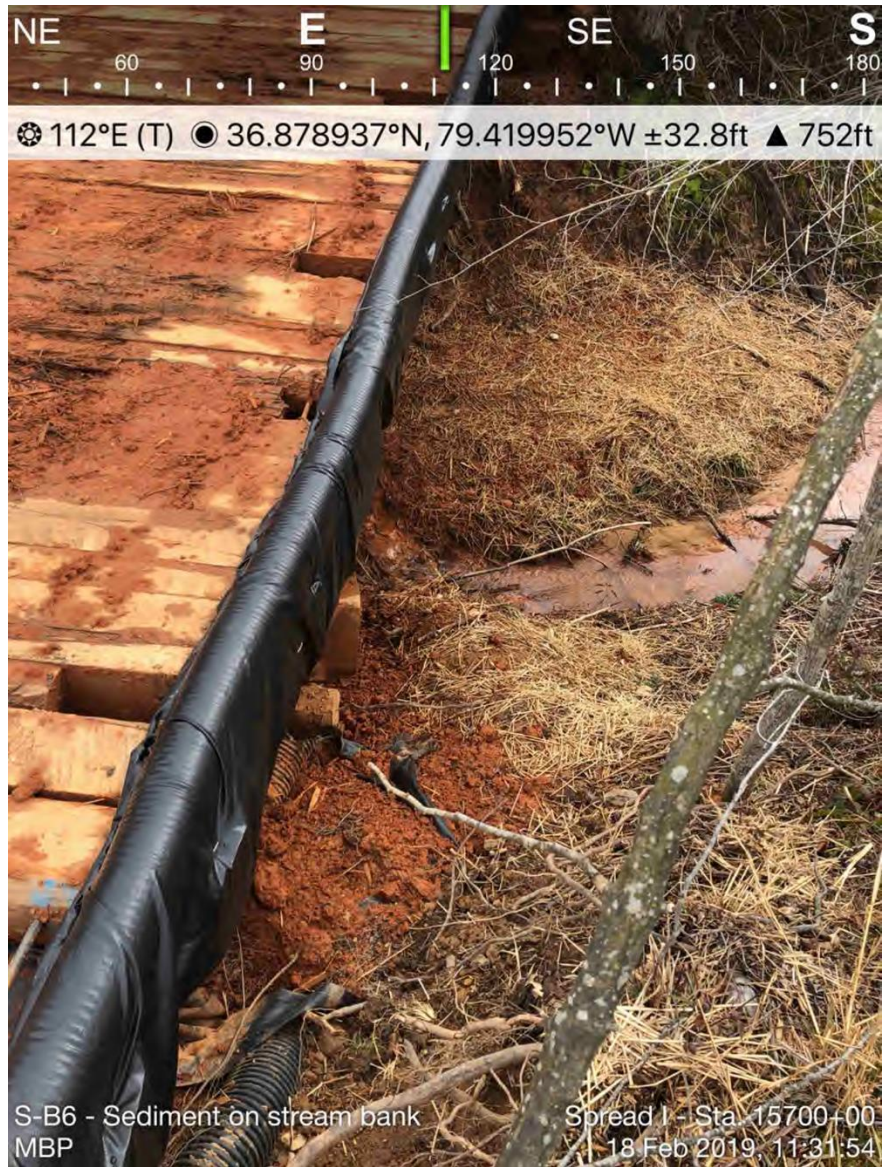
**Figure 49** - Sediment deposited off ROW onto streambank at UT to Pole Bridge Branch, February 18, 2019, Action Log ID 1901, Source: MBP [deadline to remove extended "due to wet ROW," not removed until 6 days after deposited]
