The Angle Property

The following photographs portray damage and violations caused by MVP on land and waters at the Angle family's property in Franklin County. The problems stem from MVP's failure in a number of specific requirements.

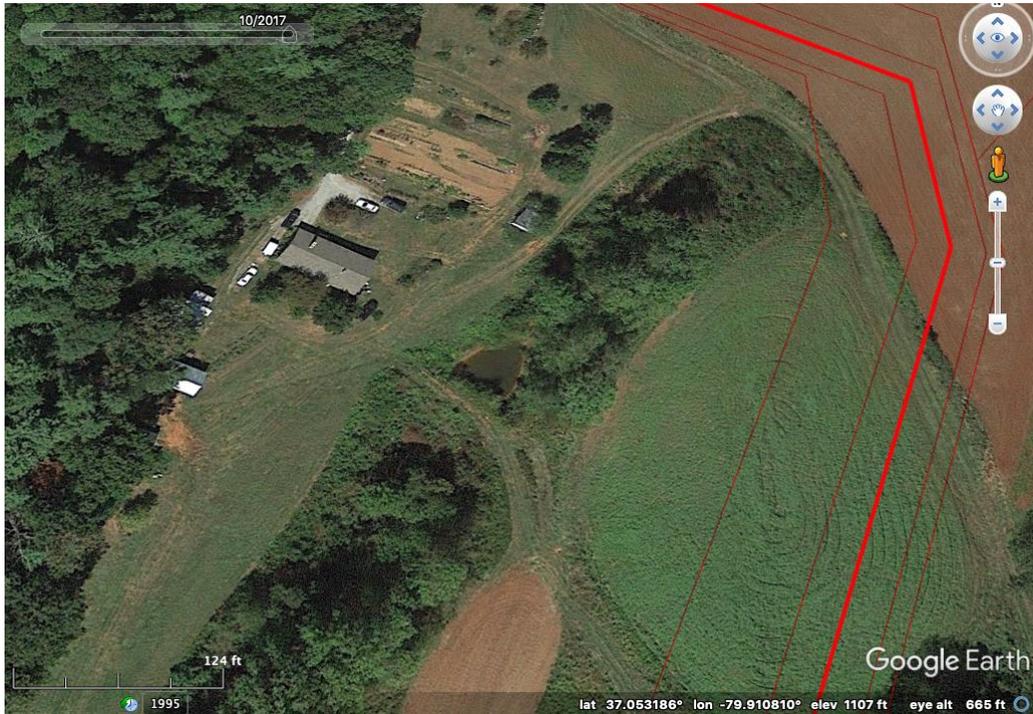
For comparison to the view above, here are two historical views of the Angle's pond from Google Earth. The first just months before MVP construction began and the other eight years ago.

Figure 10 - Angle Property and pond, October 2017 (right-of-way in red)

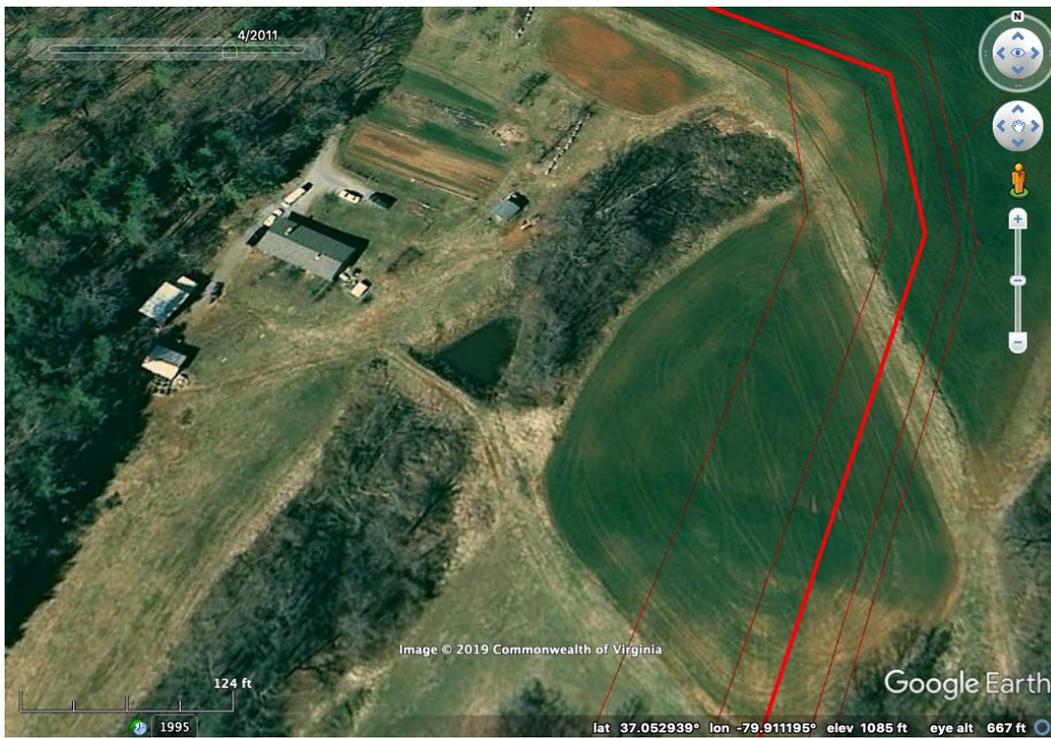
Figure 11 - Angle Property and Pond, April 2011 (right-of-way in red)
